MULTIPURPOSE DISASTER SHELTER PROJECT (MDSP)

Subject : Field Visit Report of the M&E Consultants of MDSP in Bhola District.

FIELD VISIT REPORT

6. Sites visited: 6 nos. of New construction of shelter sites in **Pkg. No. NW-11**

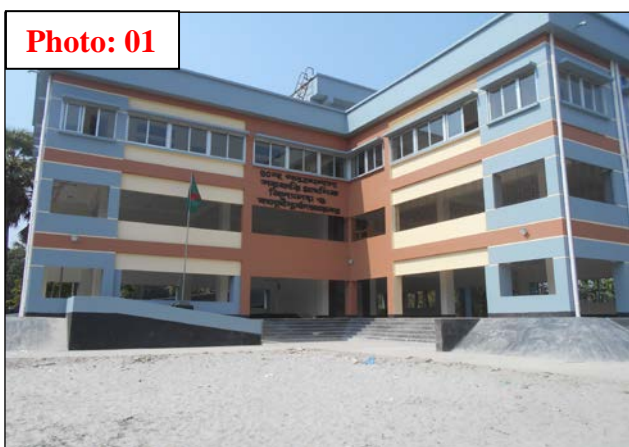
Architectural Look of the Shelter Buildings: The newly completed shelter cum school buildings have very nice look (Photo: 01). The completed shelters have provision of all modern facilities like water supply, sanitary toilet, electric power supply, solar power supply, rain water harvesting arrangements, underground water storage reservoir, dedicated floor with ramp for livestock accommodation, metaled internal road, shelter access road, supply of new furniture for teachers and students etc. These will indeed create confidence amongst the stakeholders to take shelter during devastating cyclone fore-casts. The new structure will also create a very congenial school environment. The overall quality of works of the shelters is good. The verandah is quite spacious (Photo: 02).

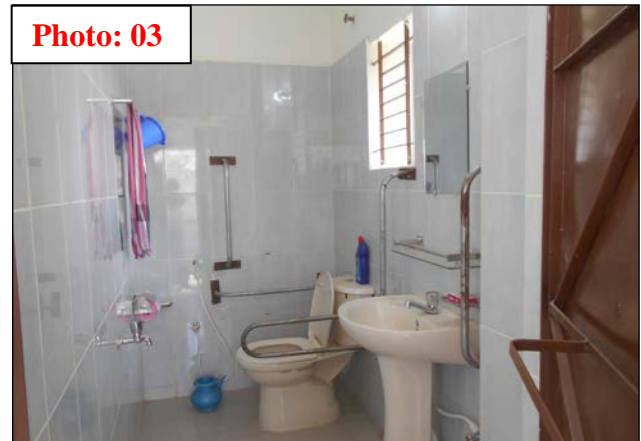
Photo: 03

The main source of water supply to the toilets is the overhead tanks receiving water from the submersible pump. The total water supply system is working properly in the visited shelter sites as reported by the school authorities (**Photo: 03**). All the submersible pumps must be kept fully operative to keep the whole water supply and sanitary system functioning properly creating a good hygienic environment.

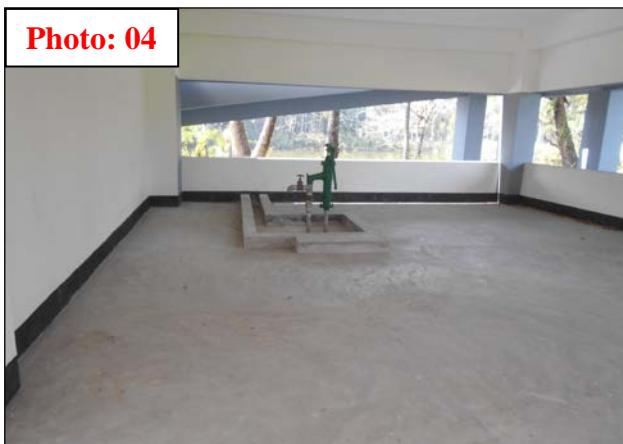
Photo: 04

DTWs were found in operation in most of the shelters (**Photo: 04**) but in some shelters these were found inoperative in GF due to pilferage of head and gate valve (**Photo: 05**). Due care must be given to keep safe the DTWs.

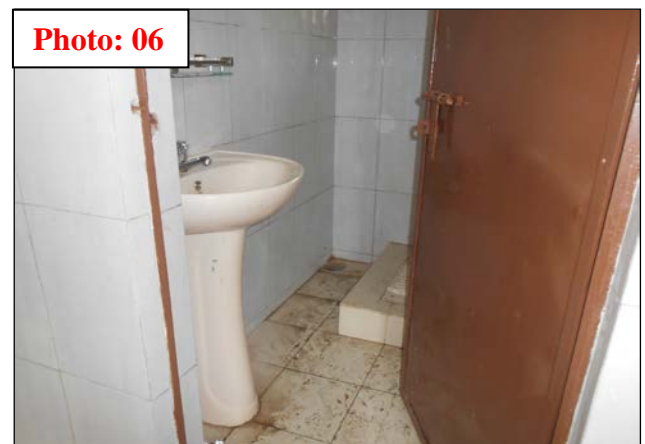
Photo: 06

Toilets have been fitted with nice tiles and fixtures (**Photo: 03**). But in some shelters, toilets at 1st floor were found uncleaned (**Photo: 06**). School Authority should take due care to keep the toilets clean.

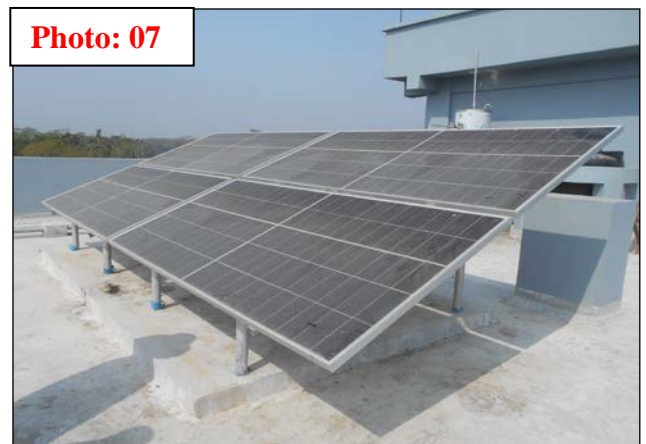
The newly installed electrification system is complete. Fans, lights etc. are working properly. The solar power system has also been found working properly (**Photo: 07**).

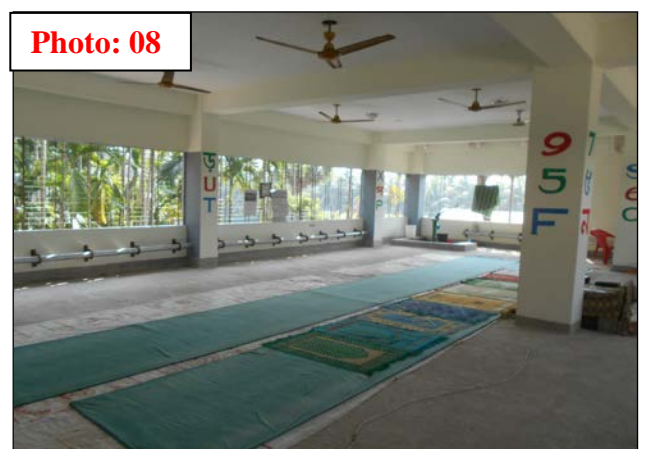
The 1st floor is also being used as prayer room (**Photo: 08**)

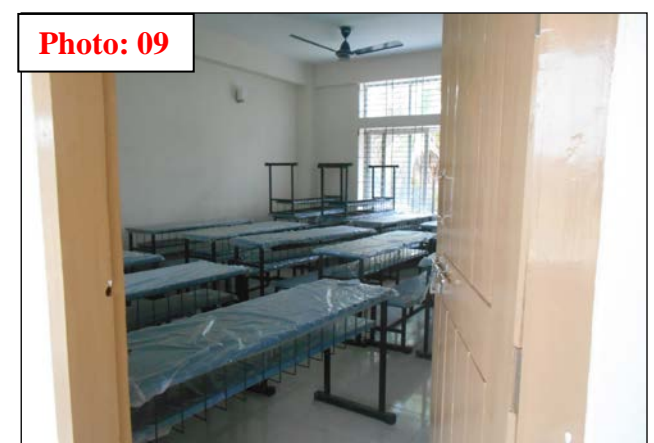
Supply of scheduled nos. of School Furniture has been completed as reported by the School Authority (**Photo: 09**)

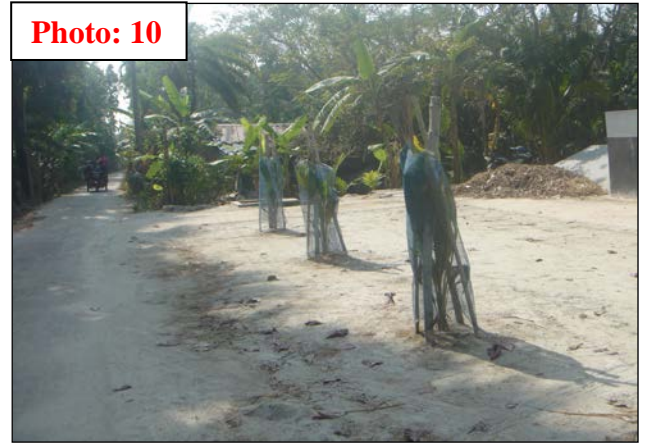
Plantation has been done in most of the shelters but post plantation nursing activity is lagging in almost all the cases. The (Photo: 10).

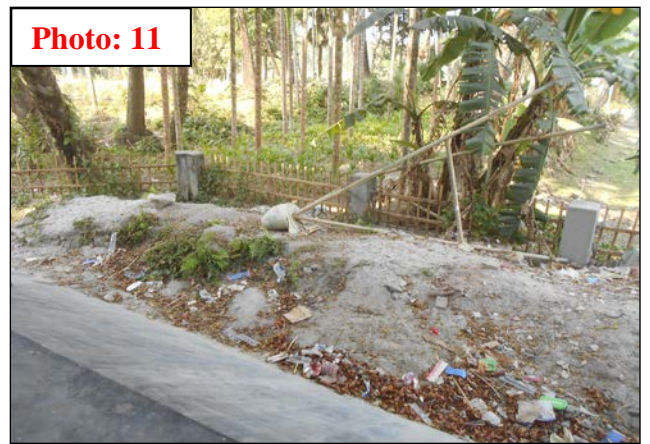
Site Cleaning: Fair post construction site cleaning has been done in many shelters. However, yet some shelters are lagging in this respect. Debris in **BHP-1202** should be removed as early as possible (Photo: 11).

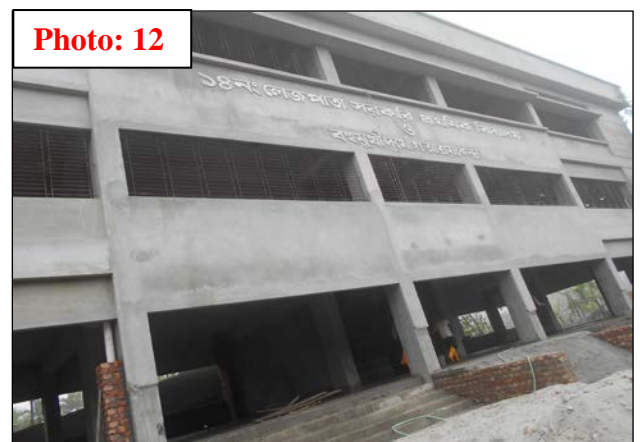
- **BHP-309:** Frame of the RCC structure including ram and part of the ancillary works have been done (Photo: 12).

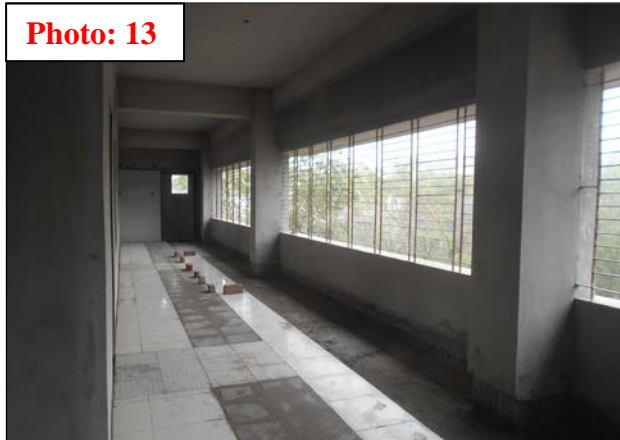
Brickwork; plastering work; tiles placement works at 2nd floor and staircase; plumbing/ sanitary works at toilets; railing placement at staircase; electrification works; installation of solar panel; fitting & fixing of PVC water tank and filter at roof etc. **(Photo: 13)**. Painting works, placement of wooden door shutters and Thai aluminium have not yet done **(Photo: 14)**.

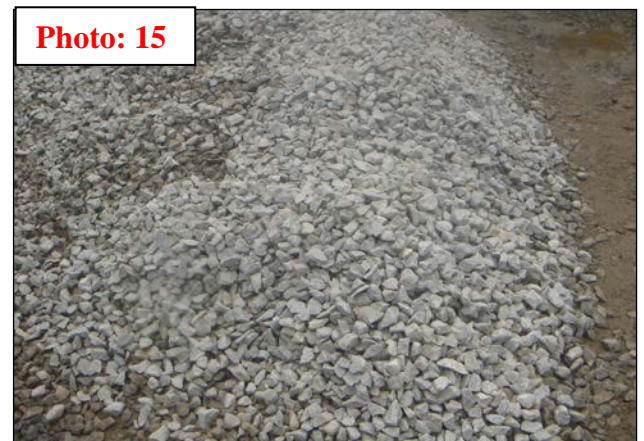
Stone Chips: The stone chips as procured does not appear to be properly graded. **(Photo: 15)**

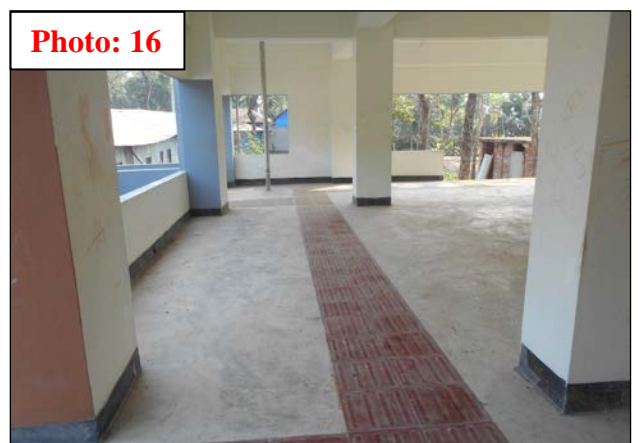
- **BHP-512:** Frame of the RCC structure including ram and part of the ancillary works have been done **(Photo: 16)**.

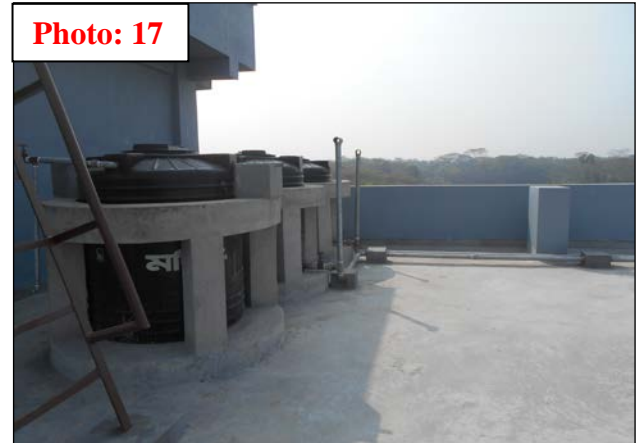
Plumbing/ sanitary works at toilets; electrification works; installation of solar panel; fitting & fixing of PVC water tank and filter at roof; painting works etc. **(Photo: 17)**. Thai aluminium work has not yet done.

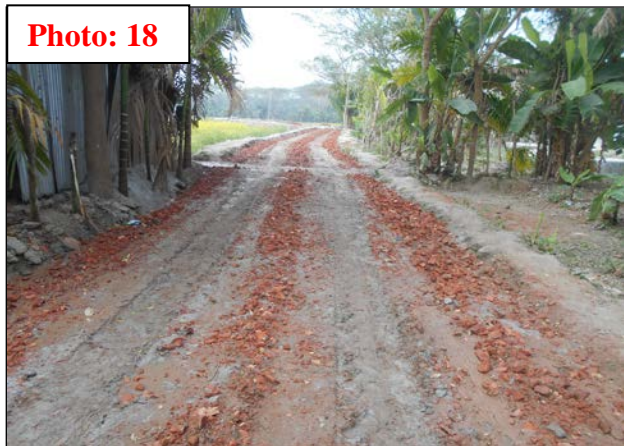
Construction work of the shelter connecting road has already been started. Preparation of sub-base is still ongoing **(Photo: 18)**. Construction of 7 nos. of culverts along the road has also been completed **(Photo: 19)**.

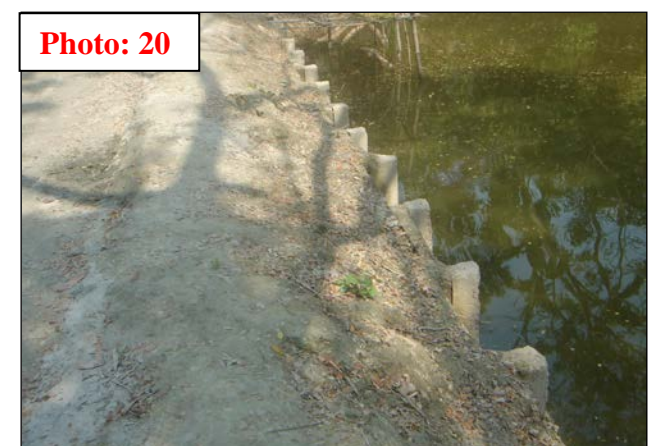
Bank protection work of the road has been completed **(Photo: 20)**
