**MULTIPURPOSE DISASTER SHELTER PROJECT (MDSP)  
Monitoring & Evaluation (M&E) Consultant**

**FIELD VISIT REPORT**

1. Period of Visit : 05 February – 06 February 2018
2. Location of Visit : MDSP Sites under Chittagong District.
3. Package No. : Pkg. No. LGED/MDSP/CHI/W-01
4. Name of Contractor : M/S M.A.H. Construction Ltd. & Munir Ahmed JV
5. Participant of visit : A.H.M. Mahbubur Rahman, TL, M&E Consultant,  
Md. Matiur Rahman, Civil Engineer/ M&E Specialist, M&E Consultant,  
Dr. Md. Barkat Ullah, Environment Specialist, M&E Consultant,
6. Officials met during Visit :

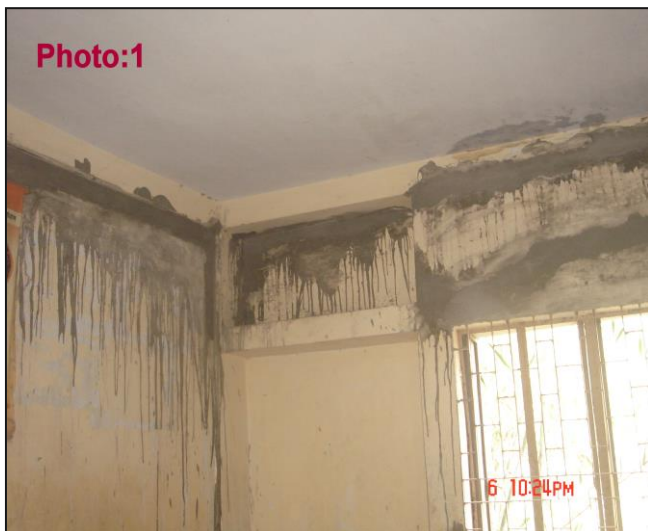
**Rehabilitation Need Assessment:** Assessment of the rehabilitation needs of the shelters should have been more exhaustive targeting overall and sustained stability of the infrastructures instead of doing some patch repair works (**Photo: 1**). In CTGE- 216, one beam on the ground floor was seen to be done by the contractor at his own initiative as it is not included in the BoQ. There is no drop wall to support the filled earth of the ground floor located close to a pond. The earthen ground floor need to be pucca. (**Photo: 2**).

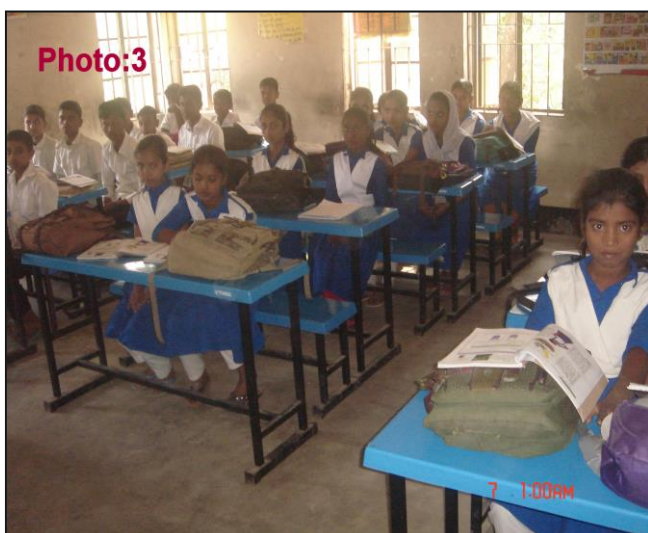
- **Supply of furniture:** High and low benches for use of the students have been supplied in some of the schools (**Photo: 3**). The high benches do not have separate shelf for keeping school bags. High benches with separate shelves may be supplied (**Photo: 4**).

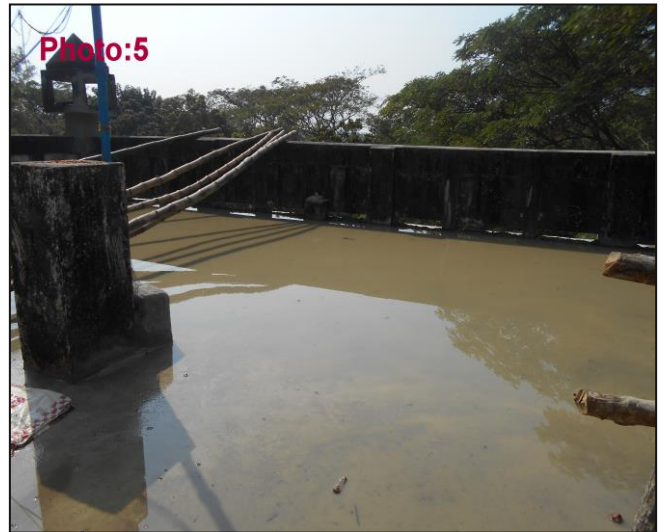
- **Roof Top Screeding:** This item of work has been completed in CTGE-187, CTGE-189, CTGE-02, CTGE-11), CTGE-37, CTGE-711 CTGE-204 and CTGE-216 (**Photo: 5**). This work was necessary stop leakage of water through the dilapidated roof slab.

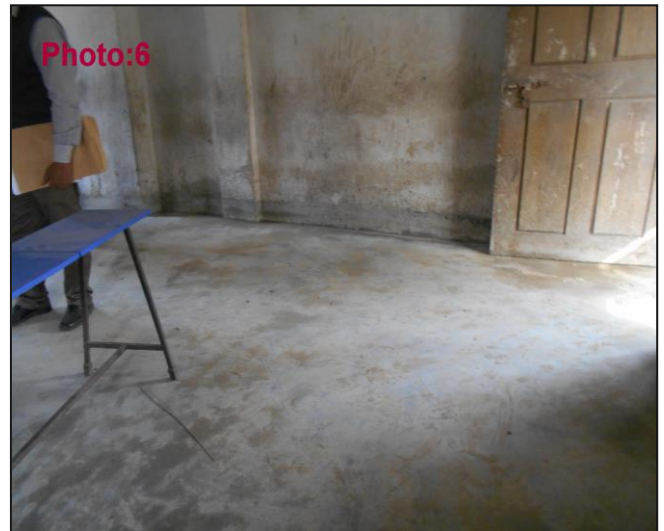
- **Lean Concreting & Patent Stone Casting:** This item of works have been completed at ground floor/ 1<sup>st</sup> floors and staircases as necessary in CTGE-187, CTGE-189, CTGE-37, CTGE-711 & CTGE-204 (**Photo :6**). Works are still ongoing in CTGE-02 & CTGE-11.

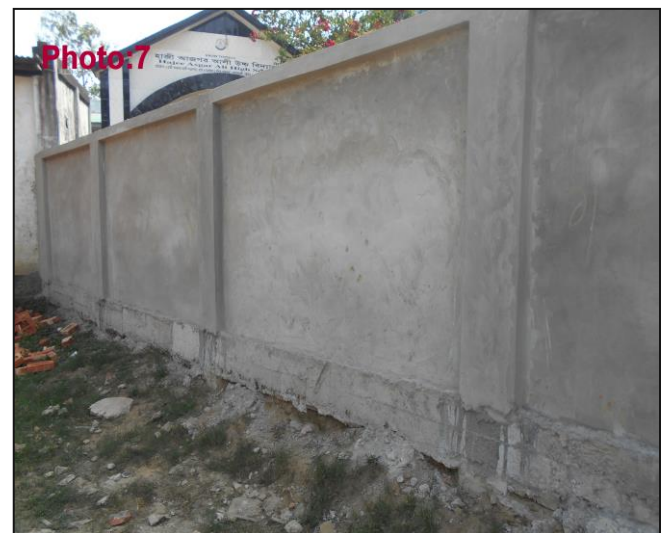
- **Brick Work and Construction/ Re-construction of Boundary Walls:** Brick work at ground floor is included in CTGE-187 & construction of boundary wall in CTGE-189 (**Photo :7**). Both works have been completed.

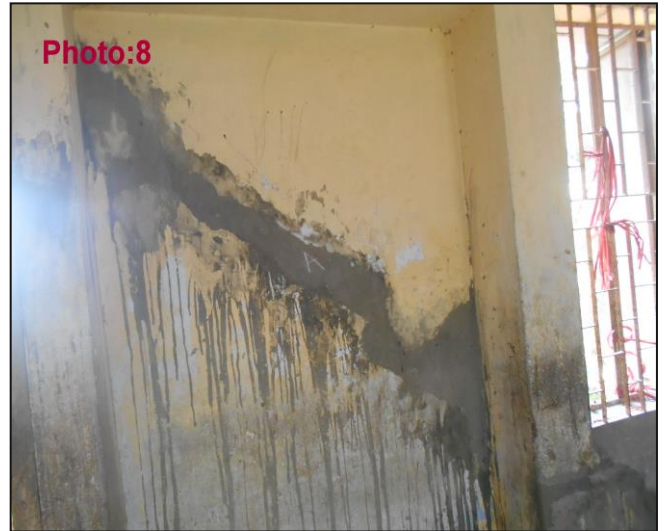
- **Outside and Inside Plastering Works:** Petty plastering works on the walls at ground floor/ 1<sup>st</sup> floors and staircases as necessary have been done in CTGE-711. Same works are still ongoing in CTGE-187 CTGE-189, CTGE-02, CTGE-11, CTGE-37, CTGE-204, CTGE-216 & CTGE-215 (**Photo: 8**).

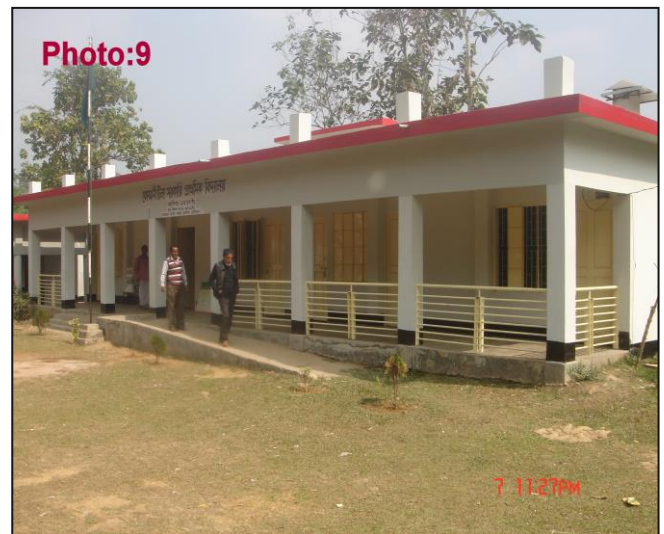
- **Outside and Inside Painting Works:** Outside and Inside Painting Works are included in all shelter sites. Works are on-going only in CTGE-02. It was seen that painting works in CTGE-711 is nearing completion. (**Photo: 9**). It was informed that Berger plastic paint will be used in all shelters.

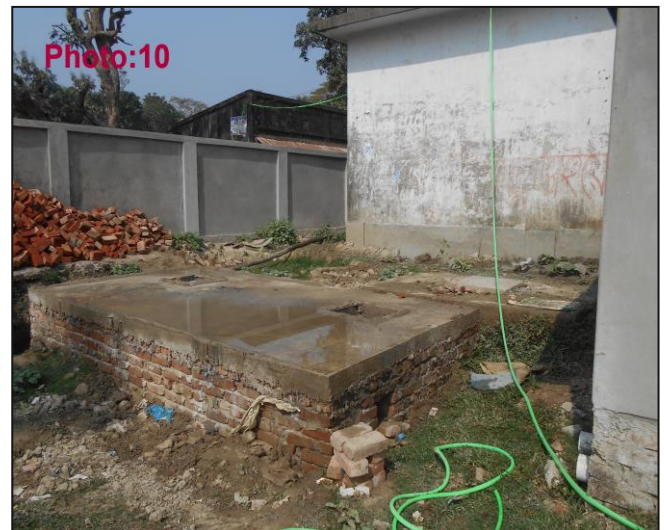
- **Construction/ Cleaning of Septic Tank:** Septic Tank construction was seen to be done in CTGE-189 (**Photo :10**). Cleaning of Septic Tank has been completed in CTGE-02 but yet to start in CTGE-11 & CTGE-37.

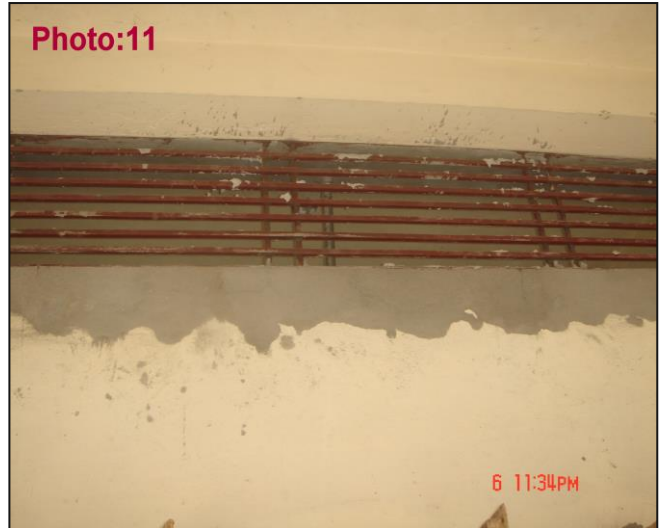
- **Supplying and Fixing of Ventilator Grills and Veranda Grills/ Railing, Installation of M.S. Grill Swing Gate etc:** This item of work is ongoing in CTGE-187, CTGE-189, CTGE-711, CTGE-204 and CTGE-216 (**Photo :11**)

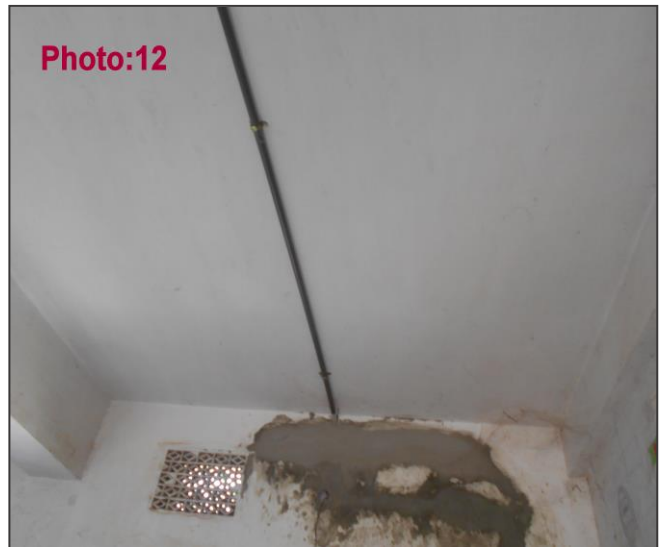
- **Electrification Works:** Patch electrical repair works are ongoing in CTGE-187, CTGE-189, CTGE-02, CTGE-11 & CTGE-37 (**Photo: 12**).

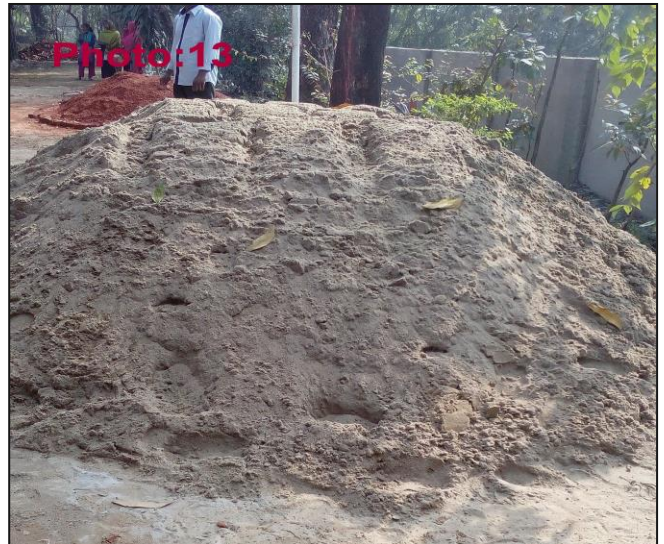
Sand stored in most of the visited sites was not covered except at CTGE-711, CTGE-204 and CTGE-216. In CTGE-189, the sacks of cements were kept on the school corridor instead of material store (**Photo:13**).

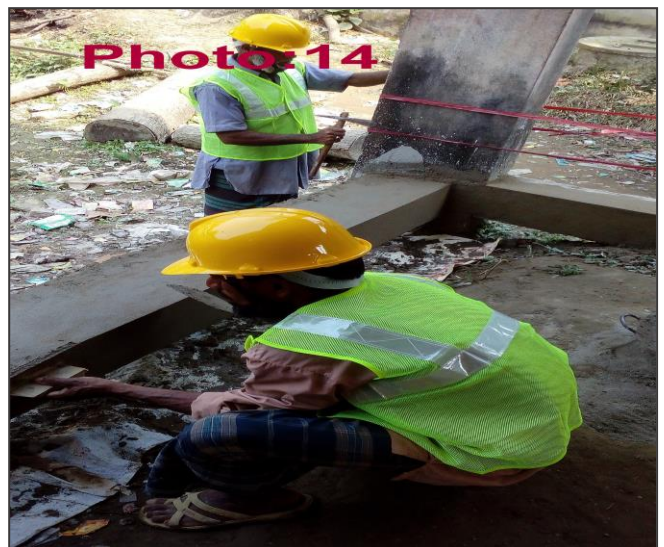
Safety gear materials (hand gloves, helmets, eye protection glasses, rubber shoes light reflecting dresses, etc.) were found in most of the visited shelter sites, but no safety gear packages were found in CTGE-11, CTGE-37 and CTGE-215. It is also important to motivate all the labours to use safety gears. (**Photo:14**).

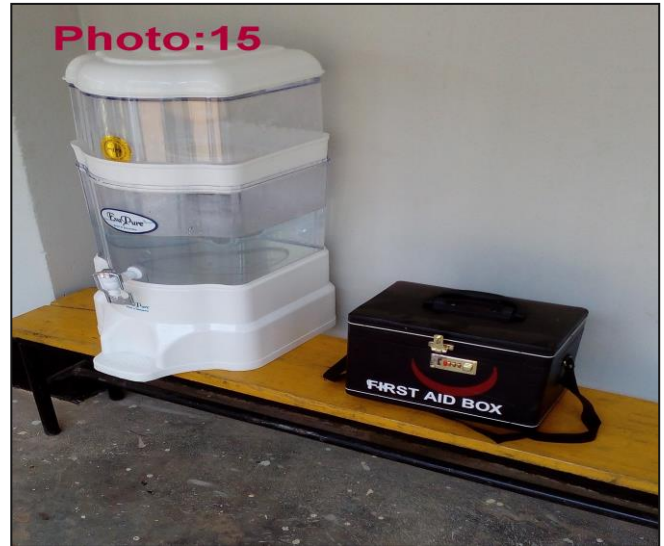
Functional water filters were found in each shelter site except CTGE-37 and CTGE-215 (**Photo:15**).
