**MULTIPURPOSE DISASTER SHELTER PROJECT (MDSP)  
Monitoring & Evaluation (M&E) Consultant**

**FIELD VISIT REPORT**

1. Period of Visit : 04 November– 05 November 2018
2. Location of Visit : MDSP Rehabilitation Shelter Sites under Chittagong District.
3. Package No. : Pkg. No. LGED/MDSP/CHI/W-01
4. Name of Contractor : M/S M.A.H. Construction Ltd. & Munir Ahmed JV
5. Participant of visit : A.H.M. Mahbubur Rahman, TL, M&E Consultant,  
Md. Matiur Rahman, Civil Engineer/ M&E Specialist, M&E Consultant,

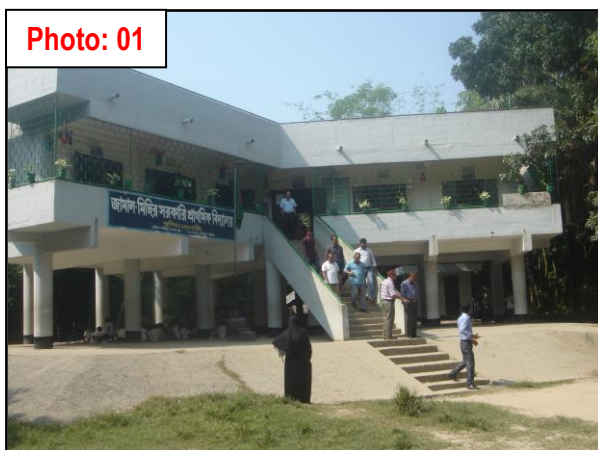
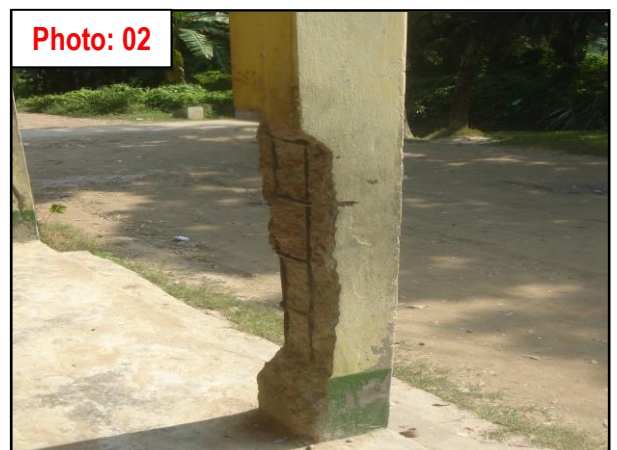
- **BOQ itemized schedule:** Site specific BOQ item wise estimates were found in all sites.
- **Rehabilitation of Jamal Misir GPS (CTGE-670):** The rehabilitation works include 2 nos. of buildings: one 2-storied and the other one storied damaged building. Works in the 2 storeyed building originally constructed by Caritas (**Photo: 01**) has been taken up but works in the other one storey building has not been taken up as it has been rightly declared abandoned (**Photo: 02**). Because of the abandonment, accommodation of students has become difficult.

The Head Master of the school requested to construct a semi-pucca structure utilizing the balance amount for use as class rooms. The matter may please be considered sympathetically.

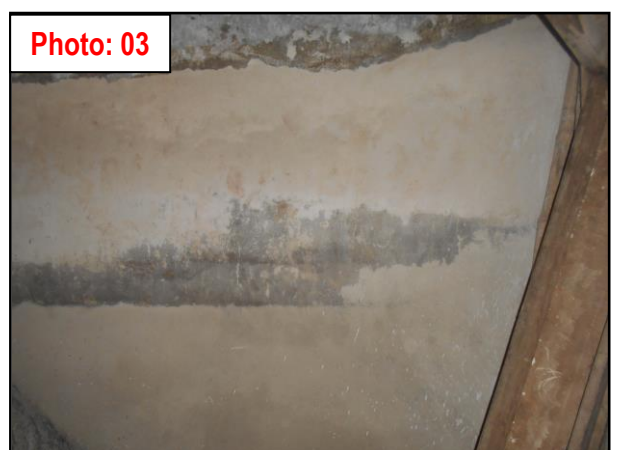
- **Rehabilitation Need Assessment:** Assessment of the rehabilitation needs of the shelters should have been more exhaustive targeting overall and sustained stability of the infrastructures instead of doing some patch repair works. (**Photo: 03**).

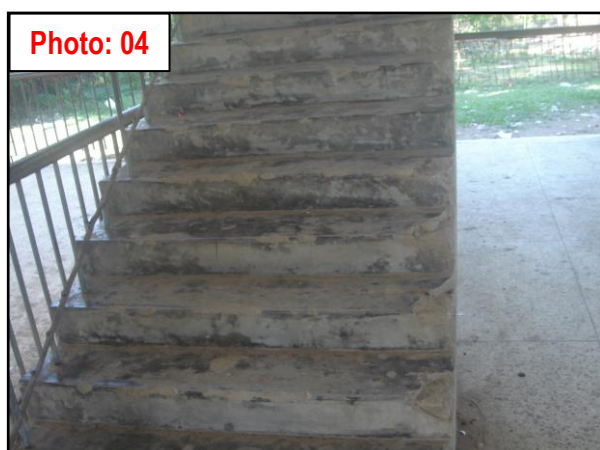
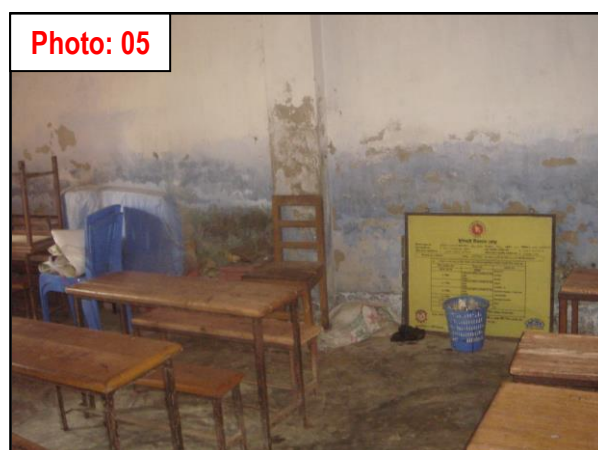
- Works ongoing at 5 shelter sites: **CTGE-11: 40%, CTGE-154: 75%, CTGE-156: 75%, CTGE-717: 40% & CTGE-307: 55 %.**
- No physical activity at 4 shelter sites: **CTGE-37: 80%, CTGE-160: 75%, CTGE-669: 75% & CTGE-670: 75%**
- Physical works untouched in 2 shelter sites: **CTGE-159: 0% (Photo: 04) & CTGE-270: 0% (Photo: 05).**

We are of the opinion that the contractor will not be able to complete the works as per contract. D&S Consultant (Engineer) supported by the PMU, LGED should take necessary penal actions against the contractor for poor performance and failure to complete the works in time.

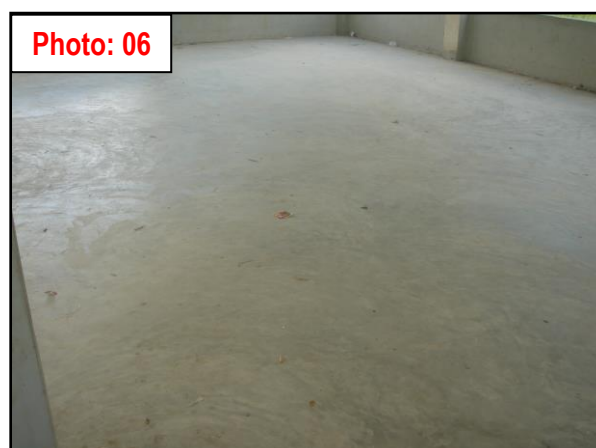
- **Roof Top Screeding:** This item of work has been completed in CTGE-11, CTGE-154, CTGE-669, CTGE-670, CTGE-717 and CTGE-307 (**Photo: 06**). This work was necessary stop leakage of water through the dilapidated roof slab.

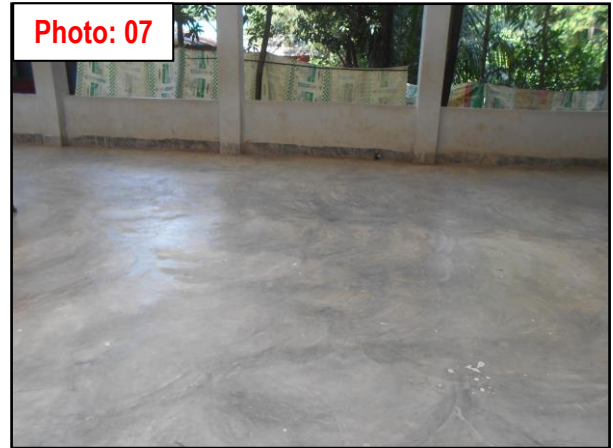
- **Lean Concreting/ Patent Stone Casting:** This item of work has been completed at ground floor/ 1<sup>st</sup> floors as necessary in CTGE-37, CTGE-154, CTGE-156, CTGE-669 & CTGE-717 (**Photo: 07**). Works are still ongoing in CTGE-307 and not yet started in CTGE-160. The quality of work is fairly good.

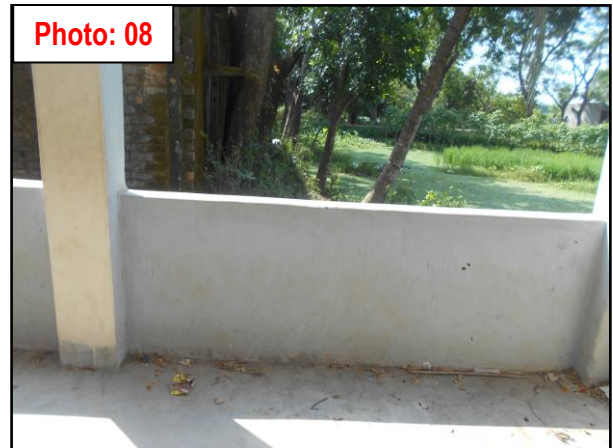
- **Brick Work as and where necessary:** Petty brick work at ground floor has been completed in CTGE-37 & CTGE-670 (**Photo: 08**). The same item of work has not yet been done in CTGE-156.

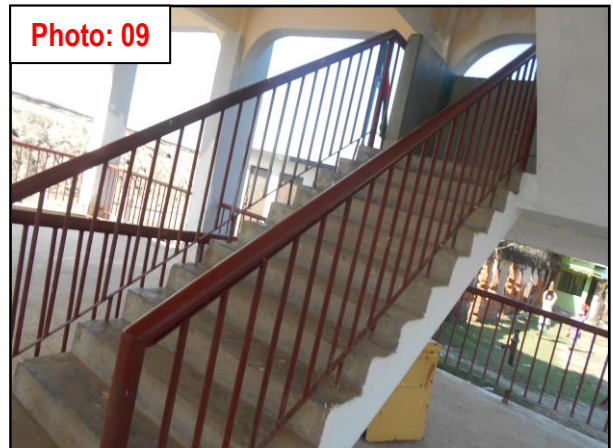
- **Construction/ Reconstruction of Staircase:** This item of work has completed in CTGE-669 & CTGE-670. Works are still ongoing in CTGE-37, CTGE-11, CTGE-154, CTGE-156, CTGE-160 (**Photo: 09**)

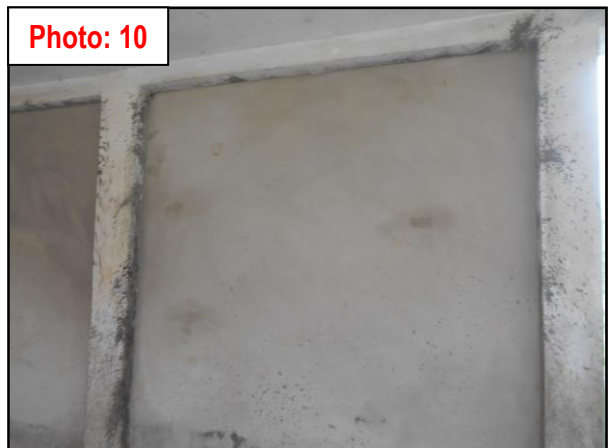
- **Outside and Inside Plastering Works:** Petty plastering works on the walls at ground floor/ 1<sup>st</sup> floors and staircases as necessary have been done in CTGE-37, CTGE-154, CTGE-156, CTGE-669, CTGE-670 & CTGE-717 (**Photo: 10**). Same works are still ongoing in CTGE-11, CTGE-160 & CTGE-307.

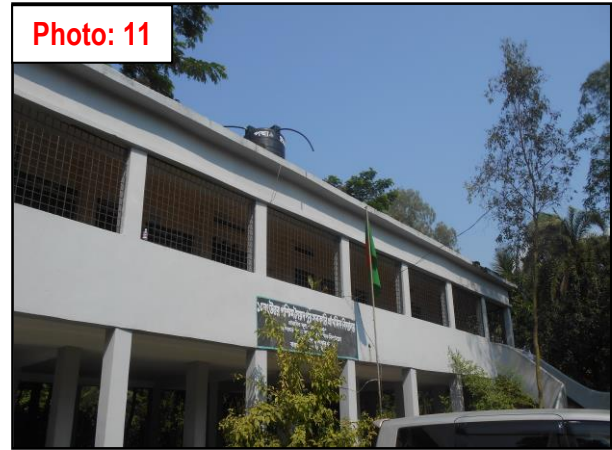
- **Outside and Inside Painting Works:** Outside and Inside Painting Works are have been done in some shelters (**Photo: 11**). It was informed that Berger plastic paint is being used in all shelter sites.

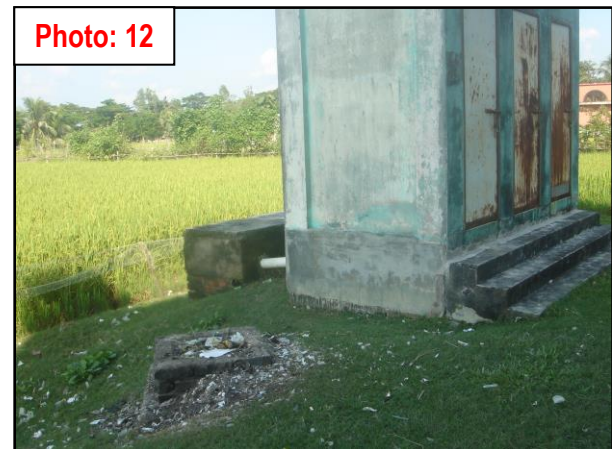
The existing septic tank of **CTGE-156** serves four toilets including one from the main building. The pit and connecting pipe from the main building is damaged. The pit and the connecting pipe should be repaired (**Photo: 12**).

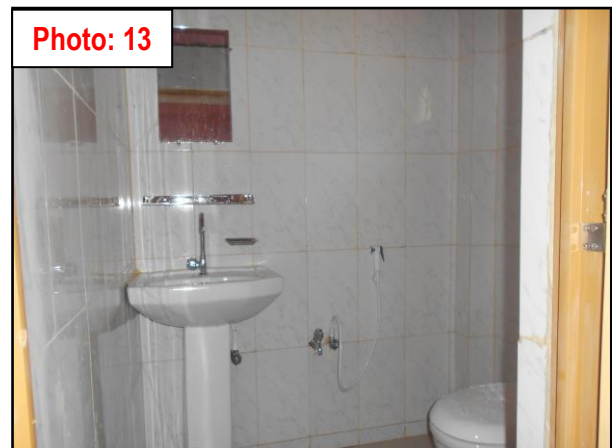
- **Construction/ Re-construction of Toilet:** This item of works has been completed in CTGE-670 (**Photo: 13**).

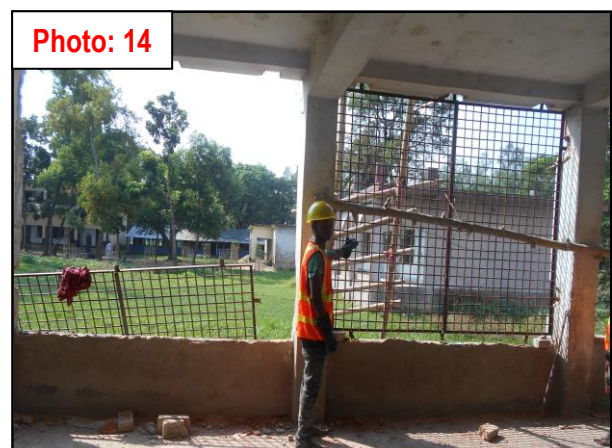
- **Supplying and Fixing of Grills & Railing at Ground Floor/ Staircase, Ventilator/ Veranda Grills, Installation of M.S. Collapsible Gate etc.:** This item of work has been completed in CTGE-670. Works are still ongoing in CTGE-11, CTGE-154, CTGE-156, CTGE-669 & CTGE-717 (**Photo: 14**) and works have yet to start in CTGE-37 & CTGE-717.

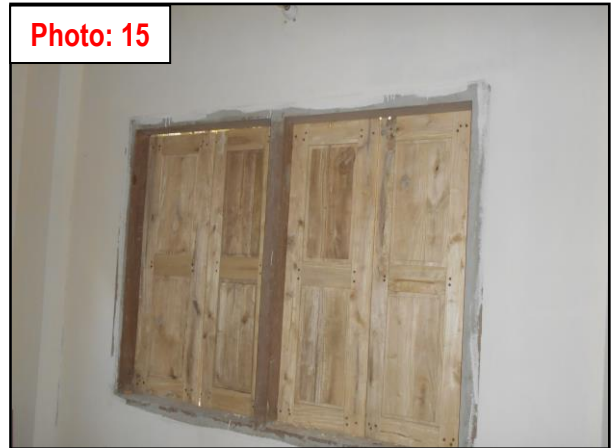
- **Supplying and Fixing of Door and Window Shutters/ Frames as and where necessary:** This item of work is ongoing in CTGE-160, CTGE- 270 & CTGE-307 (**Photo: 15**).

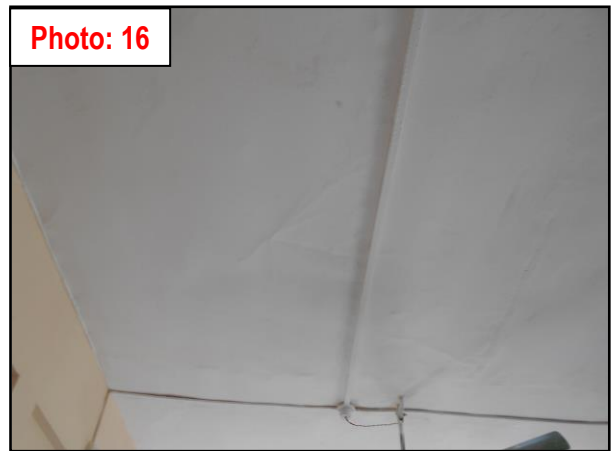
- **Electrification Works:** Electrification works have been completed in CTGE-154 & CTGE-156. Works are still ongoing in CTGE-11, CTGE-669 & CTGE-670 (**Photo: 16**).

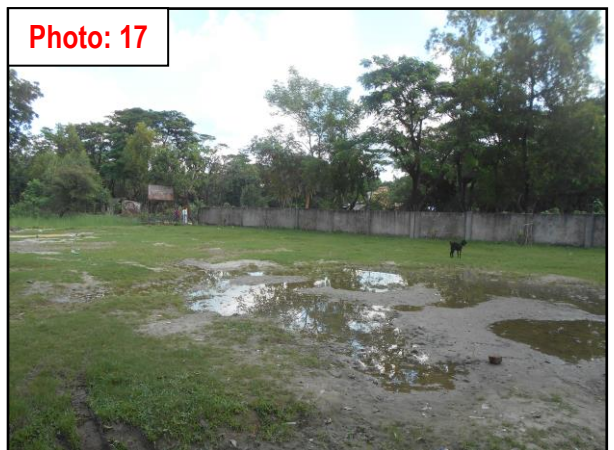
- **Installation of Deep Tube-well:** This item of work is only included in CTGE-156, but work has not yet started.
- **Site Improvement:** Site improvement by earth filling is included only in CTGE-37 (**Photo: 17**). Work has not yet started.

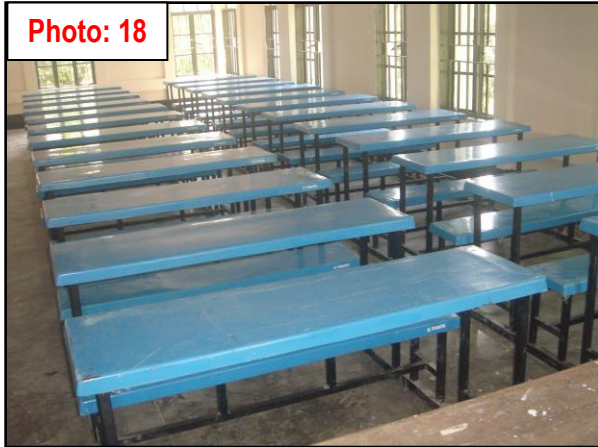
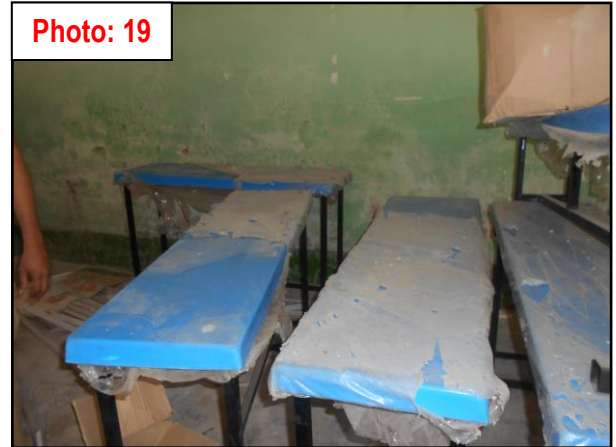
- **Furniture Supply:** Supply of school furniture (Teachers Chairs & Tables, Steel Almirah, File Cabinet, High and Low Benches etc.) is included in the BoQ. High and low benches (Tanin Brand) have been supplied in shelters of Anowara and Banskhali UZs (**Photo: 18**). The same item supplied in Sitakunda & Mirsharai UZs is not of any brand mark (**Photo: 19**).

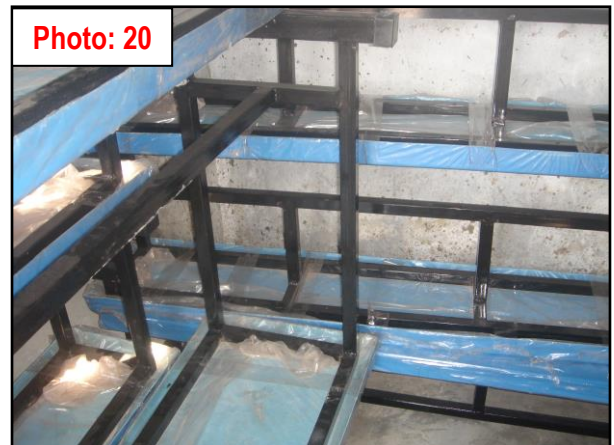
In some schools, high and low benches have been supplied although physical works have not been taken up yet. In such schools, the furniture so supplied are not in proper use for scarcity of space (**Photo: 20**). These will get damaged due to long storage.

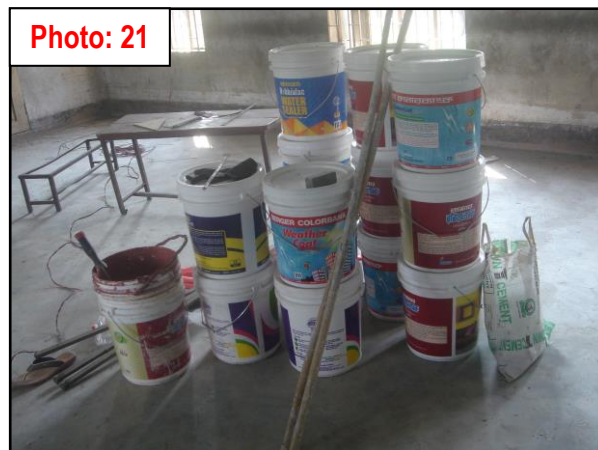
The contractor has not built any labor/storage shed at any shelter. Instead, the school class rooms have been used to store materials (**Photo: 21**).
