## MULTIPURPOSE DISASTER SHELTER PROJECT (MDSP)

#### FIELD VISIT REPORT

1. Period of Visit : 04 Feb – 05 Feb 2019
2. Location of Visit : Noakhali District.
3. Participant of visit : A.H.M. Mahbubur Rahman, TL, M&E Consultant,  
Md. Matiur Rahman, Civil Engineer/ M&E Specialist, M&E Consultant,

5. Activities of Visit : **Monitoring of the Implementation Activities of MDSP**

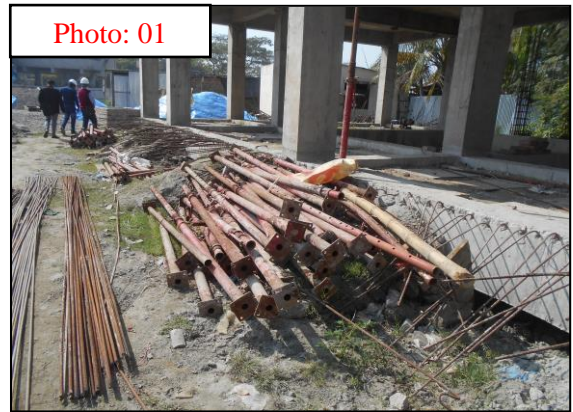
- The quality of construction materials such as MS Rod, stone chips, coarse sand etc. procured at sites appears good. Laboratory tests of MS rod, coarse sand, cement etc. have been done. Chemical test of water has also been done. Test reports have been made available during our visit.
- MS rods should be stored on raised platform to avoid mud and water (**Photo: 01**).

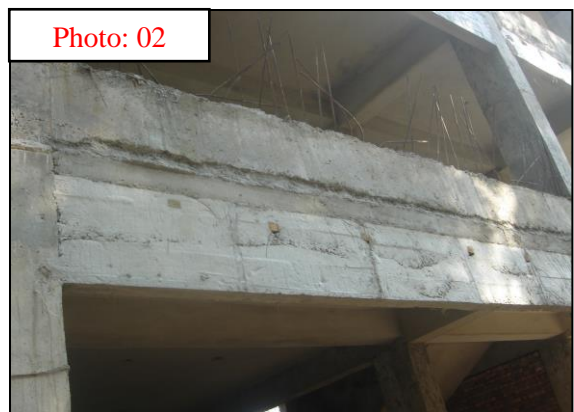
- Generally, concrete work is good but at some places, quality of concrete should be improved. (**Photo: 02**)

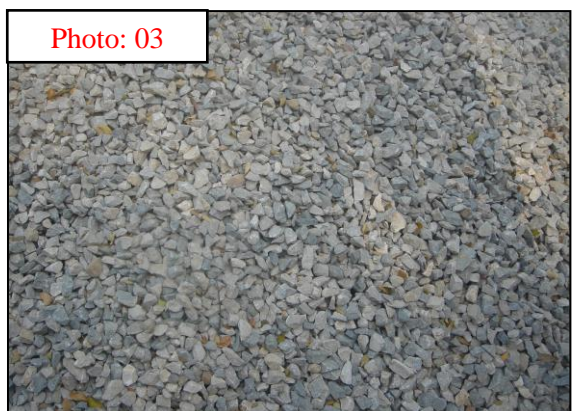
- Stone chips at some sites appear larger in size (**Photo: 03**). Properly graded stone chips should be used.

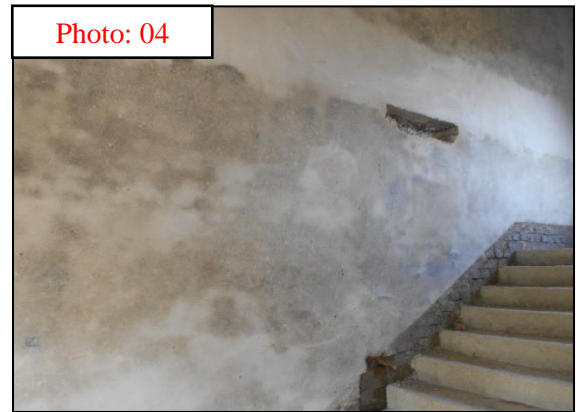
- Sand used for plastering works in **NOAP-154** exposes traces of salt. **(Photo: 04)**
- Site offices and labor sheds have been constructed in all sites.
- Steel shutter materials have been used in all RCC works.

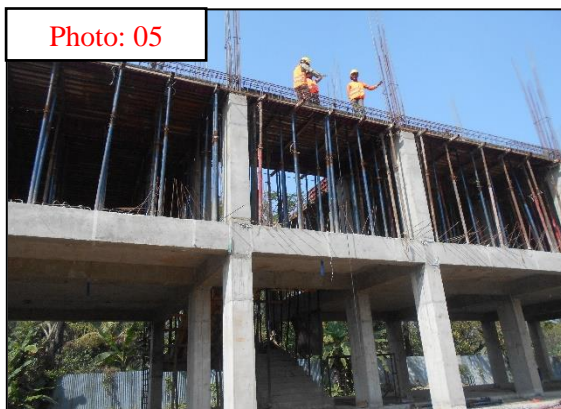
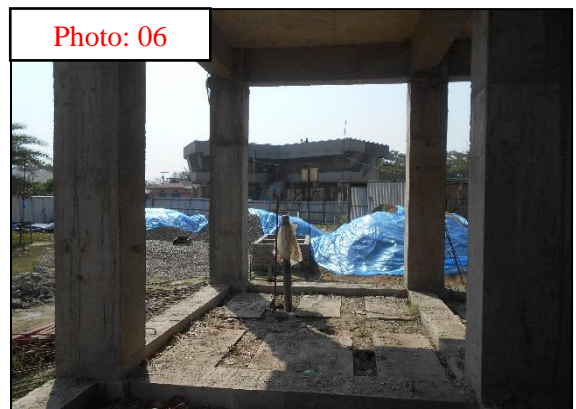
- **NOAP-376:** Shutter and re-bar placement for 1<sup>st</sup> floor slab casting is going on **(Photo: 05)**. Installation of Deep Tube-wells (4 nos.) has been completed **(Photo: 06)**.

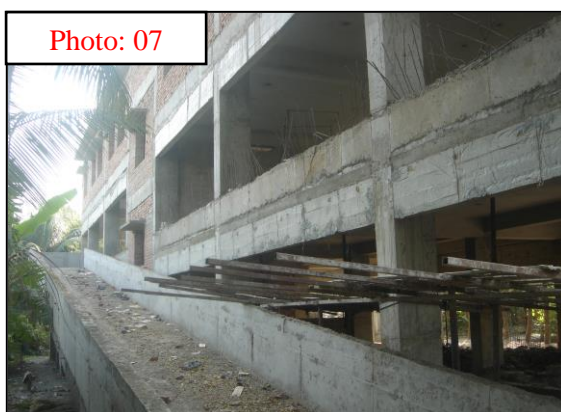
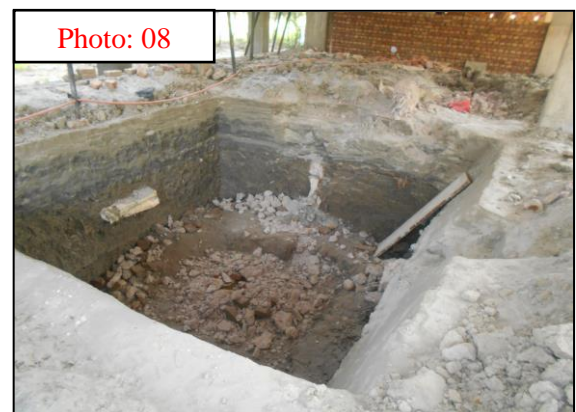
- **NOAP-154:** No physical work was observed on the day of the visit. 2<sup>nd</sup> floor slab casting has been done **(Photo: 07)**. Ramp construction including Installation of Deep Tube-wells (4 nos.) has been completed. Brickwork & re-excavation of earth for the construction of underground water tank **(Photo: 08)** were in progress.

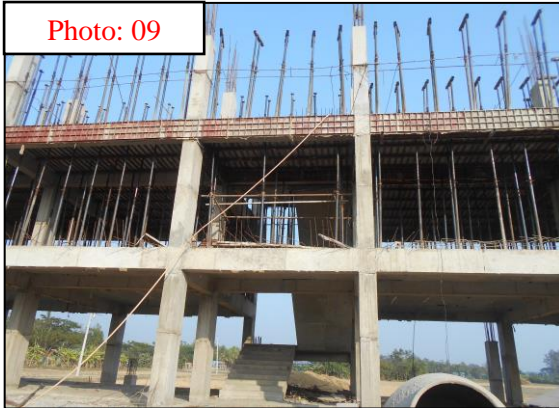
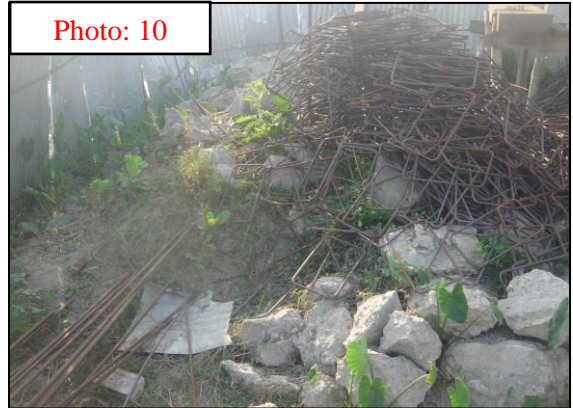
- **NOAP-336:** Shutter placement for 2<sup>nd</sup> floor slab casting is in progress (**Photo: 09**). Installation of Deep Tube-wells (4 nos.) has been completed. Important construction material like rods and stirrups have stacked haphazardly and carelessly. (**Photo: 10**)

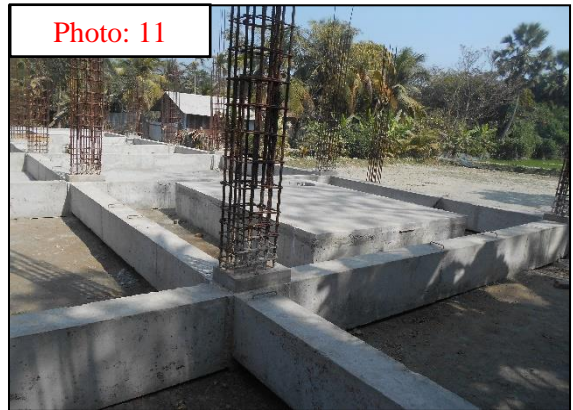
- **NOAP-210:** Physical progress is still limited to casting of column kickers (**Photo: 11**). Construction of 2 nos. underground water reservoir has been completed. It was learnt that no physical activities has been done since mid-October 2018. A lot of physical works is yet to be done to complete the shelters. The site appears barren and the progress of work is so disappointing.

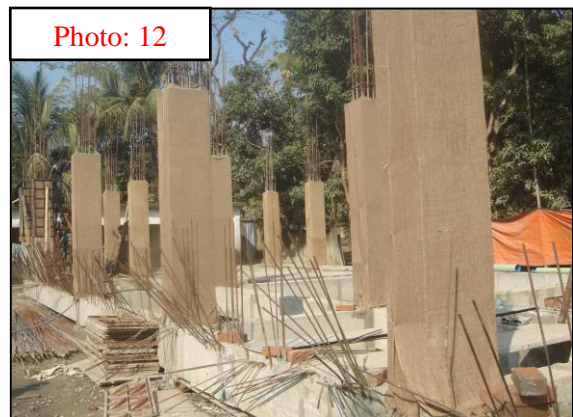
- **NOAP-100:** Ground floor columns casting is going on. Curing arrangement observed (**Photo: 12**). Construction of 2 nos. underground water reservoir has also been completed.

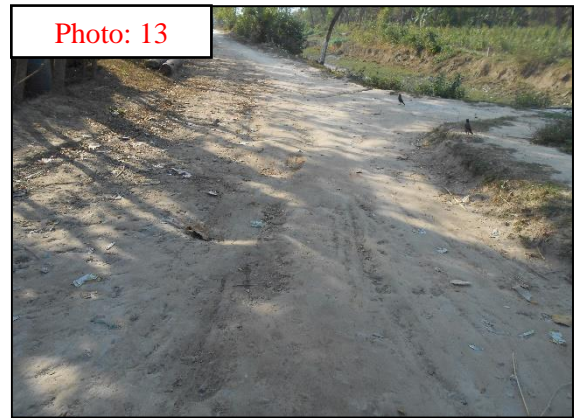
Construction works of the connecting roads have not been taken up as yet. Beneficiary and SMC of **NOAP 154** strongly demanded construction of the SCR immediately to facilitate improved communication during the ensuing monsoon (**Photo: 13**). The matter may please be taken into account.

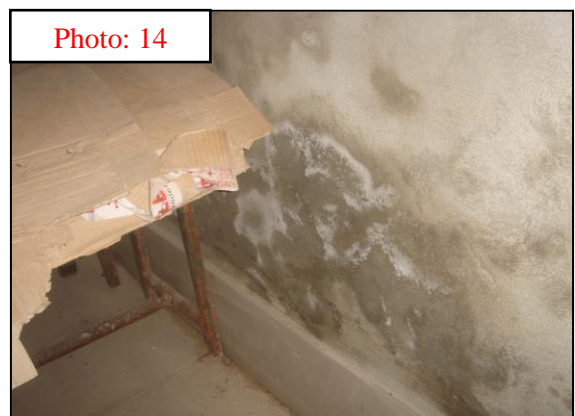
- Sand used in plastering works in some rehabilitation shelters has traces of salt content as reflected in the plaster work (**Photo: 14**). Besides, FM of sand seems to be less than 1.00. Specified sand with prior tests should be used.

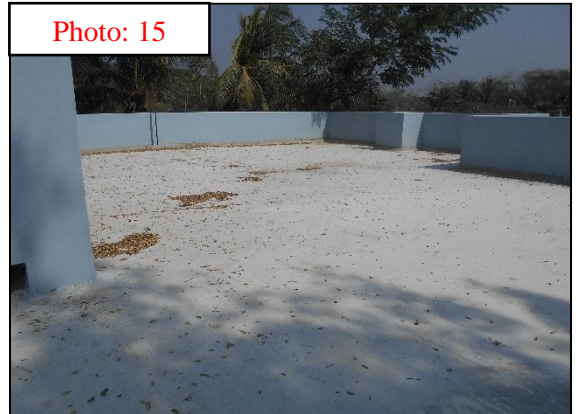
- **Roof Top Screeding:** It consists of 16 mm thick izonil plaster plus 25 mm thick patent stone casting connected by a fibre layer. Done in all visited sites (**Photo: 15**)

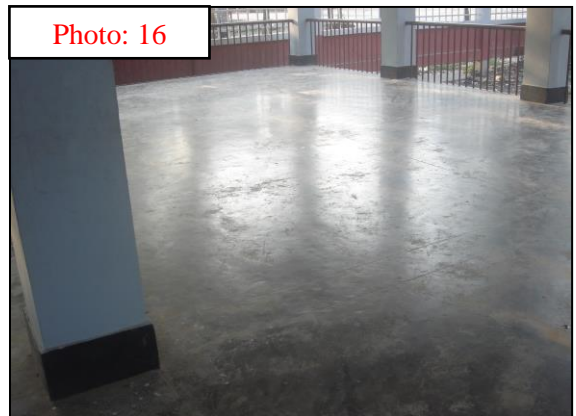
- **Patent Stone Casting:** Completed at ground floor of **NOAE-313 & NOAE-314**. The ground floor of **NOAE-313** has undulated rough surface instead of levelled smooth surface (**Photo: 16**). Curative measures should be taken.

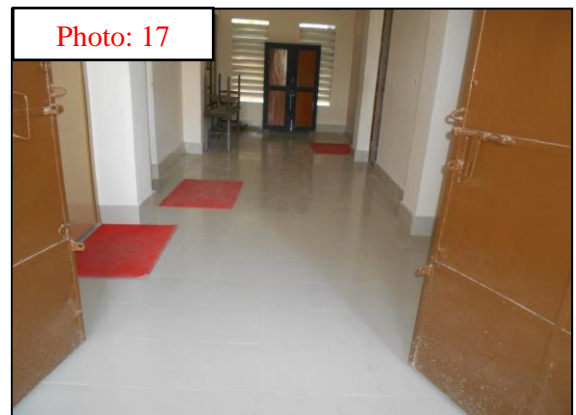
- **Tiles Placement:** Completed at staircase, ground floor/ 1<sup>st</sup> floor of **NOAE-313 & NOAE-314**, **NOAE-161**, **NOAE-402**, **NOAE-503 & NOAE- 69** (**Photo: 17**). Work is ongoing in **NOAE-509 & NOAE-59**.

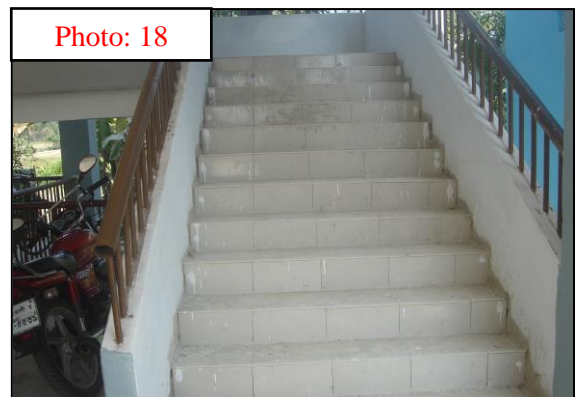
- **Brick Work:** Patch brick work has been completed in **NOAE-509**.
- **Repair of Staircase:** Done in **NOAE-313**, **NOAE-161**, **NOAE-402 & NOAE-503** (**Photo: 18**). Work is ongoing in **NOAE-314 & NOAE-69**.

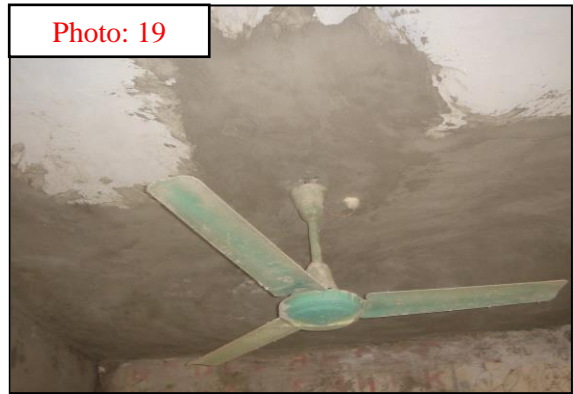
- **Outside & Inside Plastering Works** (Patch repair works where necessary): Done in **NOAE-314, NOAE-161, NOAE-402, NOAE-503 & NOAE-69** (Photo: 19). Work is ongoing in **NOAE-313, NOAE-509 & NOAE-59**.

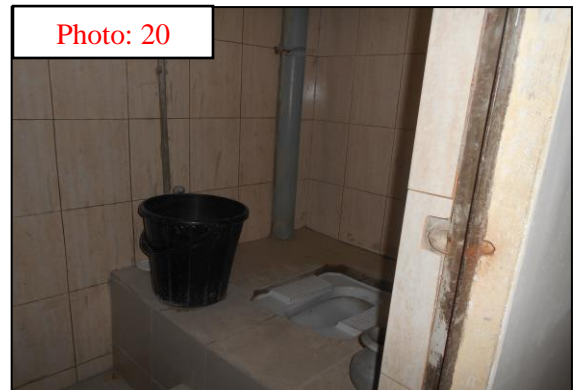
- **Reconstruction of Toilet:** Completed in **NOAE-314** (Photo: 20). Work is ongoing in **NOAE-313, NOAE-509 & NOAE-503**. There is no outlet for drainage in **NOAE-161**. Drainage outlet must be provided.

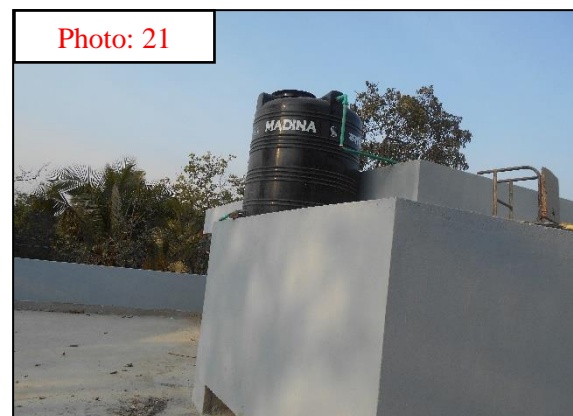
- **Construction/ Re-construction of Septic Tank:** Completed only in **NOAE-503**. Work has not yet started in other sites.
- **Installation of Water Tank at Roof:** Installation of PVC Water Tank at roofs of **NOAE-402 & NOAE-503** has been completed (Photo: 21). Work is ongoing in **NOAE-59**.

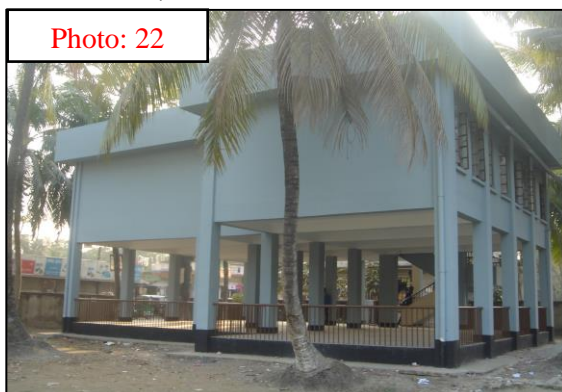
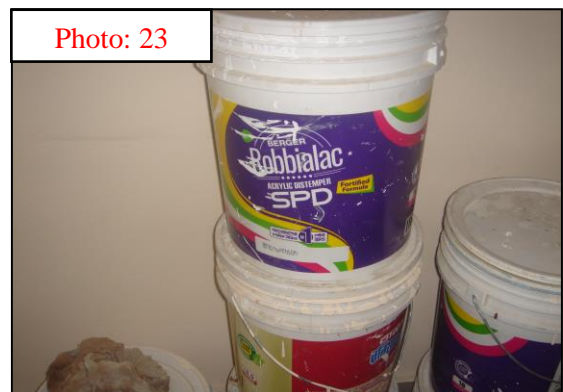
- **Outside & Inside Painting Works:** Works is ongoing in all sites except **NOAE-509** (Photo: 22). In **NOAE-402**, it was observed that acrylic distemper has been used for painting instead of plastic paint (Photo: 23).

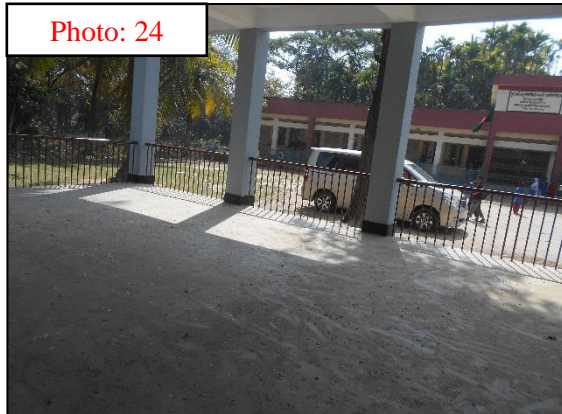
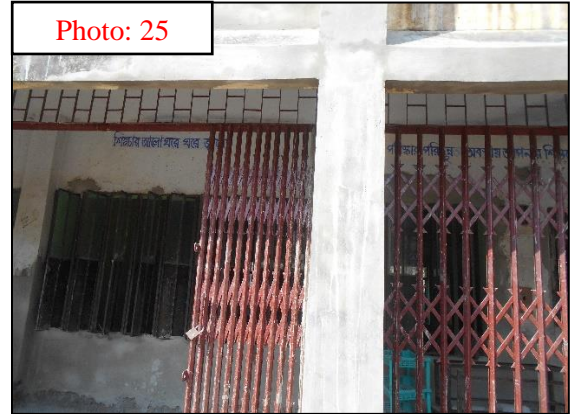
- **Supplying and fixing of Grills and Collapsible Gates:** Done in all sites (Photo: 24) & (Photo: 25)

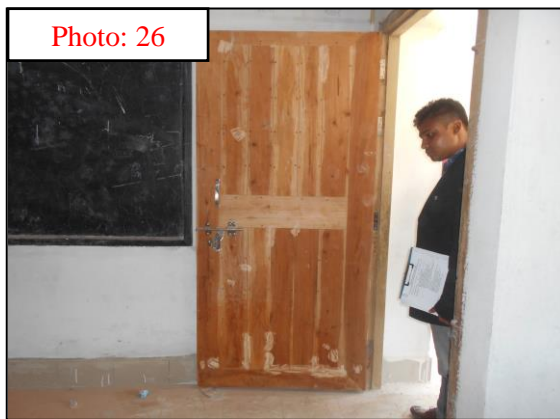
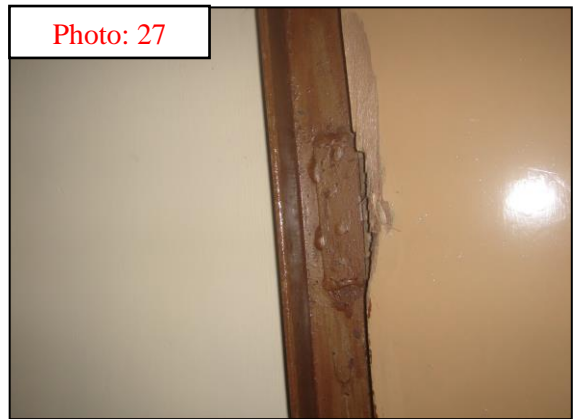
- **Repair or supplying and fixing of wooden door shutters/ frames:** Done in NOAE-314. (Photo: 26) but all workmanship is not up to standard (Photo: 27)

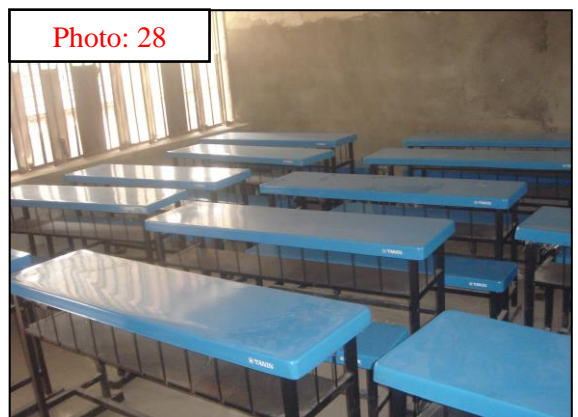
- **School Furniture Supply:** Only high and low benches of Tanin Brand have been supplied in NOAE-314 (Photo: 28). Other furniture such as Chairs and tables for the teachers, Steel Almirah etc. should be supplied early as requested by the teachers.

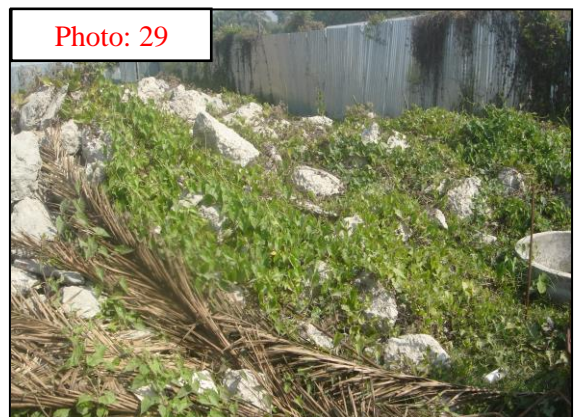
- **Temporary Camp Site Waste Disposal Facility:** Demarcated area for waste disposal particularly for disposal of construction debris like earth, concrete etc. was not observed. The contractor should arrange a separate demarcated area away from construction site to temporarily dispose construction debris in order to create a safe environment for smooth construction works. It is always advisable to remove the debris from site with immediate effect **(Photo: 29)**.

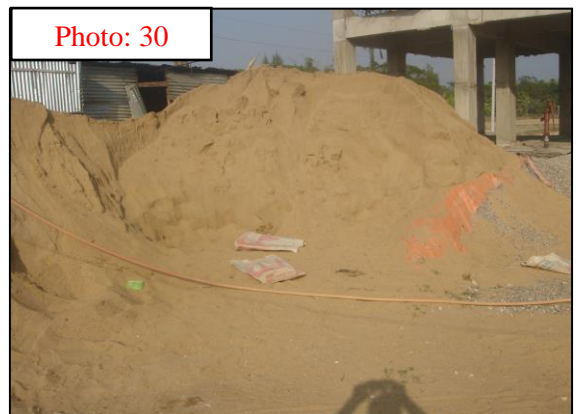
- **Dust Suppression Measures:** In some sites, sand was kept covered in order to prevent dust pollution while in some other sites, these were kept exposed. This should always be kept covered to protect from air pollution **(Photo: 30)**.

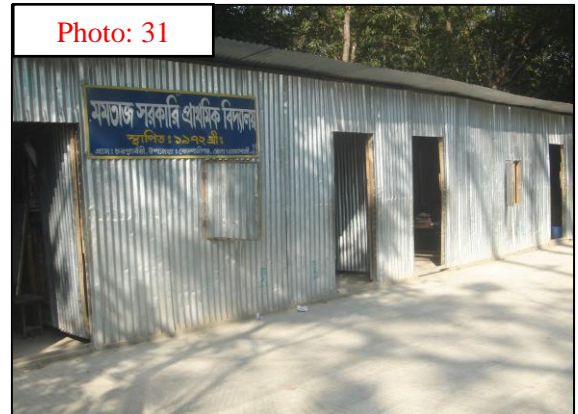
- **Construction of Temporary Shed for Uninterrupted Schooling:** There is provision to construct temporary shed for class accommodation where existing school building has been demolished. In **NOAP-204**, one thatched temporary shed for schooling has been constructed but the quality of this shed is very poor (**Photo: 31**).
