MULTIPURPOSE DISASTER SHELTER PROJECT (MDSP)
Monitoring & Evaluation (M&E) Consultant

FIELD VISIT REPORT

5. Activities of Visit : **Monitoring Field Activities of MDSP**
6. Sites visited : Package no. MDSP-II-7-LPI-0-NW-01 in Barisal district
Contractor: M/S. Navana Construction Ltd.

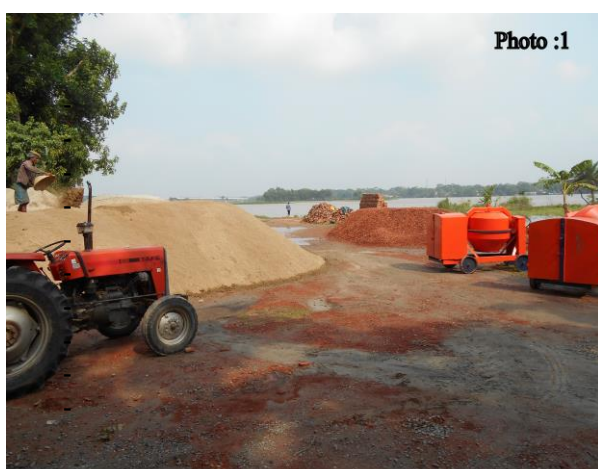
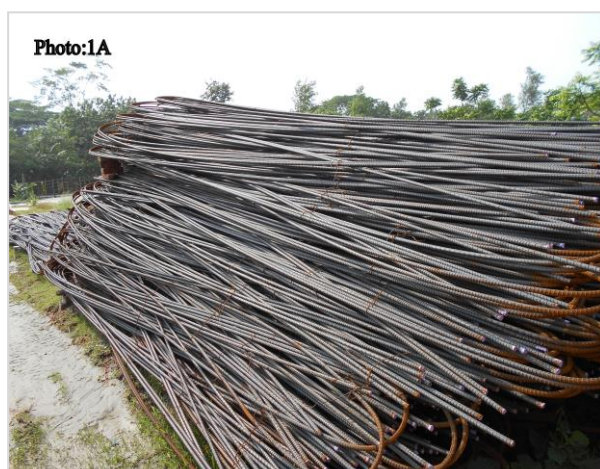
- Establishment of main stack yard at Bakerganj, 25 nos. of stack yards at different locations have been made to store materials (**Photo 1&Photo 1A**). In case of acute shortage of space, the Contractor has hired additional land close to the shelter construction sites to store construction materials and making fabrication works.

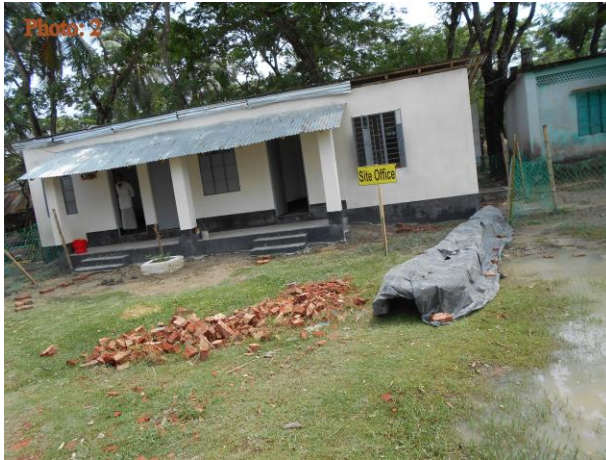
- Preparatory works in most of the shelter sites are limited to construction of site offices (**Photo 2**), sinking of tube wells, collection of construction materials etc.
- The quality of the collected stone chips and coarse sand appear to be fairly good (**Photo 2A**).

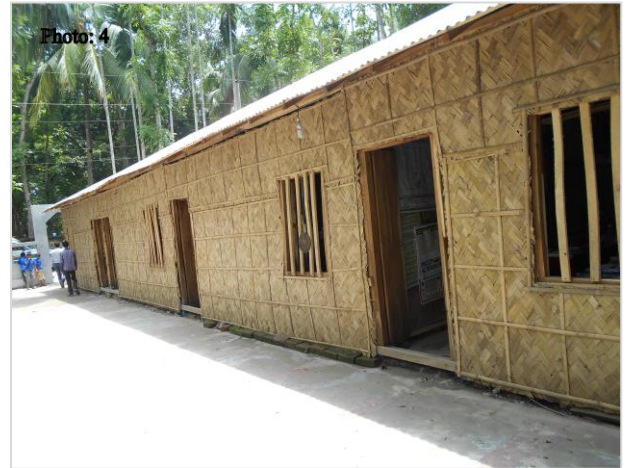
- Uninterrupted Schooling: In most shelter sites, the existing school buildings have been demolished to make room for the new construction. Alternative temporary sheds have been erected to house the classes till the completion of the new shelter (**Photo 4**).

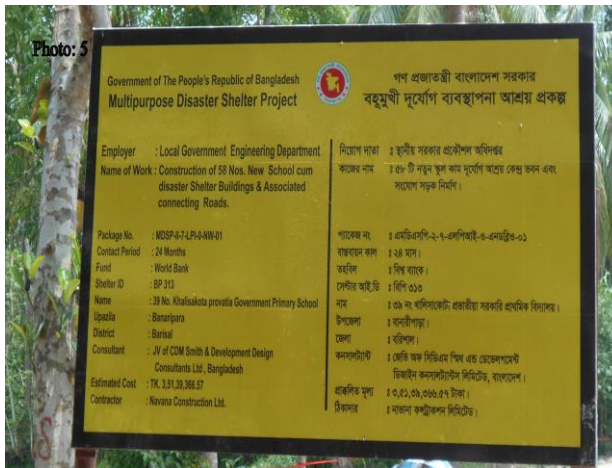
- Posting of Signboard: Contract information signboards were found describing subproject activities at all construction sites. (**Photo 5**).
- Erection of Safety Fence: Safety barrier has been erected in all construction sites to keep the students and public away to avoid danger of accident. Stone chips have been stacked partly covering road. (**Photos 6**). This should be avoided.

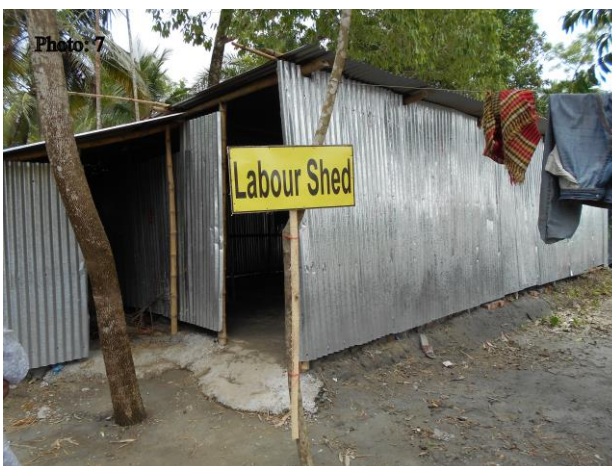
- Labor Shed: Labor sheds have been established. Labor sheds should be provided with windows for air circulation. (**Photo 7**).
- First Aid Box: First Aid Kits to ensure adequate safety gears for workers was available at sites to meet emergency accidental injuries. Labors were found to use safety gears such as vests, hand gloves, boots and other safety devices while at work. (**Photo 8**).

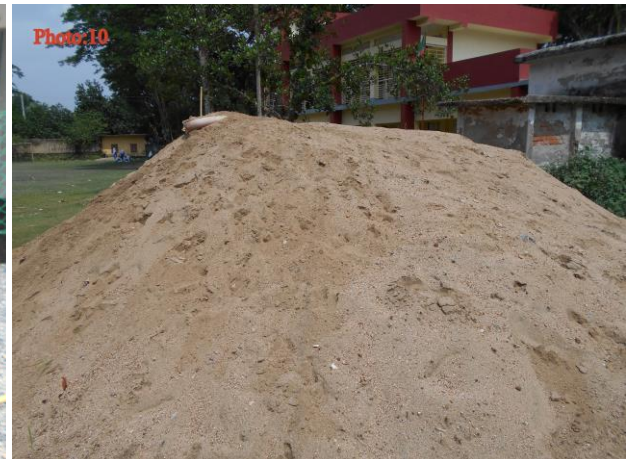
- Water Supply and Sanitation Facility: -Tube wells have been sunk. The wells are generally sunk at a depth of 275 m to 300 m to obtain good quality water free from salt and arsenic. Water quality tests are performed before installation of wells. Advised to colour the tube wells other than red as red coloured tube wells indicate arsenic presence (**Photo 9**).
- Air/Dust Pollution: In some sites, sand was kept under cover to stop dust pollution while in some sites, these were kept exposed. This should be kept under cover (**Photo 10**).
