**MULTIPURPOSE DISASTER SHELTER PROJECT (MDSP)**  
**Monitoring & Evaluation (M&E) Consultant**

**FIELD VISIT REPORT**

1. Period of Visit : 21 November 2017
2. Location of Visit : Barisal District.
3. Participant of visit : A.H.M. Mahbubur Rahman, TL, M&E Consultant,  
Md. Matiur Rahman, Civil Engineer/ M&E Specialist, M&E Consultant,
4. Officials met during Visit :

**Pkg. No. MDSP-II-7-LPI-O-NW-01:**

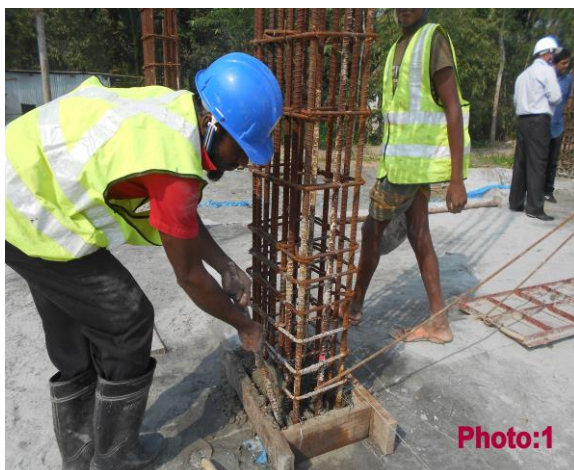
- **NS-BP-113:** Physical works are limited to the casting of some column kickers above Grade Beams (**Photo: 1**) and also in the placement of steel shuttering materials for some columns at ground floor (**Photo: 2**).

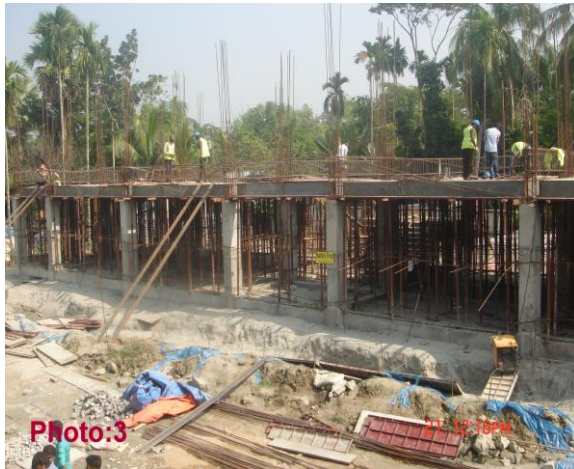
- **NS-BP-246:** Progress of physical works is more advanced compared to works of other shelter sites visited in Barisal district (**Photo: 3**). Placement of rebar & steel shuttering materials in beams & slab at ground floor is in progress. Steel shutter for beams should be closely placed without keeping any gap. The quality of concrete should be further improved (**Photo: 4**).

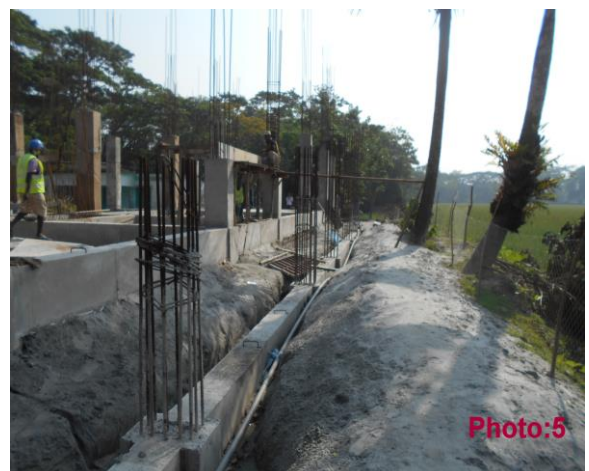
- **NS-BP-252:** Physical works are limited to the casting of columns above Grade Beams including construction of ram (**Photo: 5**).

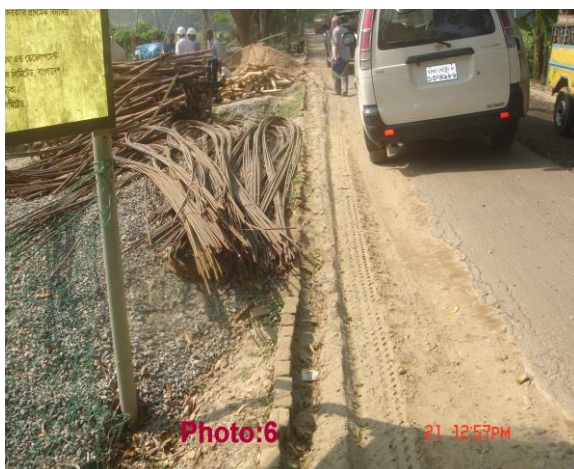
No fencing has been erected. MS rods have been stacked near road (**Photo:6**). Concrete quality is fairly good (**Photo:7**).

- **Erection of Safety Fence:** Safety barrier has been erected in many construction sites except BP-252 (Photo: 6) and BP-706 to keep the students and public away to avoid danger of accident. The quality of fencing work should be more stable.

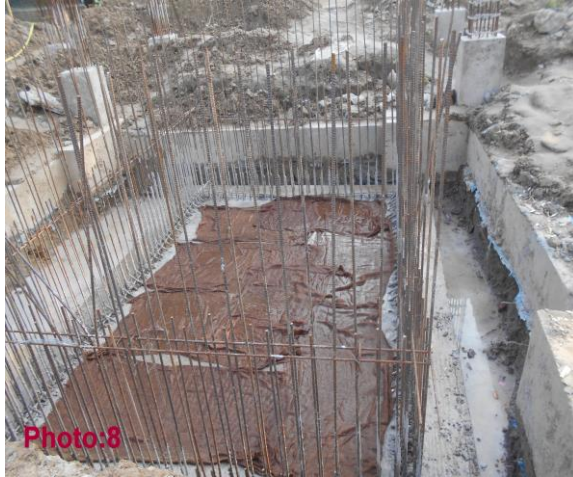
- **NS-BP-706:** Pedestal columns below Grade Beams have been completed. Works are limited to the construction of 2 nos. of underground water reservoirs (**Photo: 8**) and construction of grade beam of ram (**Photo: 9**).

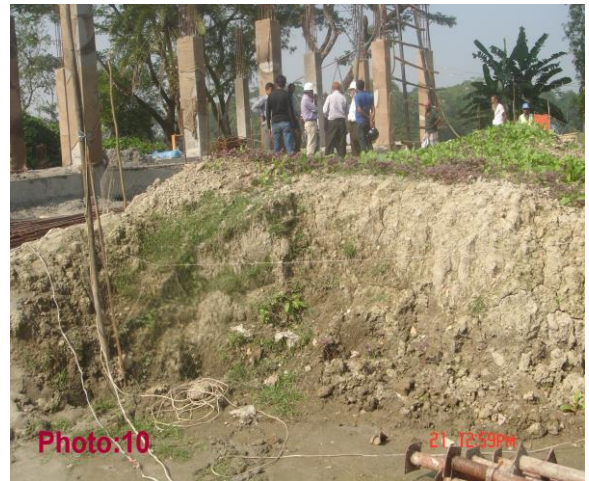
- Excavated earth has been stacked irregularly and haphazardly at construction site. Advised to immediately remove the stacked earth to separate disposal area to facilitate easy construction work (**Photo:10**).
- Good steel shutter materials have been used in all RCC works like pile caps, bracing beams and pedestal columns above pile caps, grade beams and columns etc.
- Curing is very important for concrete works. It has been observed that this aspect has been given due care.

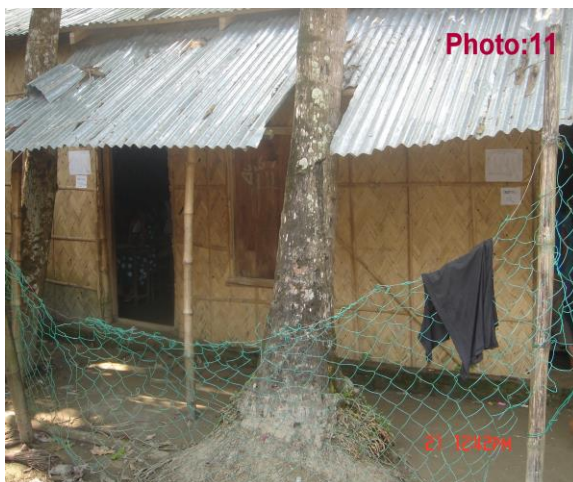
- **Uninterrupted Schooling:** There is provision of construction of temporary sheds for class accommodation where existing building has to be dismantled for construction works. This has been done. The temporary shed at **BP-246** is made of thatched fencing (**Photo:11**). Improved quality sheds should be made. During our visit of site at 10:30 hours, the Board conducted **Primary School Certificate Examination** was going on.

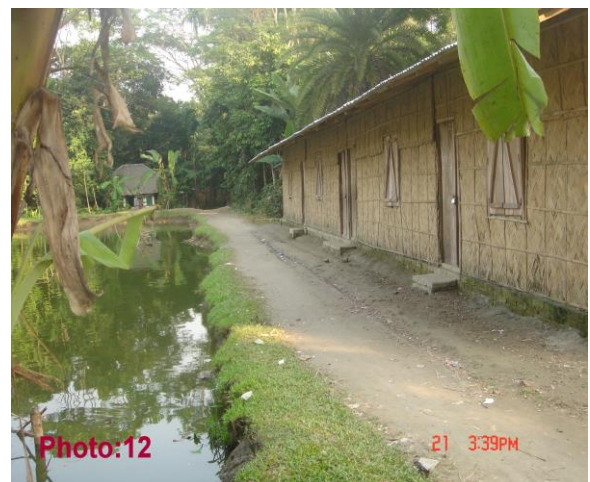
The temporary school built for **BP-706** provide good accommodation but it is located very close to a big pond which is a threat to cause accident to the minor students of the school. Advised D&S Consultant and the contractor to make a safety fencing on the bank of the pond (**Photo:12**).

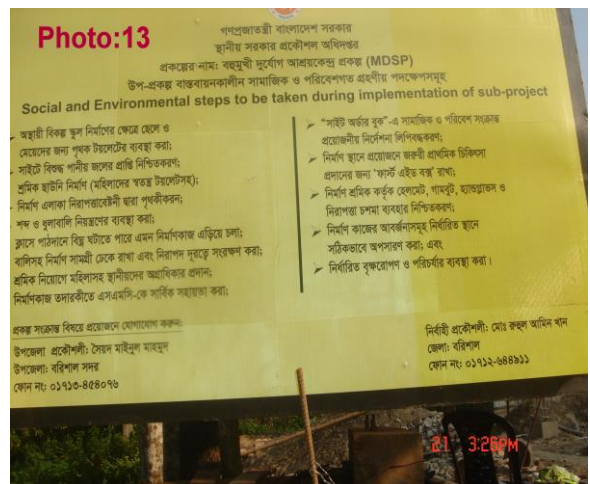
**Posting of Signboard:** Contract information signboards were found describing subproject activities at all construction sites. Sign boards describing environmental management plans have been erected in place. The telephone numbers of the XEN and UZ Engineers are given to facilitate any necessary communication (**Photo:13**).

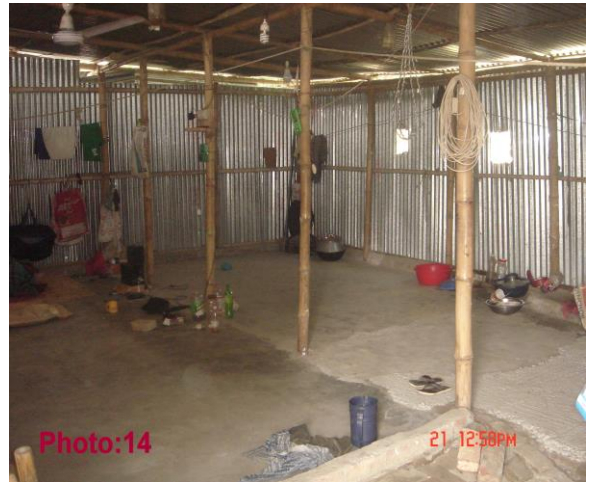
- **Labor Shed:** Labor sheds made of CI sheets have been erected (Photo:14)
- **Site Camp Office:** Site camp offices have been constructed but these are lagging required furniture like racks, almirah to keep important documents.

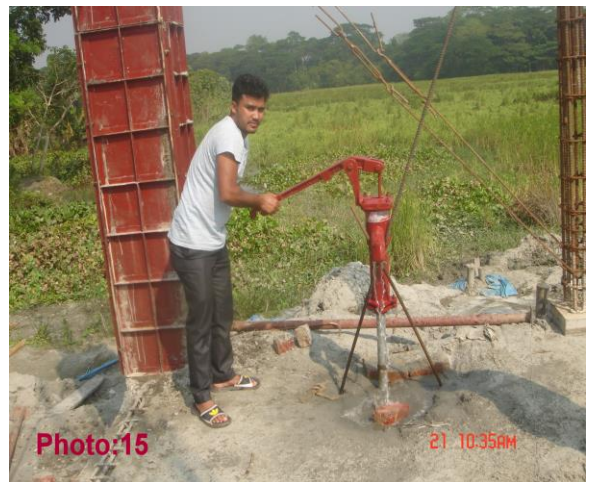
- **Water Supply and Sanitation Facility:** As primary school cum cyclone shelter, all sites have drinking water and sanitary facilities. Moreover, water supply by installation of new tube wells are in construction process. The tube well of BP-113 yields good quality water (Photo:15).

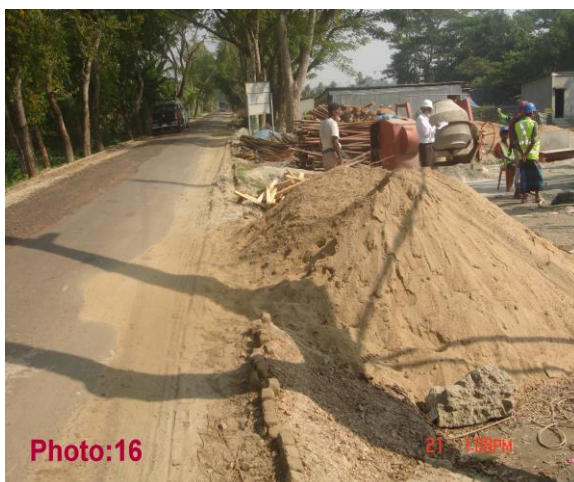
- **Air/Dust Pollution:** In some sites, sand was kept under cover to stop dust pollution while in some sites, these were kept exposed. This should be kept under cover (Photo:16).

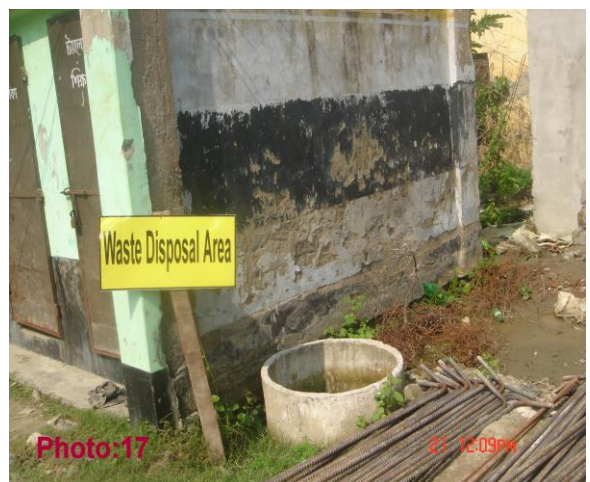
- **Drainage Congestion/ Water Logging:** No drainage congestion/water logging problem was observed.
- **Waste disposal/Management:** No planned practice of stockpiling of construction debris was observed. Under-construction debris and garbage are kept haphazardly. Garbage must be stockpiled and removed to a pre-selected distant waste disposal area. Although there is signboard of "Waste Disposal Area", it is only by name only. Disposal Wastes are if removed, should be kept in the earmarked area. FREs/ site supervisors should monitor this issue (Photo:17).
