MULTIPURPOSE DISASTER SHELTER PROJECT (MDSP)
Monitoring & Evaluation (M&E) Consultant

FIELD VISIT REPORT

1. Period of Visit : 22 November – 23 November 2017
2. Location of Visit : Bhola District.
3. Participant of visit : A.H.M. Mahbubur Rahman, TL, M&E Consultant,
Md. Matiur Rahman, Civil Engineer/ M&E Specialist, M&E Consultant,
4. Officials met during Visit :

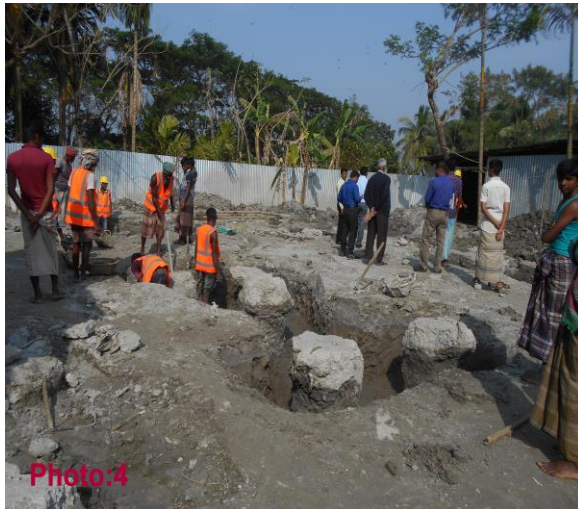
- **BHP-227:** all cast-in situ piles have been cast and breaking of pile heads is in progress (**Photo:4**). At the same time arrangement for pile load test is in progress (**Photo:5**).

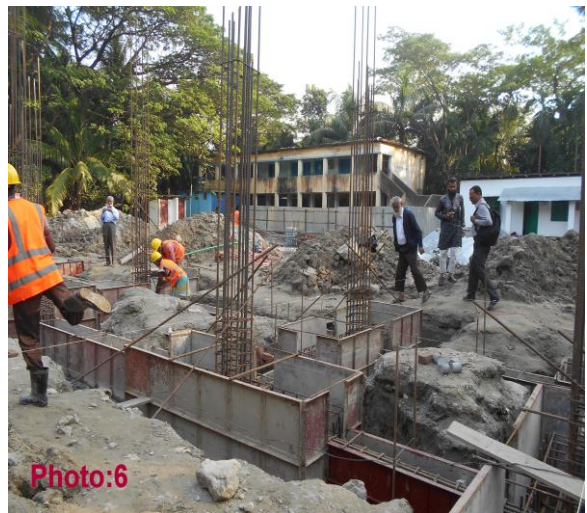
- The physical works in **BHP-302** are limited to the re-bar placement and placement of steel shuttering materials related to casting of pile caps and connecting bracing beams (**Photo:6**).

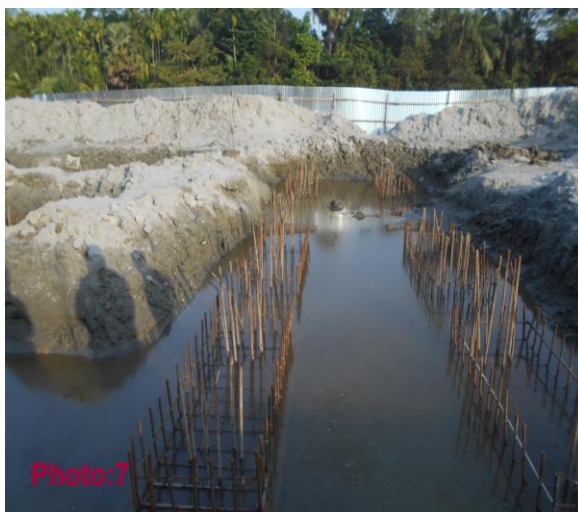
In **BHP-303**, Soling and CC work below all pile caps have been done. No physical works were in progress except fabrication and placement of re-bar for pile caps. The site was found to be filled with stagnant water (**Photo:7**). MS rods have been stacked in a manner which may cause accident (**Photo:8**).

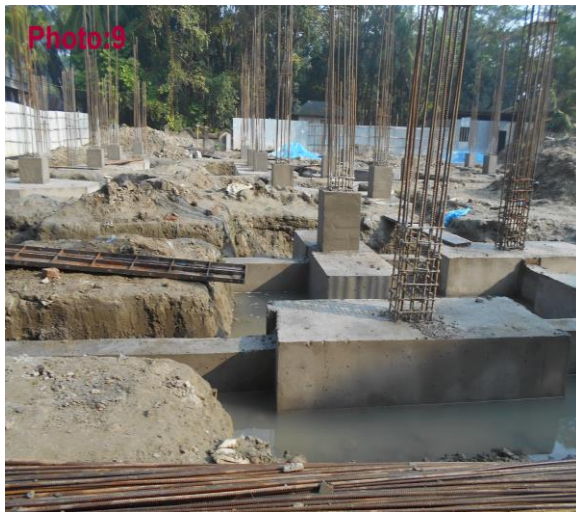
- **BHP 27:** Casting of pile caps and connecting bracing beams have been completed. Works are still limited to the construction of Pedestal columns below Grade Beams (**Photo:9**). Excavated earth has been stacked irregularly and haphazardly (**Photo: 10**).

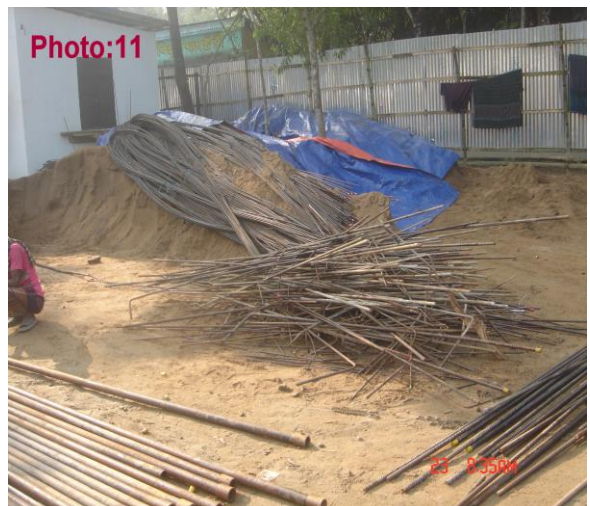
Advised to immediately remove the earth to demarcates waste disposal area. MS rods are kept scattered over sand heap (**Photo:11**).

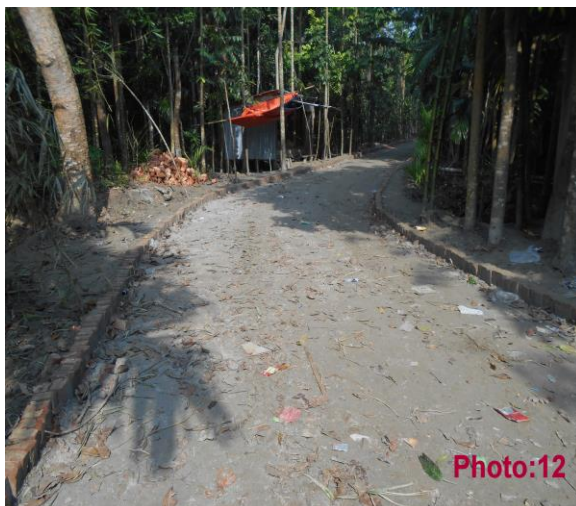
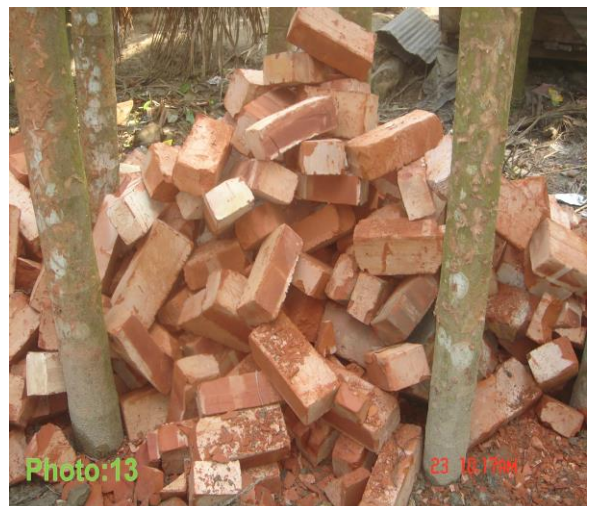
BHP-43: There is provision of shelter connecting road of length of 400 m connecting school cum shelter (Dakhin Purbo Kandrapur GPS cum CS). Construction work of the road has been started. Preparation of 10" thick Improved Sub-Grade has been completed. Preparation of 6" thick Improved Sub-Base including brick edging at two sides of the road is in progress (**Photo:12**). The quality of collected bricks is fairly good (**Photo:13**). Physical progress of the construction of road is about 15%.

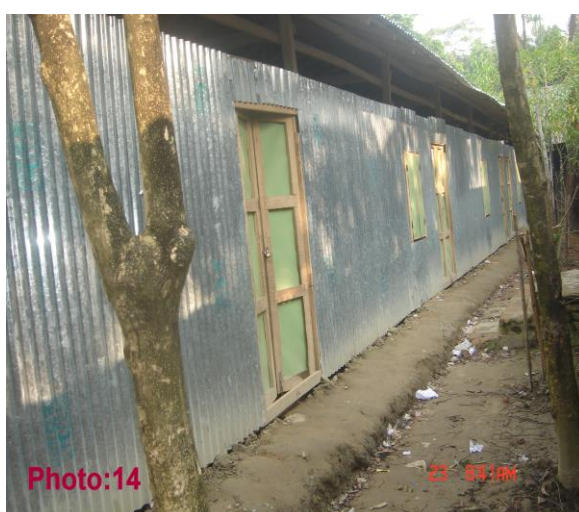
- **Uninterrupted Schooling:** There is provision of construction of temporary sheds for class accommodation where existing building has to be dismantled for construction works. This has been done at some places (**Photo:14**).
- **Posting of Signboard:** Sign boards of contract information as also EMP and SMP measures were found at all sites. (**Photo:15**).

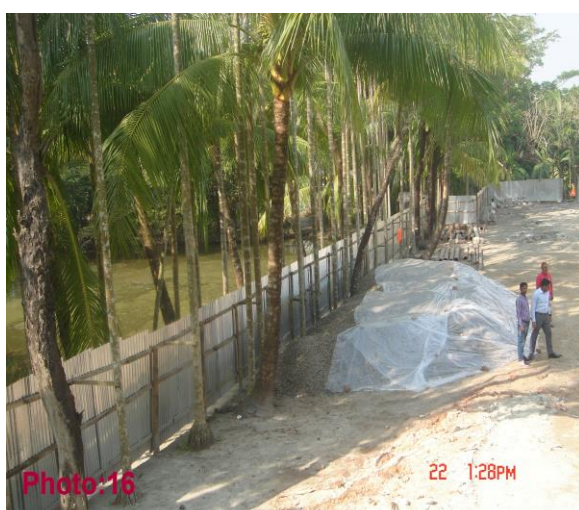
- **Erection of Safety Fence:** Safety barrier has been erected in all construction sites to keep the students and public away to avoid danger of accident. The quality of fencing work is good (**Photo:16**).
- **Labor Shed:** Labor sheds made of CI sheets have been erected (**Photo:17**). Ventilation provision should be made.

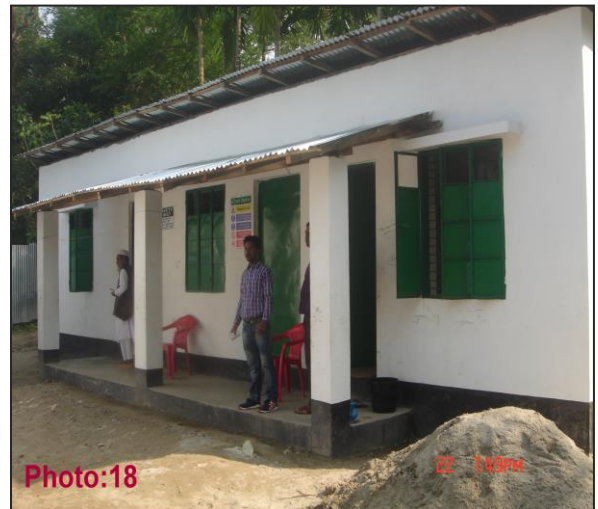
- **Site Camp Office:** Site camp offices have been constructed but these are lagging required furniture like racks, almirah to keep important documents (**Photo:18**).
- **First Aid Box:** First Aid Kits to ensure adequate safety gears for workers was available at sites to meet emergency accidental injuries. Some of the labors were seen to use safety gears such as vests, hand gloves, boots and other safety devices while at work.

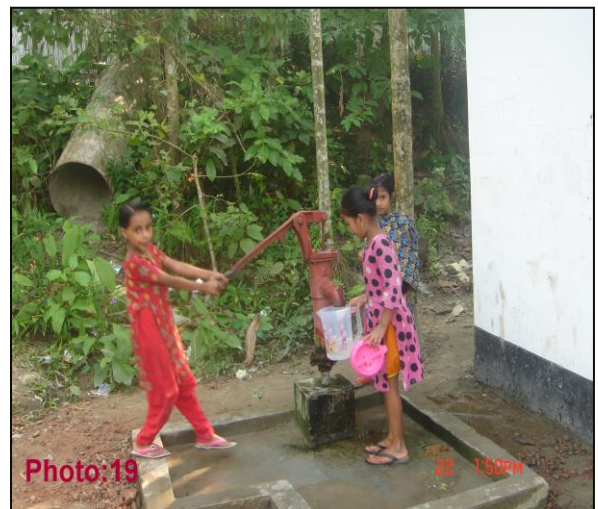
- **Water Supply and Sanitation Facility:** As primary school cum cyclone shelter, all sites have drinking water and sanitary facilities. In addition, contractor has installed tube wells for supply of water for drinking purposes and construction works (**Photo: 19**).
- **Air/Dust Pollution:** In some sites, sand was kept under cover to stop dust pollution while in some sites, these were kept exposed. This should always be kept under cover to prevent dust pollution.

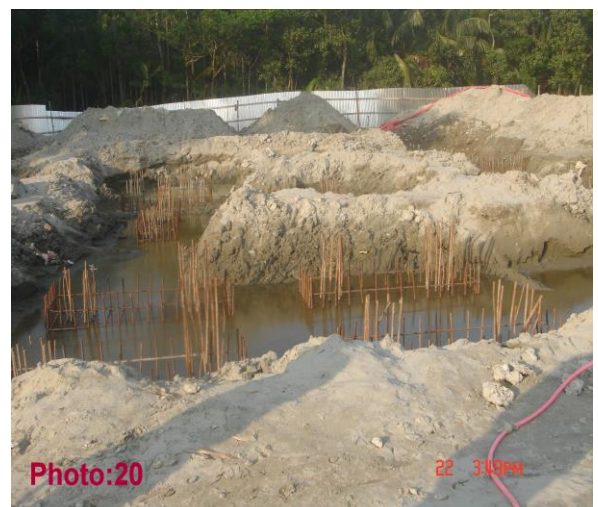
- **Waste disposal/Management:** No planned practice of waste disposal particularly disposing construction debris was observed. Under-construction debris and garbage are kept haphazardly. Garbage must be stockpiled and removed to a pre-designated waste disposal area. (**Photo:20**). FREs/ site supervisors should monitor this issue strictly.
