**MULTIPURPOSE DISASTER SHELTER PROJECT (MDSP)**  
**Monitoring & Evaluation (M&E) Consultant**

**FIELD VISIT REPORT**

1. Period of Visit : 10 September – 11 September 2018
2. Location of Visit : Bhola District.
3. Participant of visit : A.H.M. Mahbubur Rahman, TL, M&E Consultant,  
Dr. Md. Barkat Ullah, Environment Specialist, M&E Consultant.
4. Officials met during Visit :

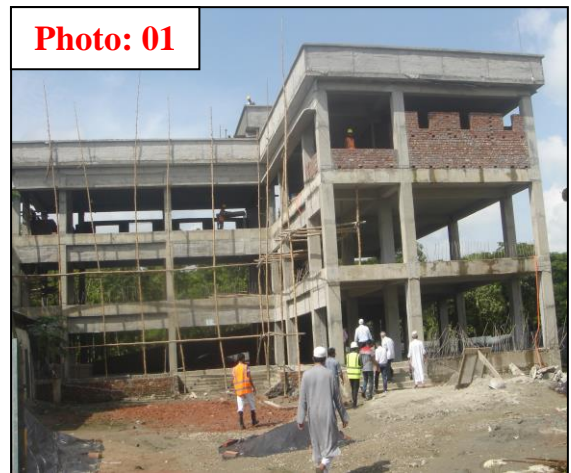
Photo of BHP-303: Uttar Shasibhusan GPS at Charfession is shown in **(Photo: 01)**.

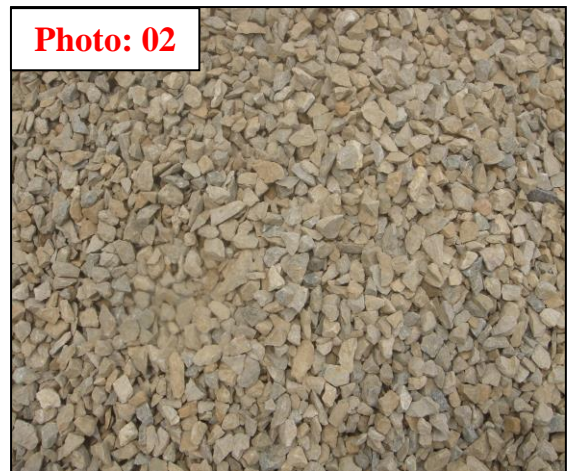
- Laboratory tests of MS rod, coarse sand, cement etc. are being done. Test reports of water, coarse aggregate/ fine aggregate have been made available in the field.
- The quality of stone chips are generally good, however at some sites, stone chips with relatively larger size have been found **(Photo: 02)**. Contractor representatives have been advised to use only properly graded stone chips following design requirement.
- Quality steel shutters with steel props have been used in all RCC works **(Photo: 03)**.
- Site offices and labor sheds have been constructed in most of the sites.
- MS rods have generally been properly stacked **(Photo: 04)** however with few exceptions.

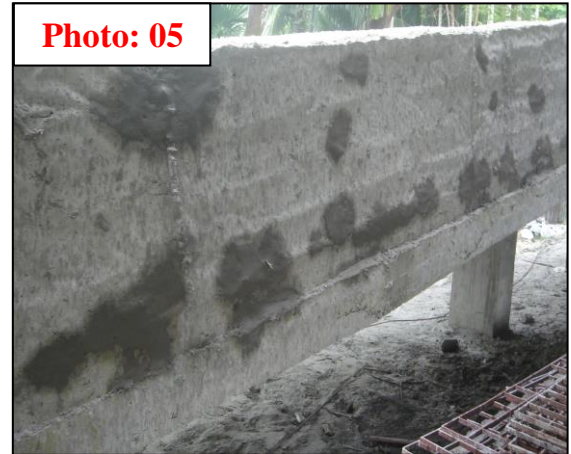
- The quality of concrete works should be further improved (**Photo: 05**).

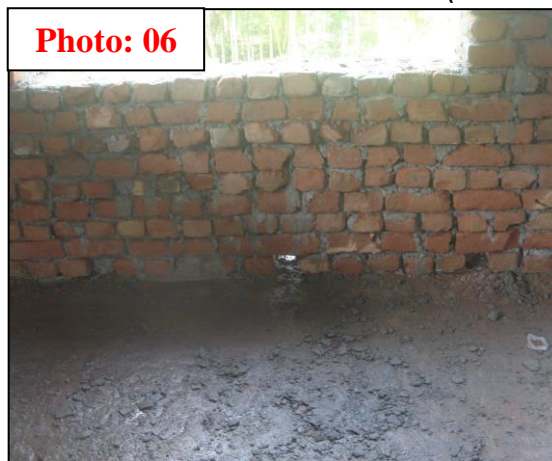
- The quality of brickworks in some shelters appears poor (**Photo 06**). The contractor's representatives informed that good quality bricks are not available in Bhola. The statement is confusing as we have seen machine made bricks at some other sites (**Photo: 07**).

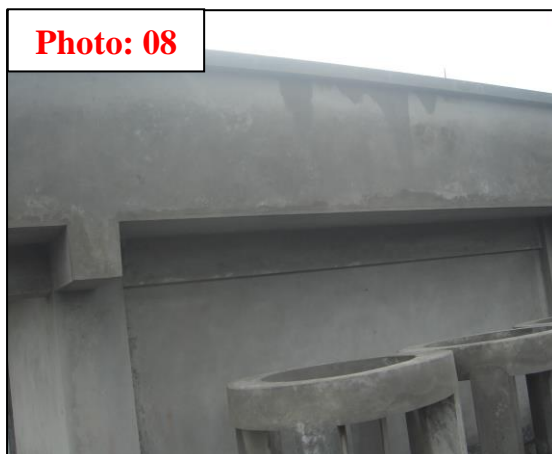
- The quality of plastering works appears fairly good (**Photo: 08**). However, the fine sand being used for plastering works should be of proper FM. The fine sand is likely to contain salinity. To neutralize the salinity, chemical re-agent 'Desalt-S' of Baral Chemical Company Ltd. Is being used. However, we have noticed scattered salt deposition at a few plaster surfaces.
- All grooves on the brick walls for fixing concealed pipes should be done before plastering. In **BHP-359**, plastering on the walls was done earlier and then grooves were made later cutting plastered walls. (**Photo: 09**). The RRE of Barisal expressed dissatisfaction for not following the standard practice.

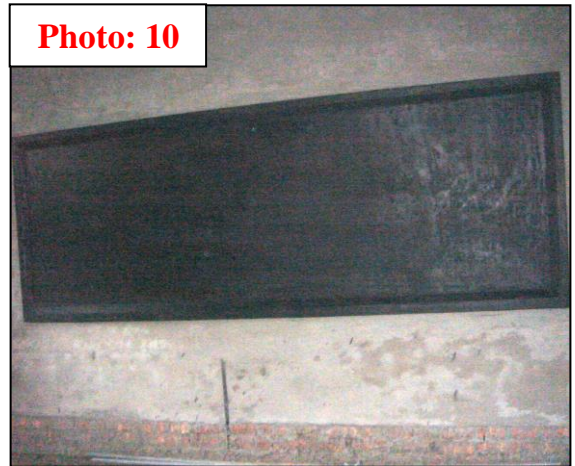
There is provision in the contract to build fixed masonry classroom blackboards on the classroom walls. In many shelters, masonry classroom blackboards have been built (**Photo: 10**). The masonry blackboards with rough surface are not user friendly. White chalks are generally used for writing purposes on the blackboards. Erasing the writings on the board using chalk duster make the surface of the blackboard white when further writings become indistinct. Again, the chalk produces dust which is inhaled by the teachers and even by the students being circulated by the running fans. This view was expressed by the teachers of **BHP-27**.

Instead of the masonry classroom writing board, we would recommend using 'Mobile Classroom Writing Boards' (**Photo: 11, Chalk board**). The features of this type of writing boards are: environment friendly, impeccable finish, hassle free installation and easy to clean.

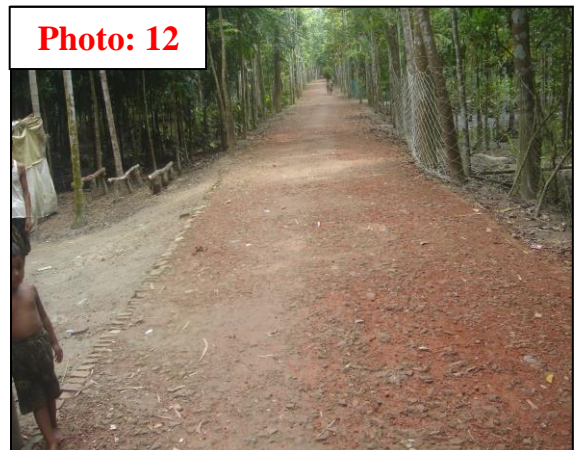
There is provision of construction of 15 nos. Shelter Connecting Roads (SCR) of various lengths under the contract of the package. Out of the 15 nos., construction of **SCR of BHP-43** having a length of 980 m has been partially done. 1<sup>st</sup> layer WBM has been done about 6 months ago (**Photo: 12**).

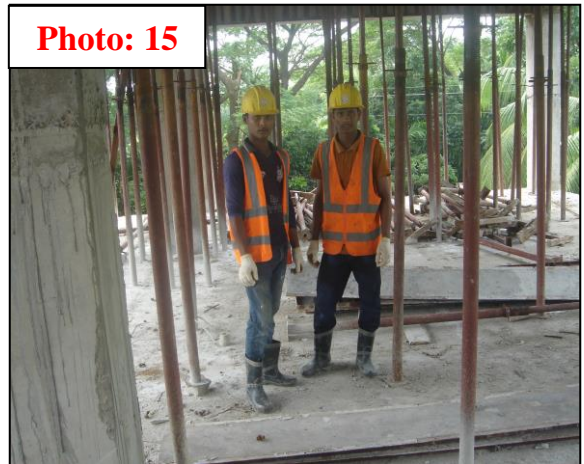
**Photo: 15**

- **Safety Gear Package:** Safety gear package such as helmets, hand gloves, rubber shoes, light reflecting dresses etc. has been found to be used by many of the workers although some workers are reluctant to use them.. (**Photo: 15**).

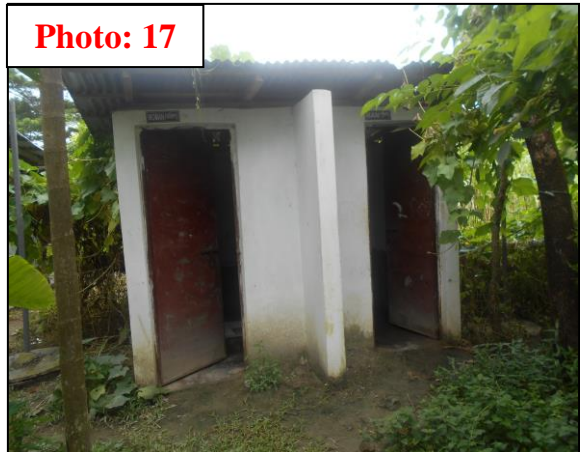
**Photo: 17**

- **Sanitary Latrine for Male and Female:** Sanitary latrines for use of the male and female labors have been constructed in most of the sites but the condition of the latrines is not hygienic (**Photo: 17**).

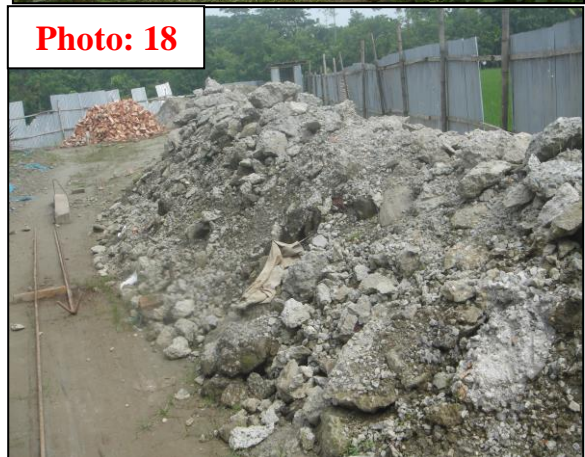
**Photo: 18**

- **Camp Site Waste Disposal Facility:** No planned practice of waste disposal particularly disposal of construction debris was observed. Under-construction debris and garbage are kept haphazardly (**Photo: 18**). Garbage must be stockpiled and removed to a pre-designated waste disposal area. FREs/ site supervisors should monitor this issue strictly.

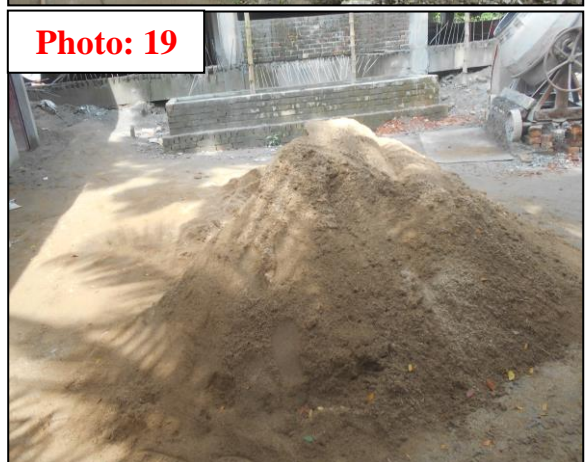
**Photo: 19**

- **Dust Suppression Measures:** Sand has been covered by polythene in all constructed sites to protect from dust pollution except fully uncovered in **BHP-43** and partially in **BHP-27, BHP-313, BHP-317 and BHP-359**. This should always be covered as suppressive to protect from air pollution (**Photo: 19**).

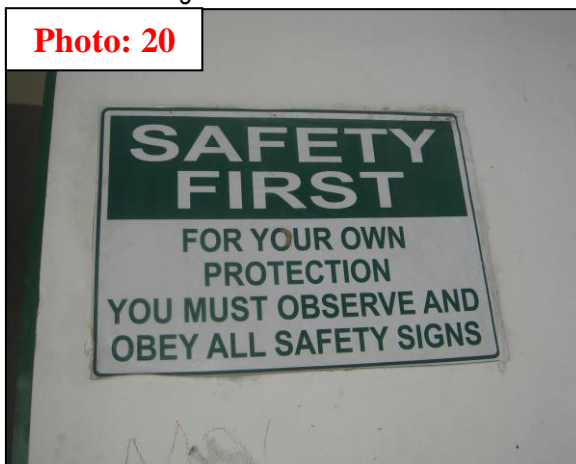
**Photo: 20**

- **Health/Safety Warning Sign:** Safety signboards have been found in all sites but these were written in English (**Photo: 20 & 21**). The safety signboards should be written in Bengali for easy understanding of the workers.

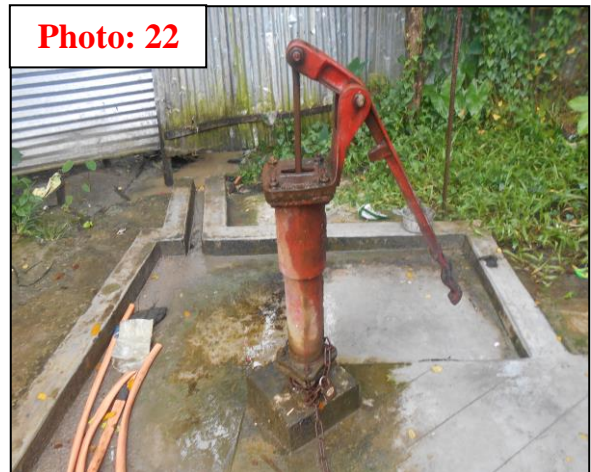
- **Tube Well:** Tube wells have been installed at all sites to obtain safe drinking water for the labors and site staff and also for use in construction works. The colour of head of the tube well is red (**Photo: 22**). This is confusing. As a convention, red color in tube wells indicates arsenic presence. The color of the tube wells head should be anything other than red preferably green.
