MULTIPURPOSE DISASTER SHELTER PROJECT (MDSP)
Monitoring & Evaluation (M&E) Consultant

FIELD VISIT REPORT

1. Period of Visit : 28-29 March 2018
2. Location of Visit : Cox's Bazar District.
3. Participant of visit : Engr. A.H.M. Mahbubur Rahman, TL, M&E Consultant
Dr. Md. Barkat Ullah, Environmental Specialist, M&E Consultant
4. Officials met during Visit :

Package no. LGED/MDSP/COX/14-15/NW-04:

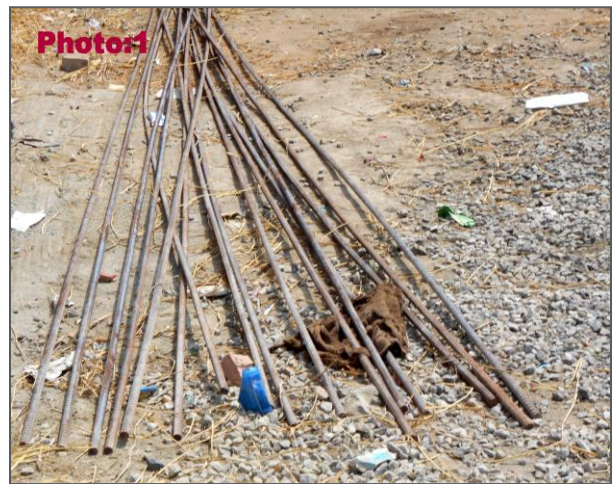
- Reinforcement steel have not been properly stacked at sites (**Photo: 1**). There should be raised platform in safe location to store MS rod, MS angles, Steel shutter materials etc.

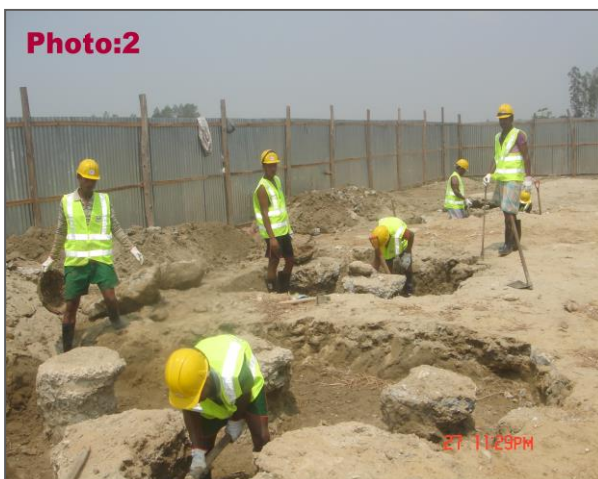
- **COP-336:** All 75 nos. cast-in situ piles of lengths of 15.1 m and diameter of 500 mm have been cast. Breaking of pile heads for pile cap casting in some piles is in progress (**Photo: 2**). Bricks have been improperly stacked at gate entry point (**Photo:3**).

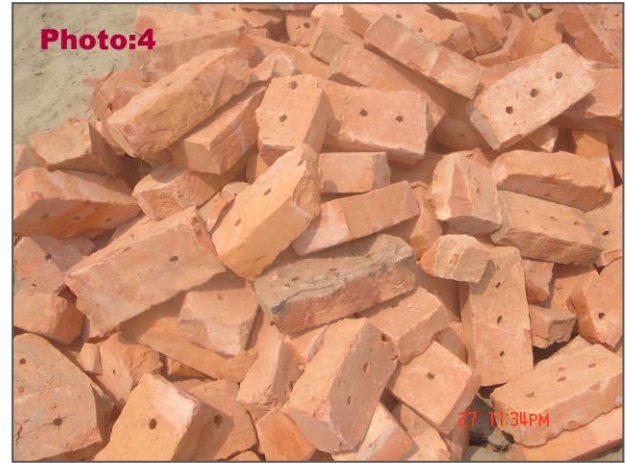
- The quality of construction materials such as MS Rod, stone chips, coarse sand etc. procured at sites appears good. The quality of procured bricks however, does not meet the standard specification. Bricks of proper specification should be used in work. Laboratory tests of MS rod, coarse sand, cement etc. have been done. Test reports have been made available in the field.

The quality of bricks should be improved (Photo:4).

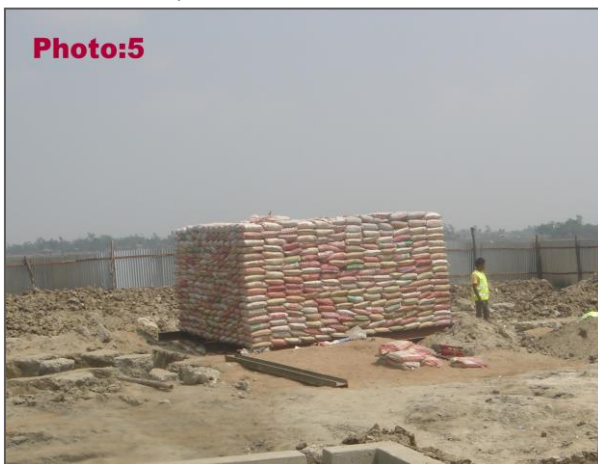
- **COP-456:** All 70 nos. cast-in situ piles of lengths of 11.6 m and diameter of 500 mm have been cast. Pile load test preparations are being taken (Photo:5). Site office is under construction. MS rod should be properly stacked in raised platform (Photo:6).

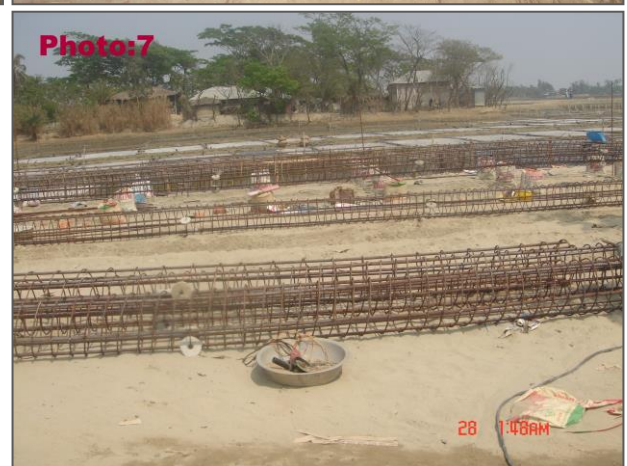
- **COP 451:** Re-bar fabrication for casting of situ piles is in progress. (Photo:7). 30 nos. cast in situ piles out of 70 nos. have been cast so far. Each pile has a length of 19.5 m and diameter of 500 mm.
- **COP-344:** Casting of all 75 nos. situ piles have been completed. The length of each pile is 6.0 m. Earthwork for pile cap casting was going on.
- **COP-345:** Cast in situ piles have been completed. Breaking of pile heads have been done (Photo:8), Re-bar fabrication for pile cap casting is underway.

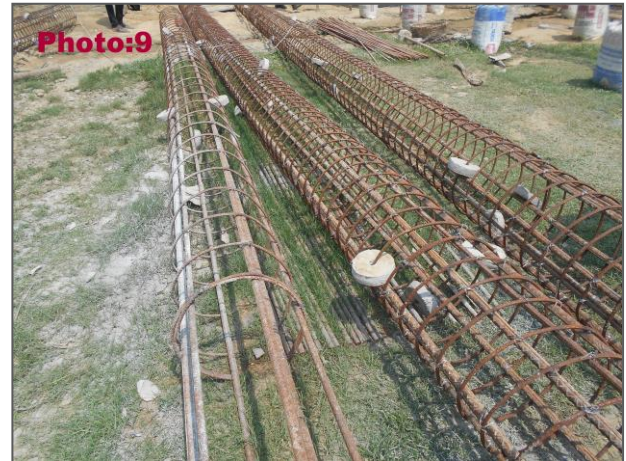
- **COP-180:** 44 nos. cast in situ piles out of 75 nos. have been cast so far. Each pile has a length of 20.1 m and diameter of 500 mm. Preparations for casting of situ piles is in progress (**Photo:9**).

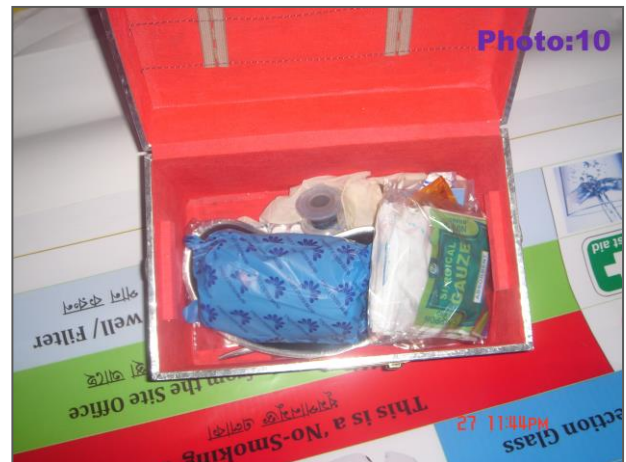
- **First Aid Box:** First aid boxes with standard contents have been procured for all sites (**Photo:10**).

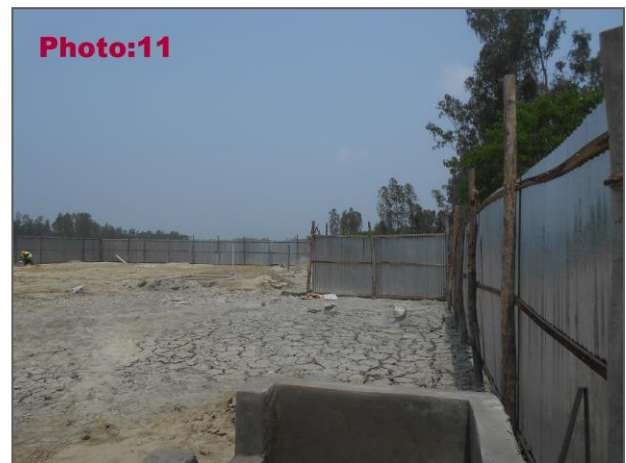
- **Safety Fence:** Safety fence has been erected in all construction sites except **COP-451** to keep the students and public away to avoid the danger of accident. The fencing has been made by corrugated iron sheets. The quality of fencing is fairly good (**Photo:11**).

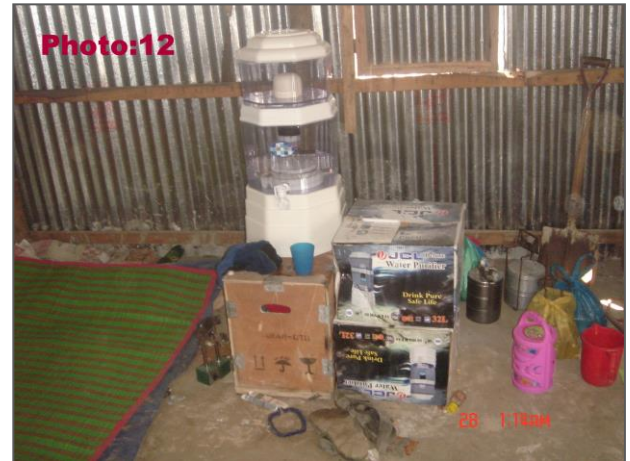
- **Water Filter:** Water filters have been procured for every site (**Photo:12**).

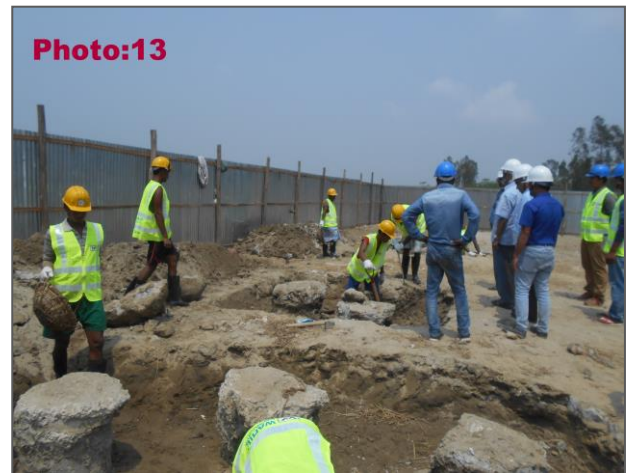
- **Safety Gear Package:** Safety gear package such as helmets, hand gloves, rubber shoes, light reflecting dress etc. have been procured. Labors were seen using them (**Photo:13**). However, we were informed that labors are reluctant to use these safety gears as they are not used to it. They should be motivated by explaining the benefit of using the safety gear materials.

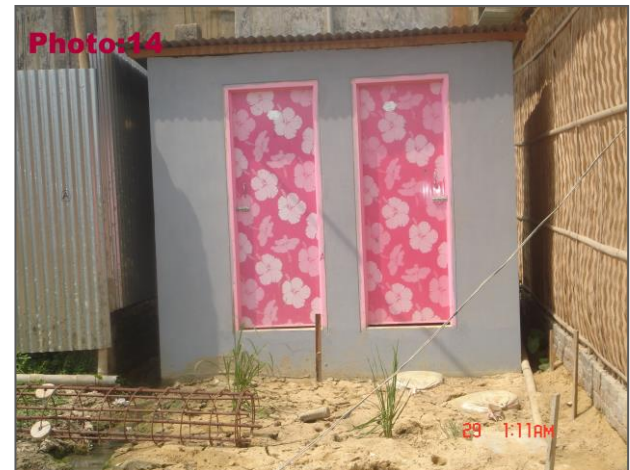
- **Temporary Sanitary Latrine:** Temporary sanitary latrines for use by the labors were found in all visited sites except **COP-336**. These are twin latrines, one is for use by the male labors and the other one by the female labors (**Photo:14**).

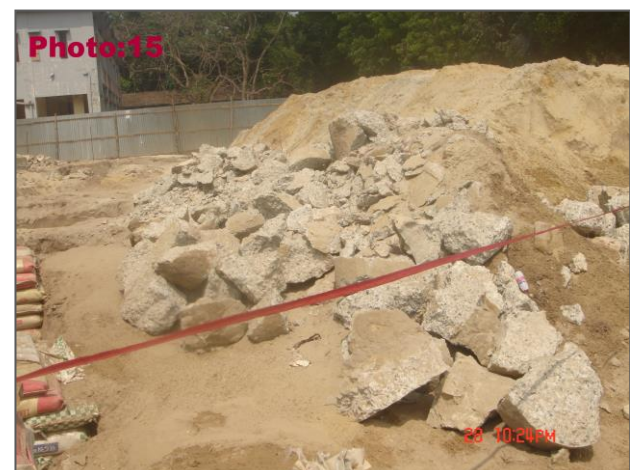
- **Waste disposal facility:** No planned practice of waste disposal particularly disposal of construction debris was observed. Under-construction debris and garbage are kept haphazardly (**Photo:15**). Garbage must be stockpiled and removed to a pre-designated waste disposal area. FREs/ site supervisors should monitor this issue strictly.

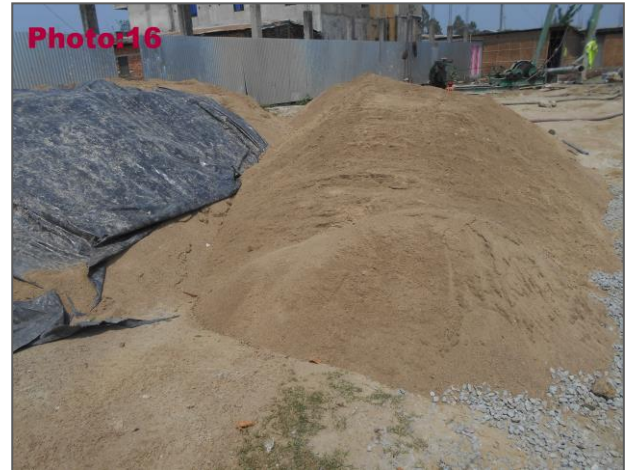
- **Dust Suppression Measures:** In some sites, sand was kept under cover to stop dust pollution while in some other sites, these were kept exposed (**Photo:16**). This should always be kept under cover to prevent dust pollution.
- **Environmental and Social/Safeguard Personnel:** Environmental and Social/Safeguard personnel are yet to be deployed.
- **Health/Safety Warning Sign.** Poster indicating health/safety warning sign was found at all sites (**Photo:17**).

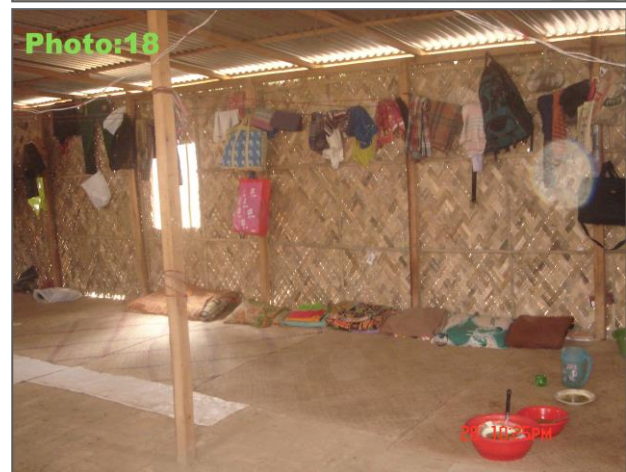
- **Labor Sheds.** Labor sheds have been made but the quality of the sheds should be improved. Ceiling fans should be fixed (**Photo:18**).

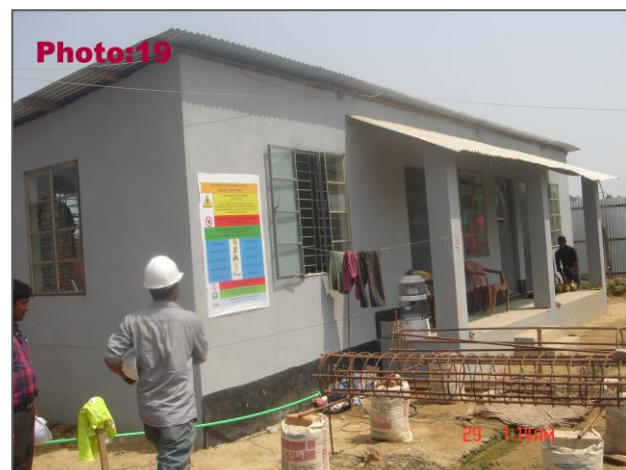
- **Site Camp Office:** Site camp offices have been constructed but these are lagging required furniture like Racks, Almirah etc. to keep important project documents (**Photo:19**).

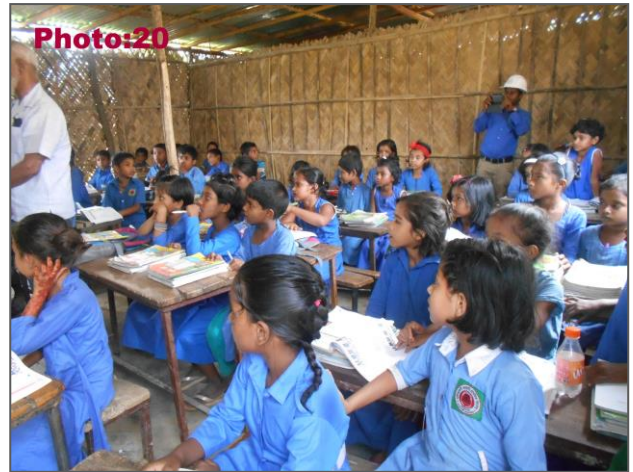
- **Tube Well:** Tube wells have been installed at all sites to get safe drinking water for the labors and site staff. The colour of head of tube well should be other than red as red colour indicates arsenic presence in water of the tube well.
- **Construction of Temporary Shed for Uninterrupted Schooling:** There is provision of construction of temporary sheds for class accommodation where existing building has to be dismantled to make room for construction of the new shelters. In **COP-180**, one thatched temporary shed has been constructed. The quality of the shed appears to be weak with chances of rain water being splashed in or even the shed being damaged by strong winds (**Photo:20**). The D&S Consultants may think of designing a typical temporary shed for the purpose. The students demanded fixation of a few ceiling fans in the class rooms.
