MULTIPURPOSE DISASTER SHELTER PROJECT (MDSP)
Monitoring & Evaluation (M&E) Consultant

FIELD VISIT REPORT

1. Period of Visit : 19 December – 20 December 2016
2. Location of Visit : Feni District.
3. Participant of visit : A.H.M. Mahbubur Rahman, TL, M&E Consultants,
Ahmedur Rahman, DTL/ ICT Specialist, M&E Consultant,
4. Officials met during Visit :

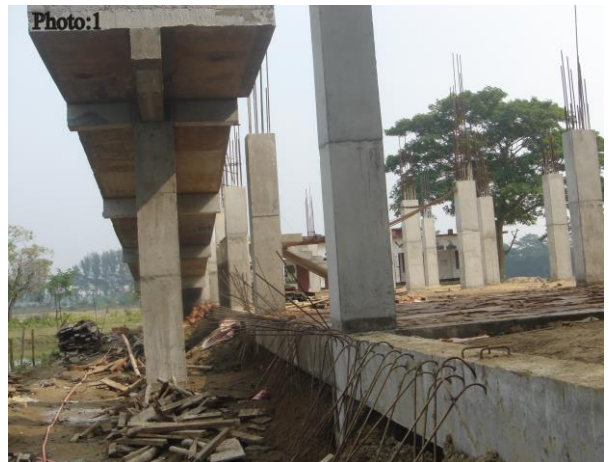
- Physical works in most of the shelters are limited to collection of construction materials, construction of cast-in-situ piles. Grade beams, Columns and rams have been cast in some shelters (**Photo 1**).

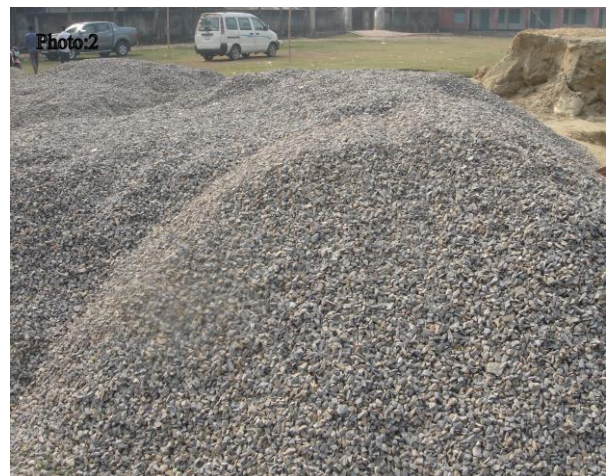
- The quality of the collected stone and coarse sand appear to be fairly good (**Photo 2**). In **FEP-335**, M S Rods have been properly stacked (**Photo 3**). The same practice should be adopted in other construction sites (**Photo 4**).

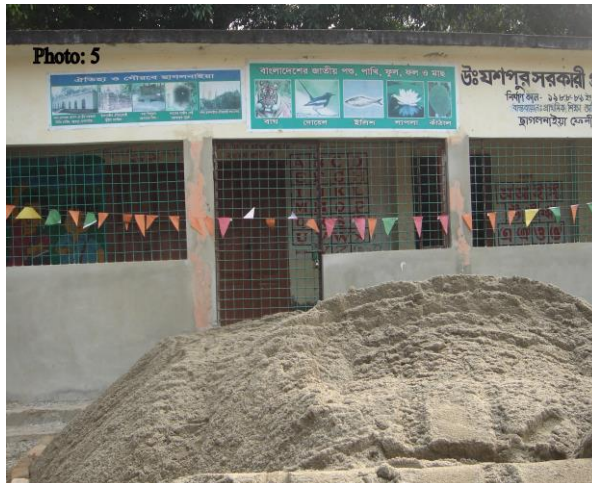
- In some shelter sites, space available for construction works, storage of construction materials, fabrication of MS Rod, storage of shutter materials and storage of excavated earth is limited(**Photo 5**). Separate yard to serve the above purpose and construction of labor sheds, toilets etc. may be arranged/ hired by the contractors for smooth construction works without hampering normal school activities.
- New steel shutter materials have been used in the grade beams and columns (**Photo 6**). This has resulted in production of good concrete with smooth surface. However, care should be taken in placing shutters for second stage casting of columns to avoid bulging.

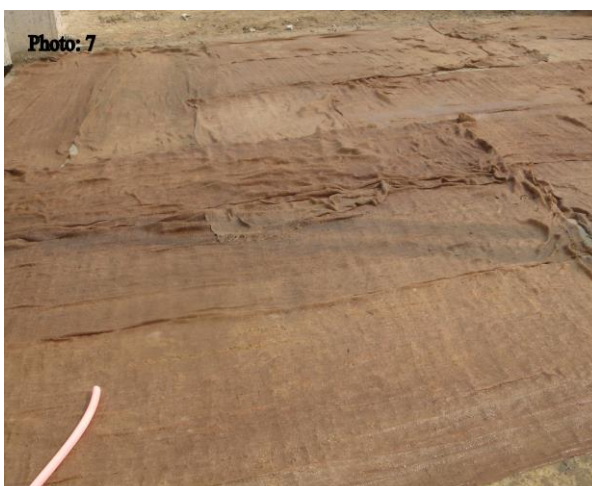
- Curing is very important for concrete works. It has been observed that this aspect has been given due care (**Photo 7**).
- Floor filling is being done by earth reportedly as per design provision. For proper compaction, sand filling is preferable.

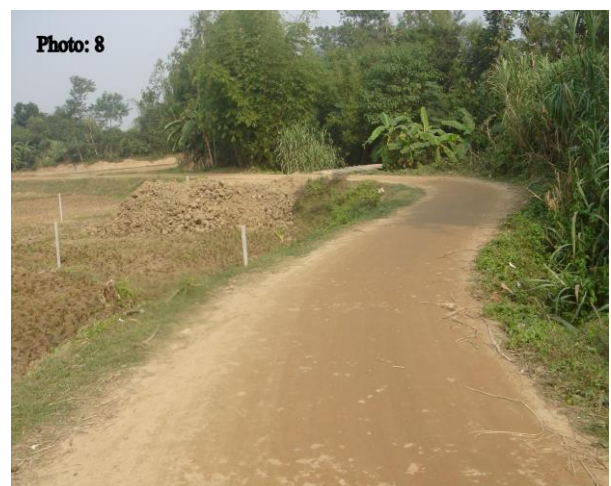
Construction work of the 850m access road connecting **FEP-210: Islamia Bazar GPS cum CS at Fulgazi UZ** is under progress. WBM work has been done so far (**Photo 8**). Carpeting is yet to be done.

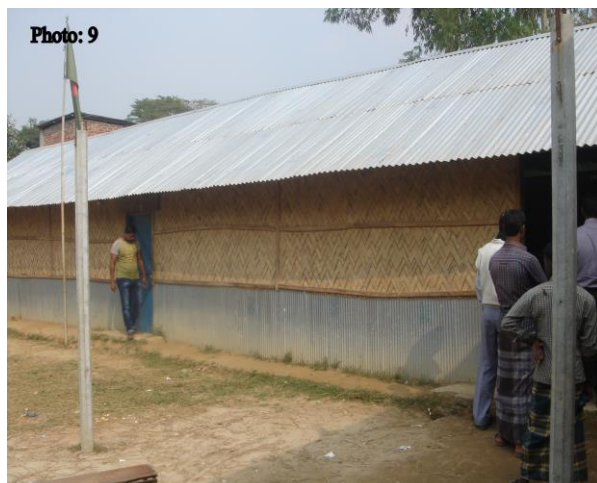
- **Uninterrupted Schooling:** In most shelter sites, the existing school buildings have been demolished, for new Construction As an alternative, temporary sheds have been erected to house the classes till the completion of the new shelter (**Photo 9**). In **FEP-015**, (**Photo 10**), no temporary shed was built resulting acute space problem. Due to storage of sand, the entry and exit to class rooms have been very narrow.

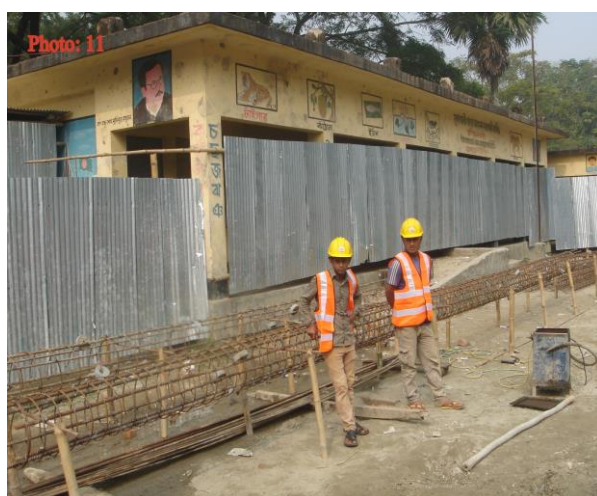
- **Posting of Signboard:** Contract information signboards were found describing subproject activities at all construction sites.
- **Erection of Safety Fence:** Safety barrier has been erected in all construction sites to keep the students and public away to avoid danger of accident. In **FEP-341**, fencing has been so closely done to existing class rooms that it obstructs light and air circulation (**Photo 11**). The fencing should be shifted to make room for proper lighting and air circulation to class rooms.
- **Labor Shed/Camp:** Labor sheds and good camp offices have been established.
- **First Aid Box:** First Aid Kits to ensure adequate safety gears for workers was available at sites to meet emergency accidental injuries. Labors were found to use safety gears such as vests, hand gloves, boots and other safety devices while at work. (**Photo12**).

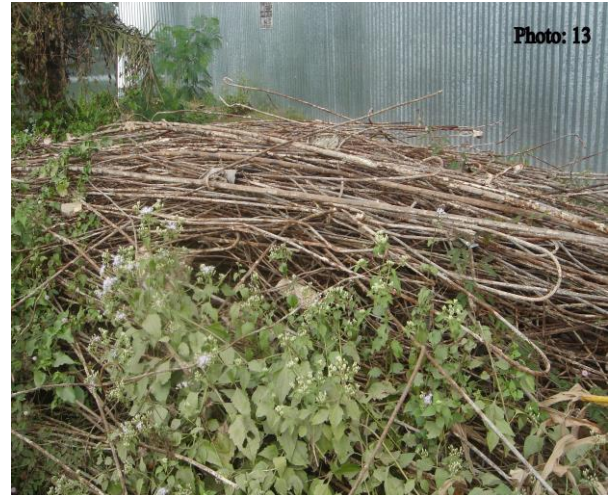
- **Drainage Congestion/ Water Logging:** No drainage congestion/water logging problem was observed.
- **Waste disposal/Management:** No planned practice of stockpiling of construction debris was observed. Under-construction debris and garbage are kept haphazardly. Garbage must be stockpiled and removed to a pre-selected distant place on discussion with school authority/local communities (**Photo 13**). FREs/ site supervisors should monitor this issue.

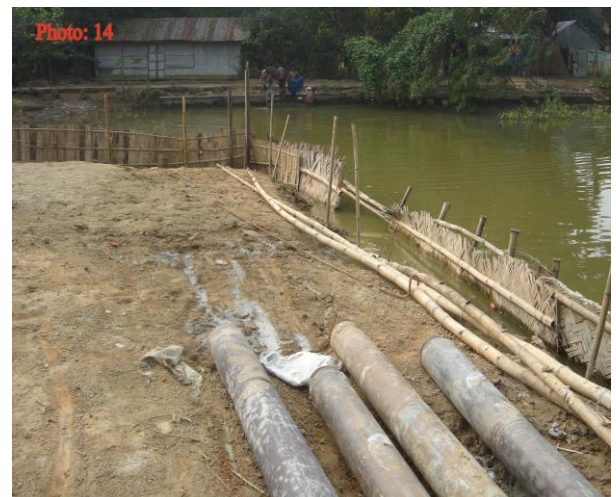
- **FEP-020** is being built on land encroaching a big pond (**Photo 14**). It was informed that the land owner voluntarily allowed to construct the shelter encroaching the pond. However, the technical aspect of the stability and possibility of erosion of the structure built on partially filled pond may please be looked into.
- Construction of **SCRs** requires extra land on both sides of existing narrow village roads. SCR construction often need of use of private land as in the case of **FEP-210 (Photo 8)**. The local people informed that the land owners voluntarily donated the land for road construction.

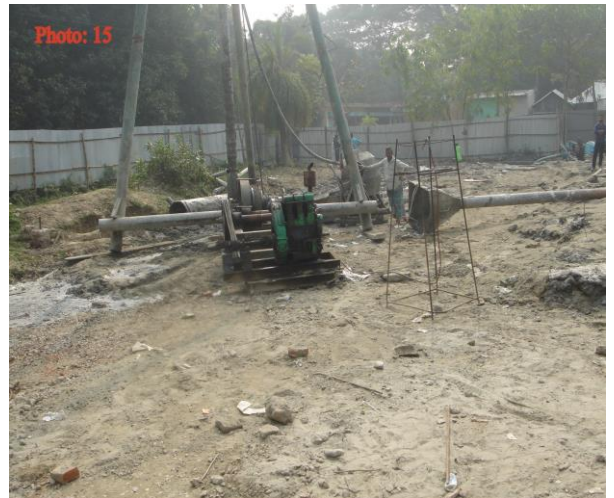
There is a graveyard within the premises of **FEP-341 (Photo15)**. All care need be taken so that the graveyard is not affected by construction works.
