MULTIPURPOSE DISASTER SHELTER PROJECT (MDSP)
Monitoring & Evaluation (M&E) Consultant

FIELD VISIT REPORT

1. Period of visit : 23-25 September 2017
2. Location of visit : Feni district.
3. Participants of visit : A.H.M. Mahbubur Rahman, TL, M&E Consultant
Md. Barkat Ullah, Environmental Specialist, M&E Consultant
4. Officials met during visit :

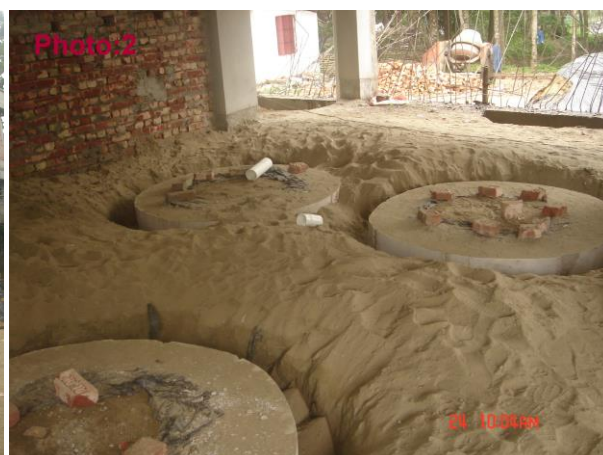
- The reported physical progress of the construction of the 6 new shelter works are as follows: **FEP-176: 65%; FEP-333: 32%; FEP-292: 30%; FEP-014: 34%, FEP-020: 36% and FEP-171: 63%.**
- The completion dates of almost all the shelters are **31 December 2017**. Progress of physical works in most of the shelters under **Contract Package No.03** are advanced compared to works of Contracts of **Packages 1 and 2**. It is however apparent that the works of the three packages may not be completed in time.
- **FEP-176:** all the RCC work of ground floor, 1st floor and 2nd floor has been done. The quality of concrete should be improved (**Photo 1**).
Because of scarcity of land, sanitary pit concreting has been done inside for subsequent placement outside (**Photo 2**).

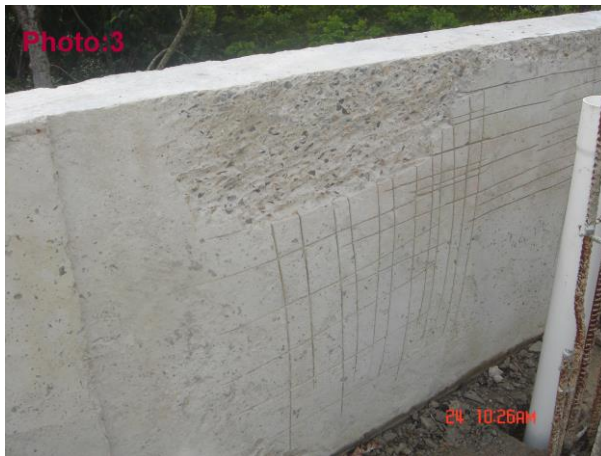
- There is bulging in the concrete of parapet which is seen to be scrubbed before plastering (**Photo 3**).
- **FEP-333:** construction of the grade beams have been done. Concrete quality of grade beam looks fairly good (**Photo 4**).
Preparation for casting columns above grade beam is in progress. Column shutters should be so placed that there remains no gap in the joint (**Photo 5**).
The labor shed has been made by using CI sheets but there is no cross ventilation arrangement. Ventilation arrangement should be made (**Photo 6**).

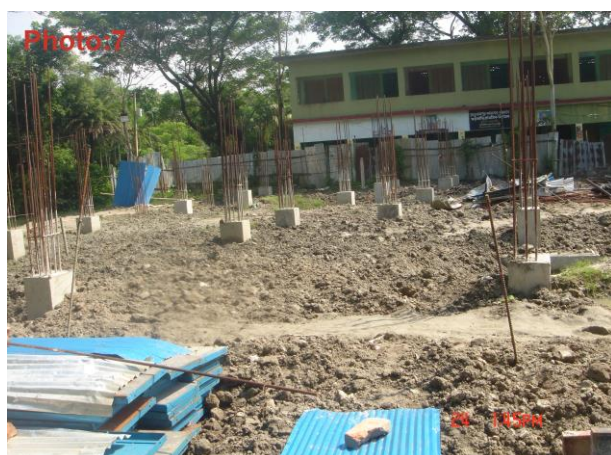
- **FEP-292:** only columns below grade beam level has been cast (**Photo 7**). No labor was working at site. It is hardly possible to complete the work in time.
- **FEP-014:** the progress is disappointing (**Photo 8**). No labor was working at site.

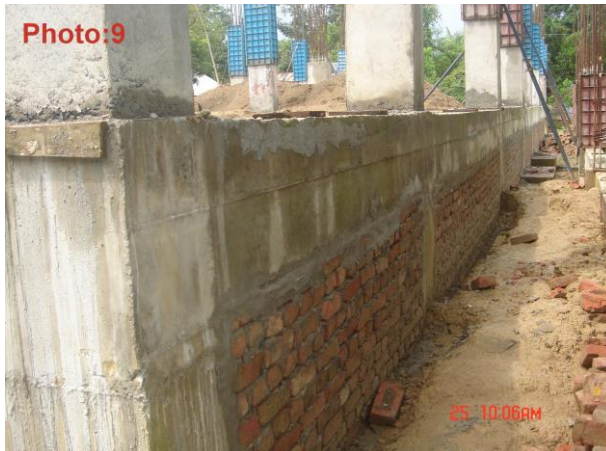
- **FEP-020:** the progress is too slow. No labor was found working at site. Quality of concrete is also not good (**Photo 9**).

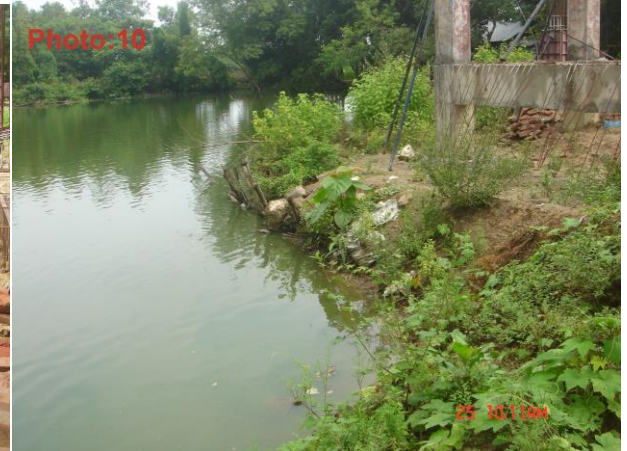
Since the structure is located on an existing pond, some protective work need to be done for the safety of the shelter cum school. There should be barrier in the back side of the structure for the safety of the child students of the school (**Photo 10**).

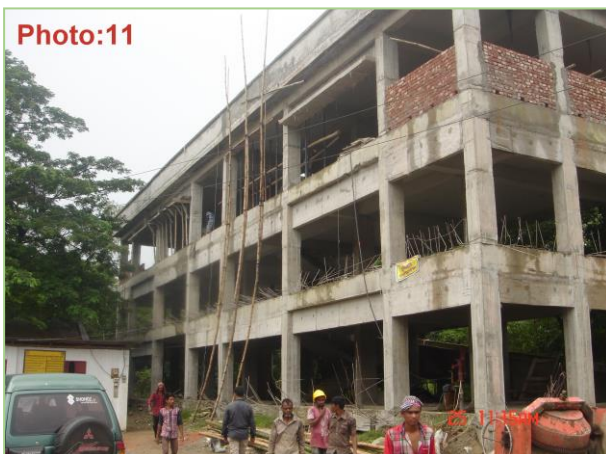
- **FEP-171:** Physical progress is better compared to other structures (**Photo 11**). However, the quality of concrete work should be improved (**Photo 12**).

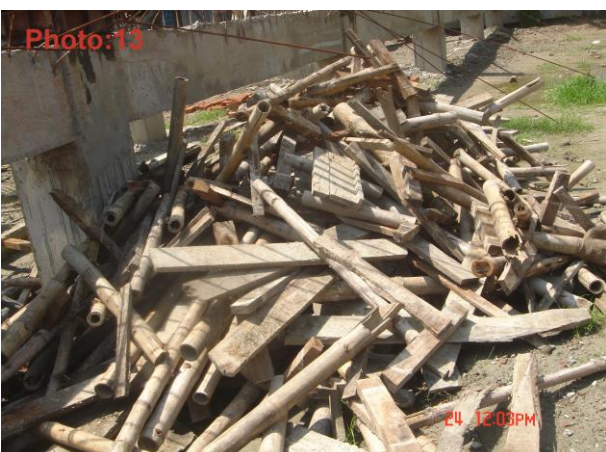
- Shutter materials have not been properly stacked at safe location (**Photo 13**).
- M.S rods have been kept covered but should have been placed on raised platform (**Photo 14**).

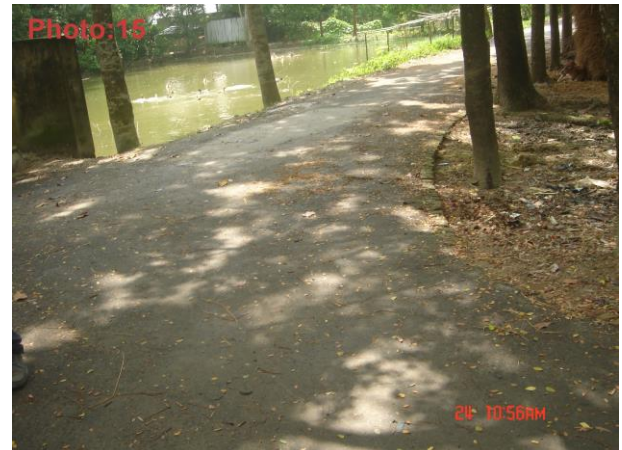
The 180 m long shelter connecting road relating to **FEP 176** has been completed. The road passes very close to a pond. Some protective works are required to be done at pond location for the sustainability of the road (**Photo 15**).

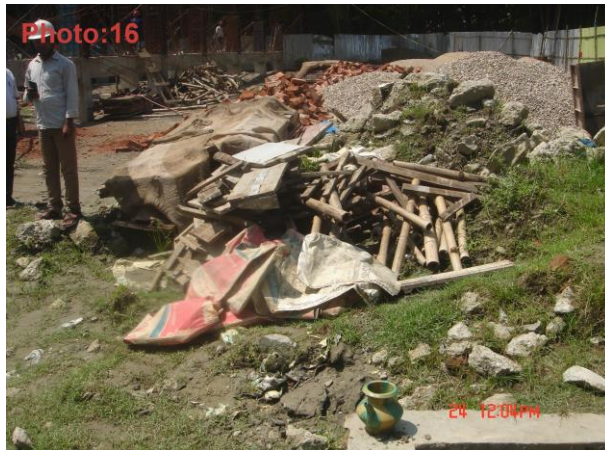
- **Camp Site Waste Disposal Facility:** There is provision in BoQ to construct waste disposal (one organic waste and one inorganic waste disposal) in each subproject but no waste disposal facility was observed during field visit.

We understand that this item is meant for earmarking separate waste disposal areas away from construction sites to dispose of all construction wastes. In reality, the wastes are kept haphazardly in construction sites creating an unhealthy environment (**Photo 16**).

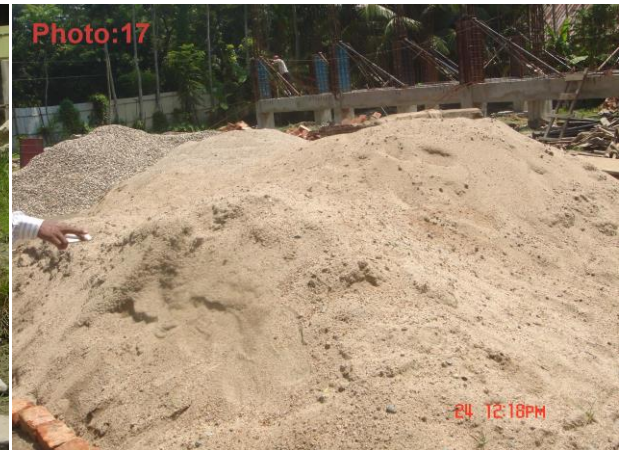
- **Dust Suppression Measures:** Mostly sand was kept under cover but in many places this remained exposed (**Photo 17**).

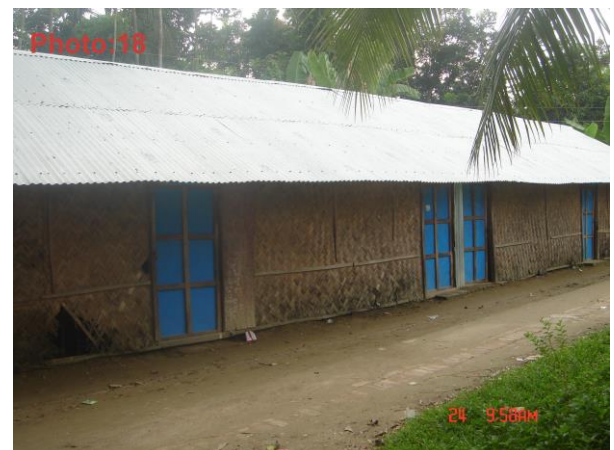
- **Health/Safety Warning Sign:** Health/safety warning sign was found in every subproject site to give the warning of students and general public related to health.
- **Tube well Installation:** Tube wells have been installed in each subproject to get safe drinking water for the labour and the site staff.
- **Temporary Shed:** One temporary shed for alternate accommodation of classes was found in **FEP: 176**. Cross ventilation facility has not been made in the temporary shed (**Photo 18**). This should be done. There is no temporary shed in other visited shelters.
