MULTIPURPOSE DISASTER SHELTER PROJECT (MDSP)
Monitoring & Evaluation (M&E) Consultant

FIELD VISIT REPORT

1. Period of Visit : 06 November 2018
2. Location of Visit : Feni District.
3. Participant of visit : A.H.M. Mahbubur Rahman, TL, M&E Consultant,
Md. Matiur Rahman, Civil Engineer/ M&E Specialist, M&E Consultant,
4. Officials met during Visit :

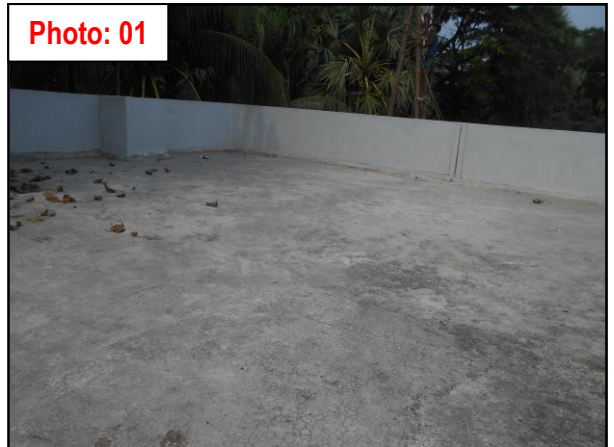
Photo: 01

- **Roof Top Screeding:** Done in both FEE-87 & FEE-86 (**Photo: 01**)

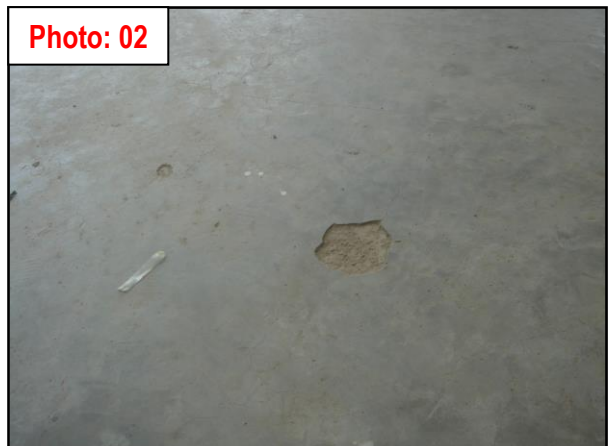
Photo: 02

- **Floor Casting:** Completed at ground floor/ 1st floor of FEE-87 & FEE-86. The surface of the floor of FEE-86 has developed some scattered holes (**Photo: 02**). Curative measures should be taken.

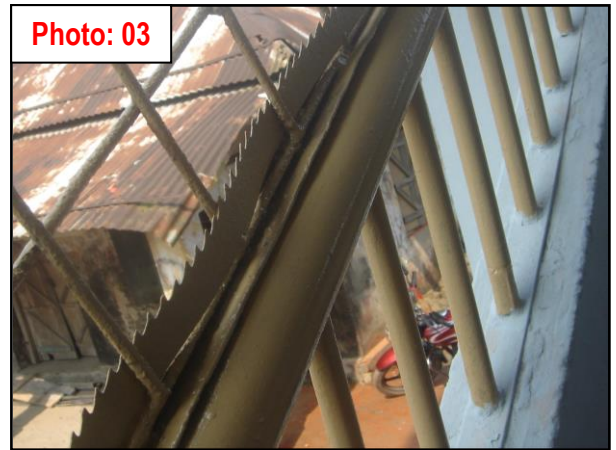
- **Repair of Staircase:** Done in FEE-87 & FEE-86. The stair railing of FEE-87 has sharp saw type steel plate which is dangerous and may cause accident at any moment (**Photo: 03**). It is not understood why the saw plate has been kept on the repaired railing. It should be removed.

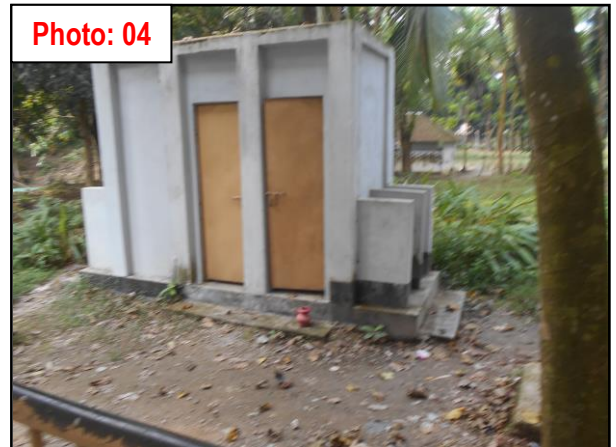
- **Reconstruction of Toilet:** Completed in FEE-87 & FEE-86 (**Photo: 04**)

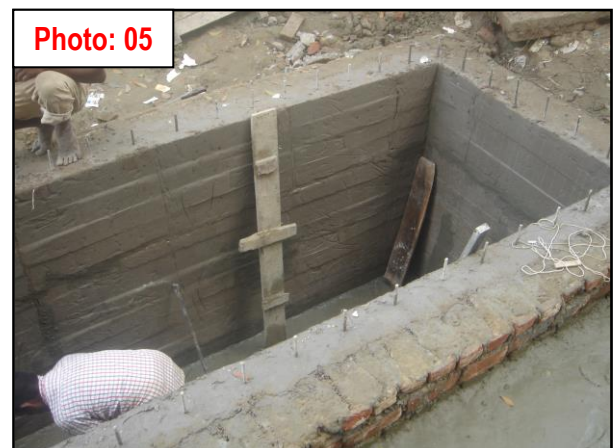
- **Construction/ Re-construction of Septic Tank:** Ongoing in FEE-87 (**Photo: 05**)

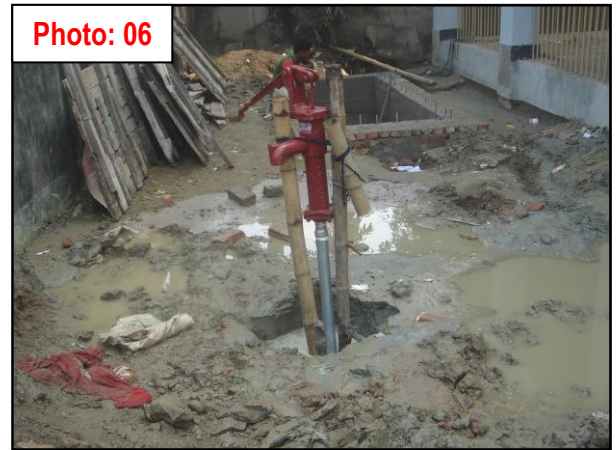
- **Installation of Deep Tube-well:** Work is also ongoing in FEE-87 (**Photo: 06**).

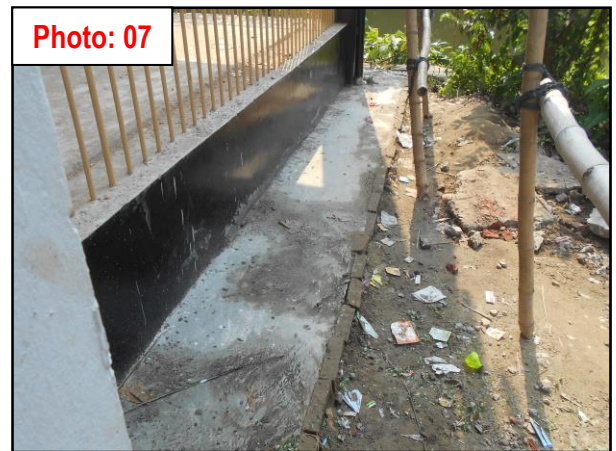
- **Construction of Apron:** Done in FEE-87 but the workmanship should have been more improved. (**Photo: 07**)

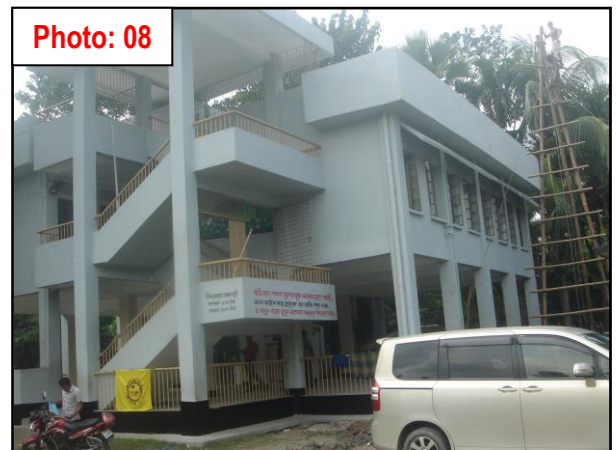
- **Outside & Inside Painting Works:** Works completed in FEE-87 and is still ongoing in FEE-86 (**Photo: 08**)

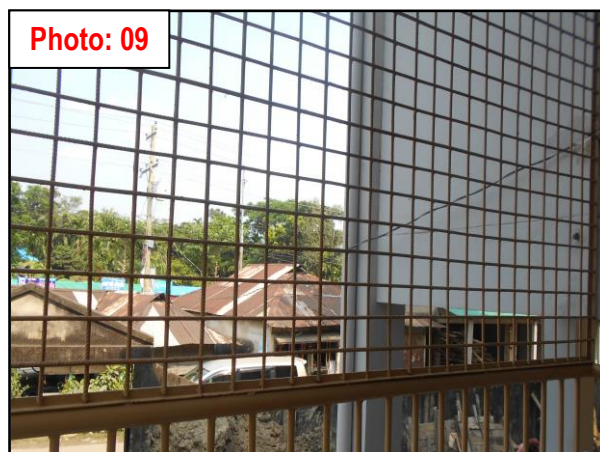
- **Supplying and fixing of Ventilator / Veranda Grills and Collapsible Gate:** Done in FEE-87 & FEE-86 (**Photo: 09**)

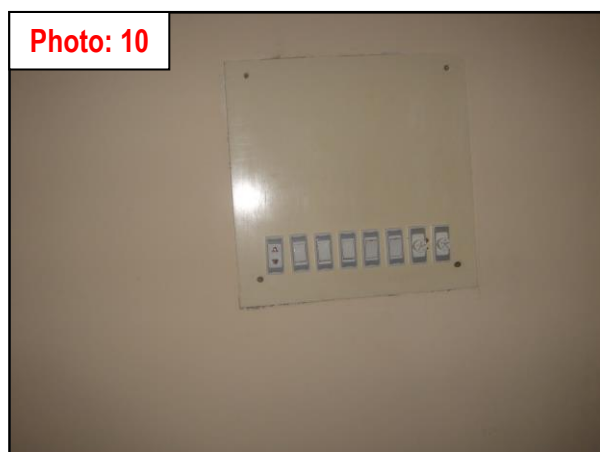
- **Electrification Works:** Done in FEE-87 & FEE-86 (**Photo: 10**). The quality of electrification fittings should be improved.

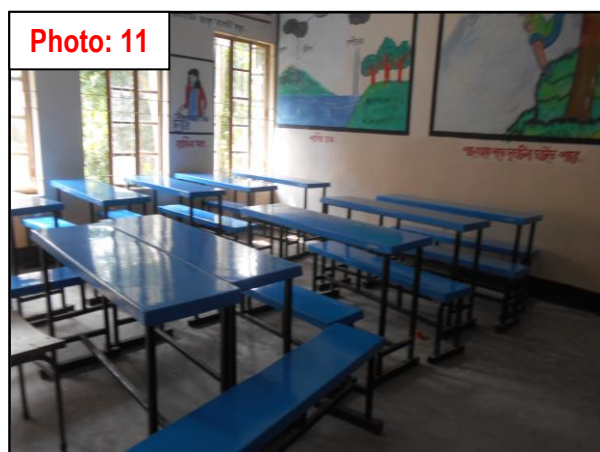
- **School Furniture Supply:** Only high and low benches of Tanin Brand have been supplied in FEE-87 & FEE-86 (**Photo: 11**). Other furniture such as Chairs and tables for the teachers, Steel Almirah etc. should also be supplied.

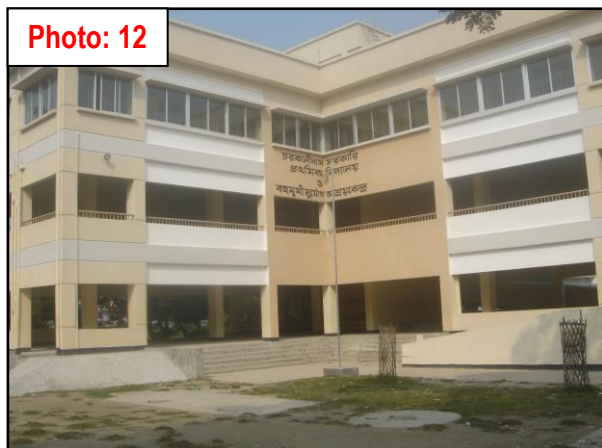
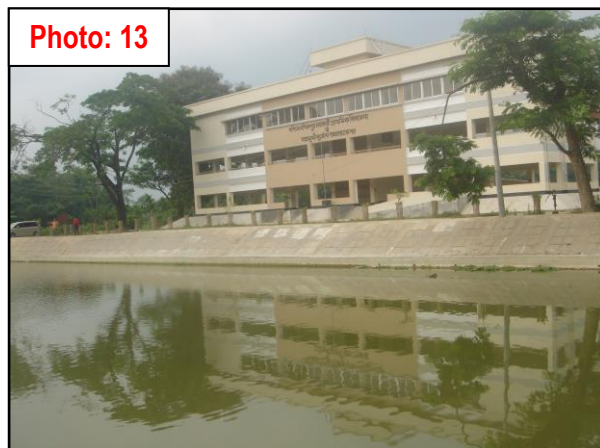
The package includes construction of 6 nos. School cum shelters. Construction of all the shelters have been completed (**Photo: 12**) & (**Photo: 13**). The overall quality of the completed shelters is good. Bank protection works on the pond both in front and back of the structure has been rightly done.

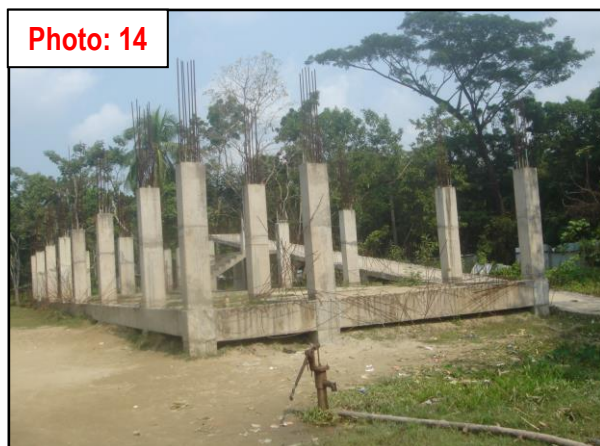
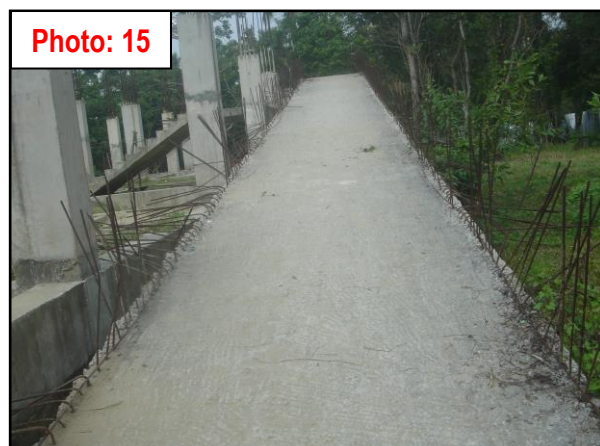
- **FEP-341:** The physical progress is 32%. The shelter site looks like an abandoned site. It has been stated that there had been no physical work since 24 February 2018. Columns at ground floor have been cast (**Photo: 14**). Ramp construction (**Photo: 15**) including 2 nos. of underground water tanks have also been casted.

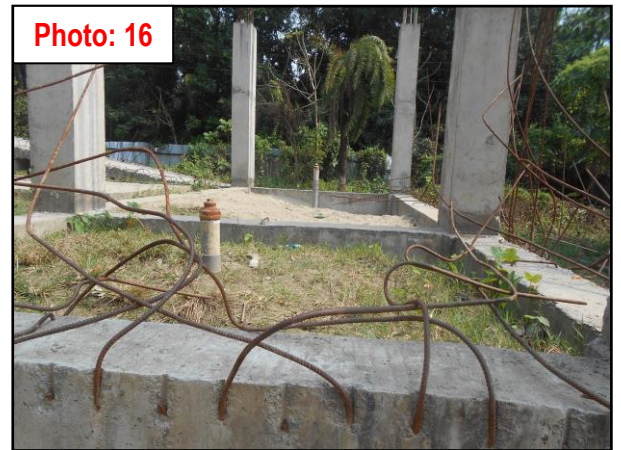
Installation of Deep Tube-wells (4 nos.) have been done (**Photo: 16**). It was informed that the SMC has temporarily taken out the head of the tube well to avoid theft.

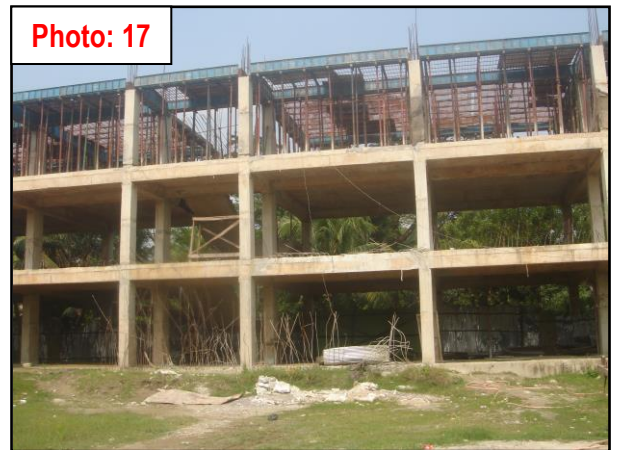
- **FEP-335:** Up to date progress is 52%. No physical work has been done for the last ten days, as reported. Shutter placement for 2nd floor slab casting was in progress (**Photo: 17**). Ramp construction including 2 nos. of underground water tanks have been casted. However, the quality of work so far done is good.

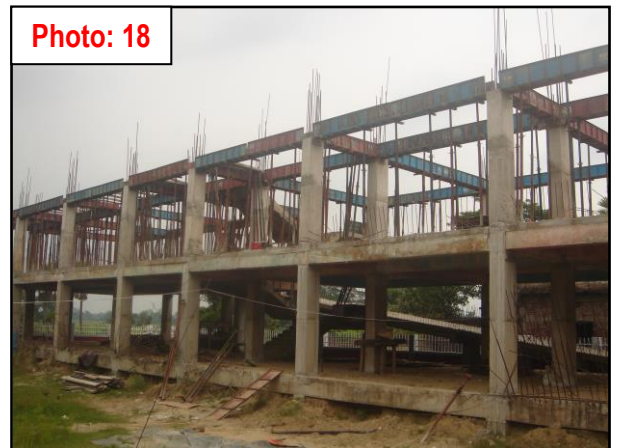
- **FEP-014:** Physical progress is 44%. Shutter placement for 1st floor slab casting is going on (**Photo: 18**). Ramp construction including 2 nos. of underground water tanks have been casted. Installation of Deep Tube-wells (4 nos.) has been completed.

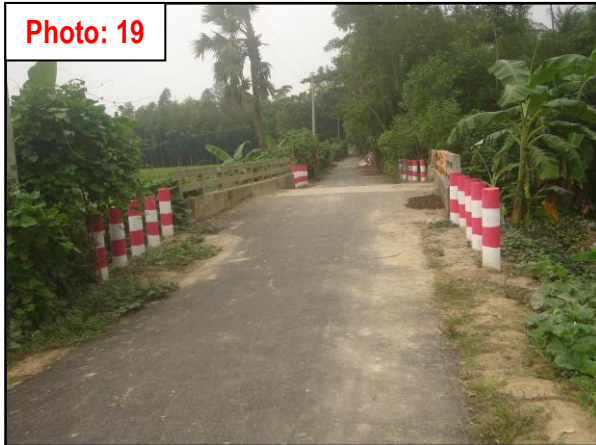
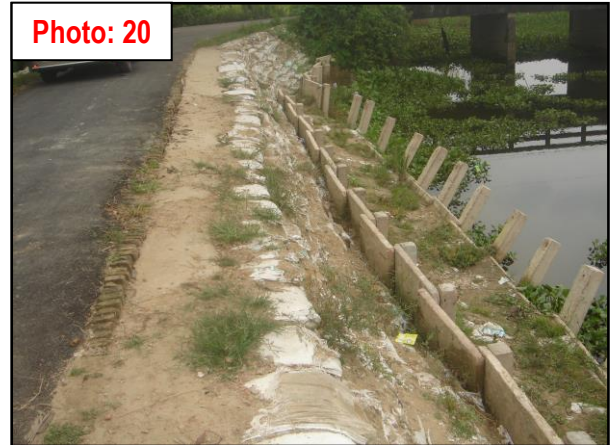
- Relating to **FEP-201**, there is a provision of construction of shelter connecting road for a length 253m with one no. (1 vent) box culvert. The SCR has already been completed (**Photo: 19**). The pallasiding work attached to the culvert to protect the SCR has been slightly tilted (**Photo: 20**).

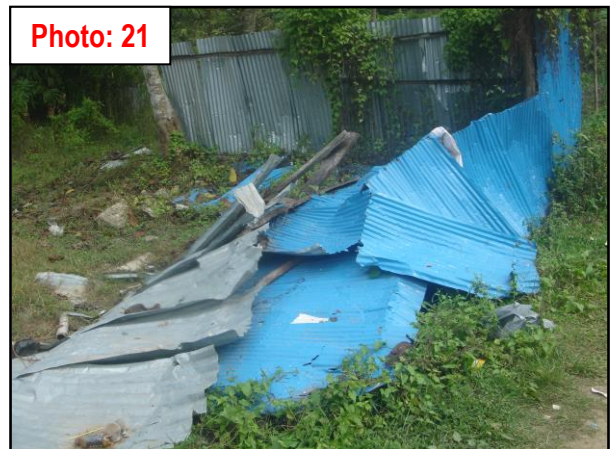
- By and large, the compliance of environmental safety aspect is disappointing particularly on the ongoing sites. No Community Organizer was met in the field. As there was little activity in the field, the measures have been overlooked.
- In **FEP-341**, the boundary fences have been found damaged site remains wide open (**Photo: 21**).

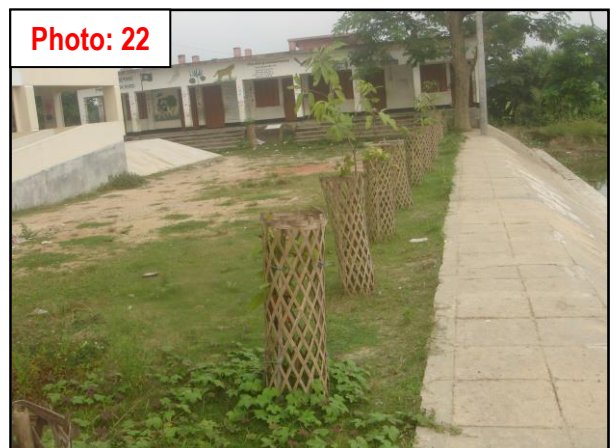
- In both completed shelters FEP-181 & FEP-201, tree plantation has been done. (**Photo: 22**)
