MULTIPURPOSE DISASTER SHELTER PROJECT (MDSP)
Monitoring & Evaluation (M&E) Consultant

FIELD VISIT REPORT

1. Period of Visit : 06 Feb – 07 Feb 2019
2. Location of Visit : Lakshmipur District.
3. Participant of visit : A.H.M. Mahbubur Rahman, TL, M&E Consultant,
Md. Matiur Rahman, Civil Engineer/ M&E Specialist, M&E Consultant,
4. Officials met during Visit :

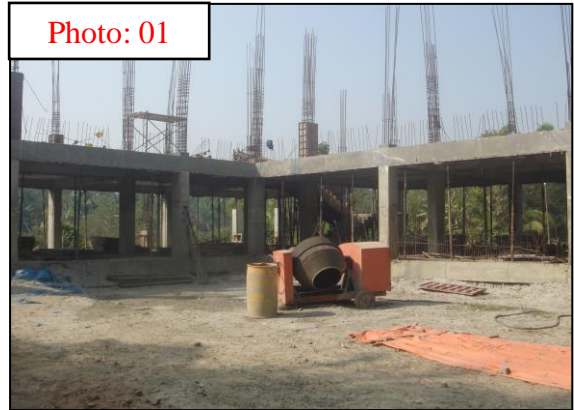
- **Staff Mobilization by the Contractor:** At the start, M/S. Navana Construction Ltd. made good mobilization of field personnel. Project Manager, Deputy Project Manager, Assistant Project Manager, Area Manager, Community Organizers, Site Engineers and other support staffs etc. were mobilized. It was learnt that there has been no physical activity since early January, 2019. We were informed that the poor physical activity is due to financial constraint. Project Manager, Deputy Project Manager of the contract package have left Laxmipur since long for which we were unable to interact with them. Community Organizers responsible for ensuring environmental and social safeguards were also not met during the visit. The shelter sites appear barren and the progress of work is indeed disappointing (**Photo: 01**).

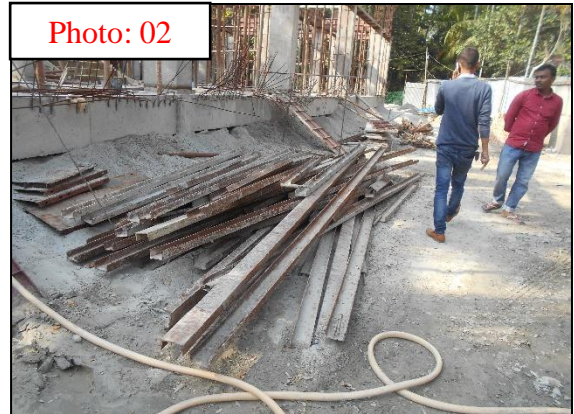
- MS angles has been kept irregularly and haphazardly (**Photo: 02**). These should be kept on raised platform in safe location.

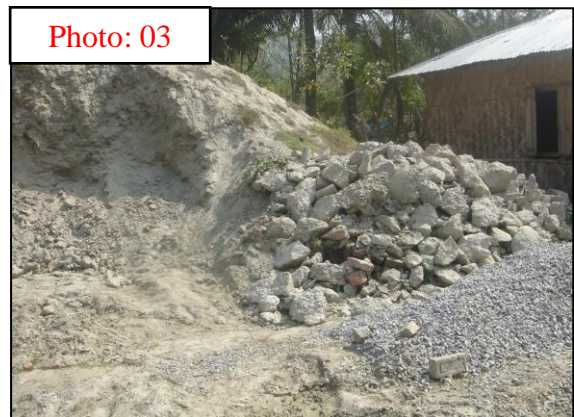
- Excavated earth has been stacked irregularly and haphazardly (**Photo: 03**). Advised to immediately remove the earth from construction sites.

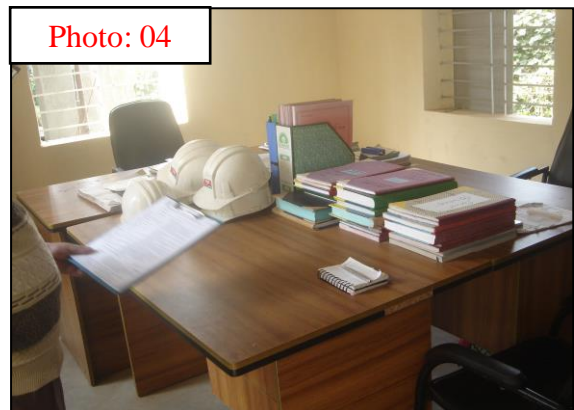
- Site offices and labour sheds have been constructed but presently remain out of use (**Photo: 04**).

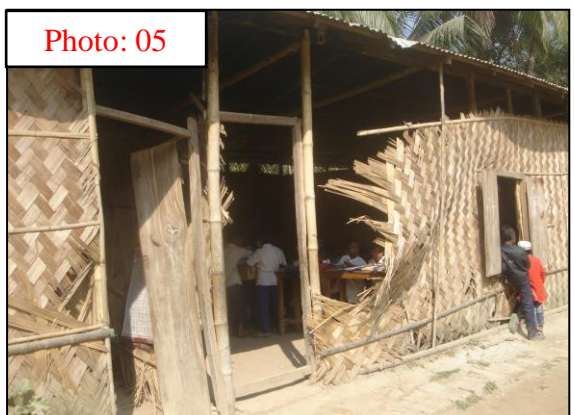
- Thatched temporary shed for continued schooling are in poor and dilapidated condition (**Photo: 05**). Dilapidated school sheds should be repaired as construction works will be delayed.

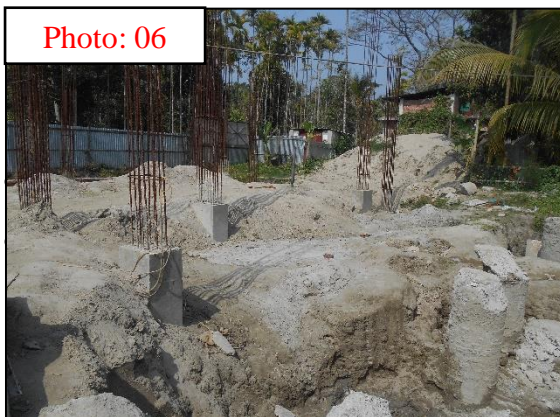
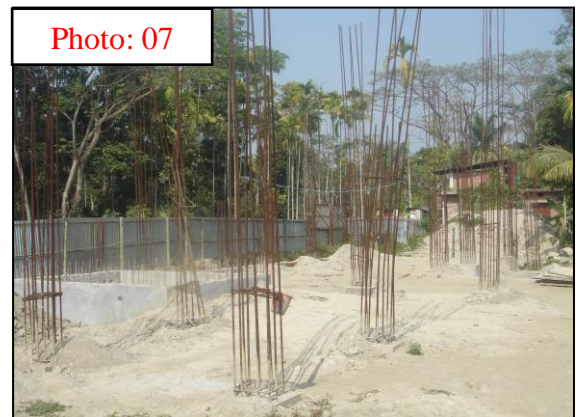
- **LAX-105:** Physical progress is still limited to shutter and re-bar placement for columns casting at 1st floor. Construction of underground water tank (2 nos.) including installation of Deep Tube-wells (4 nos.) has been completed. It was learnt that no physical activities has been done since early January 2019. The site appears barren and the progress of work is disappointing.
- **LAX-106:** No physical work was going on. Physical progress is still limited to casting of pedestal columns up to grade beams (**Photo: 06**). Installation of Deep Tube-wells (4 nos.) has been completed. Physical progress was also limited to ramp construction including construction of underground water tank (1 no.) (**Photo: 07**).

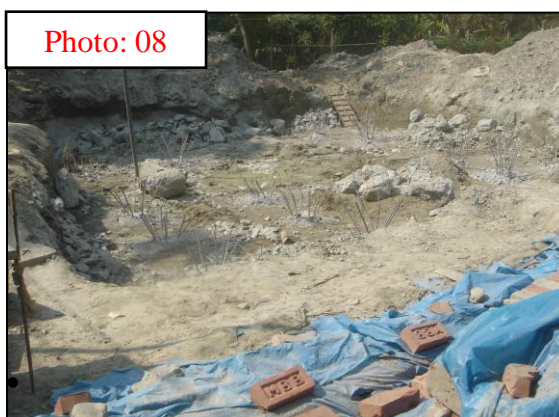
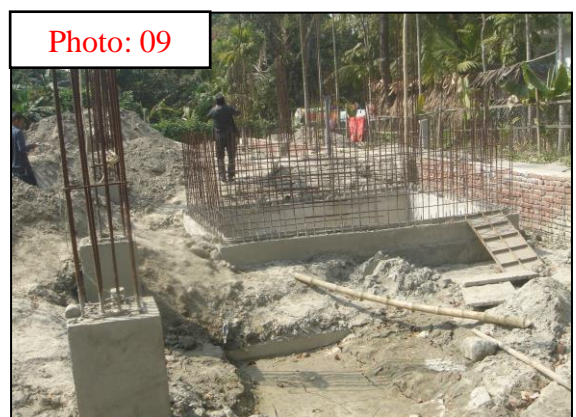
- **LAX-113:** No physical work was observed during the visit. It was known that there has been no activity since 2nd week of January 2019. Physical progress is limited to foundation works. (**Photo: 08**). Installation of Deep Tube-wells (4 nos.) has been completed. Construction of underground water tank (1 no.) has been partially done (**Photo: 09**).

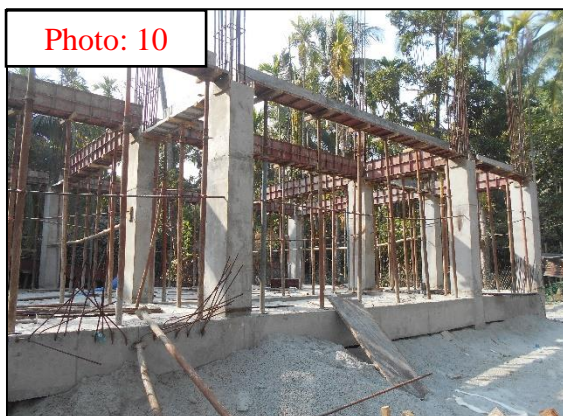
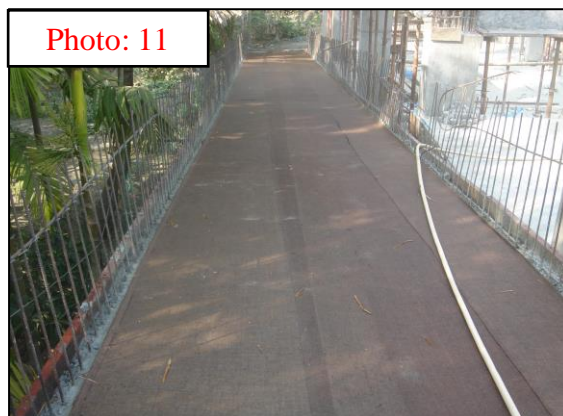
- **LAX-23:** Shutter and re-bar placement for ground floor slab casting was being done only by a few labours. **(Photo: 10)**. Construction of 2 nos. underground water reservoir including installation of Deep Tube-wells (4 nos.) has been completed. Part of the ramp has been recently cast. **(Photo: 11)**.

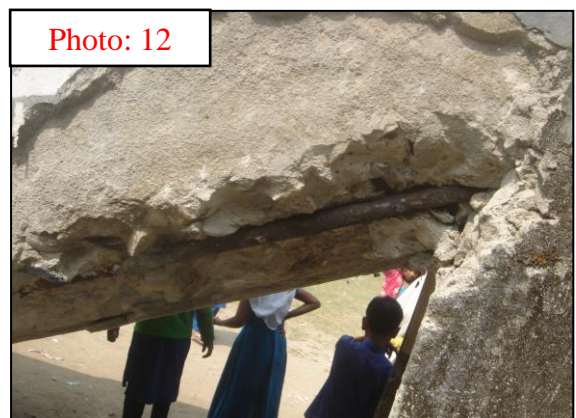
- **Construction Schedule:** No construction schedule of the contract package as also of individual shelter was available. General Construction Schedule of the package along with site specific construction schedule showing the dates of actual implementation of the various work elements against targets should have been prepared for proper monitoring by the responsible persons.
- **Material Test:** No material test report was available during the visit. It is learnt that no test of materials has been conducted till date.
- **Rehabilitation Need Assessment:** Assessment of the rehabilitation needs of the shelters could have been more exhaustive targeting overall and sustained stability of the infrastructures (**Photo: 12**).

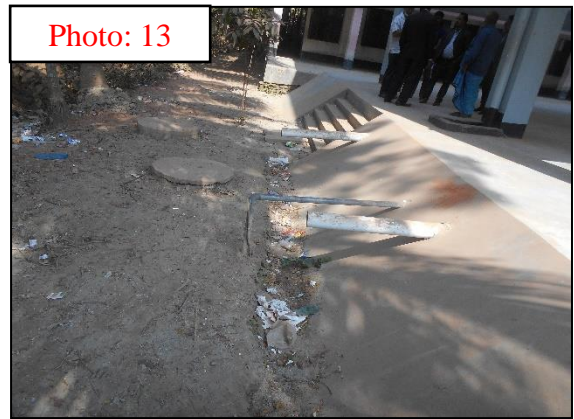
- In **LAXE-270**, construction of one septic tank for one toilet has been considered in rehabilitation item of works. Other toilet at the west of the school building has not been considered in the rehabilitation programme. It may be connected to the nearby existing soak-wells by including in the revised estimates. **(Photo: 13)**.

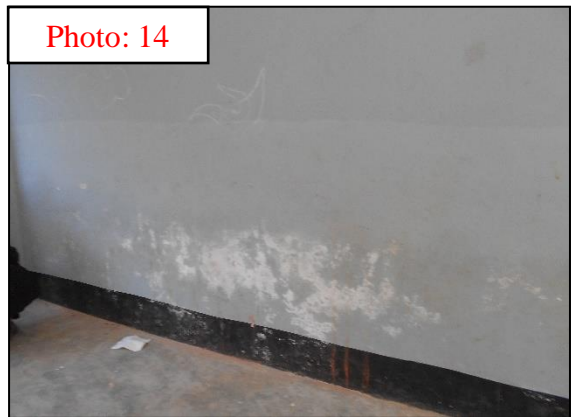
- Sand used in plastering works in some rehabilitation shelters has traces of salt content as reflected in the plaster work **(Photo: 14)**. Besides, FM of sand seems to be less than 1.00. Specified sand with prior tests should be used.

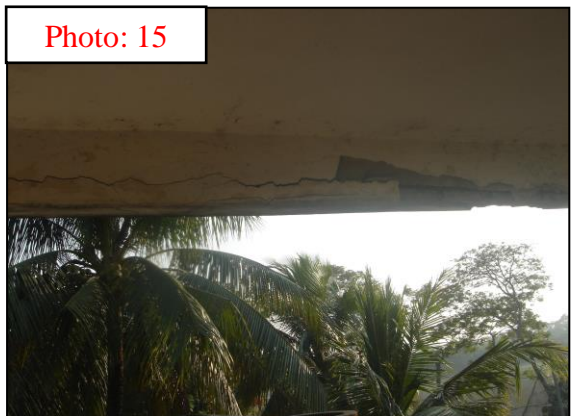
- As per BoQ item of works, submersible pump has been considered for lifting water in all shelters under Raipur UZ. The submersible pumps cannot be installed in the existing tubewell pipes because the diameter does not match. It may be replaced by conventional suction pump.
- Unlike other shelters, no provision of tile placement in staircase has been made in rehabilitation shelters of Raipur UZ.
- No work has yet been done in **LAXE-24**. The condition of the school cum shelter is very bad and needs immediate rehabilitation **(Photo: 15)**.

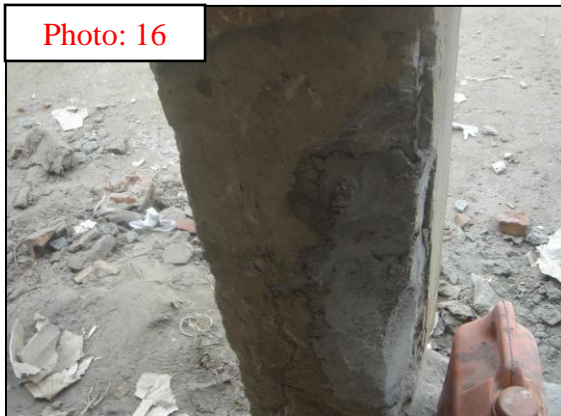
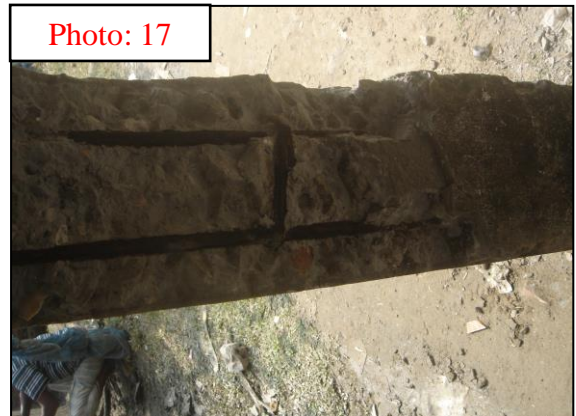
- **LAXE-207:** Repair work has been undertaken. However, the condition of the building is very critical because the existing columns, beams and slabs have almost failed (**Photo: 16 & 17**).

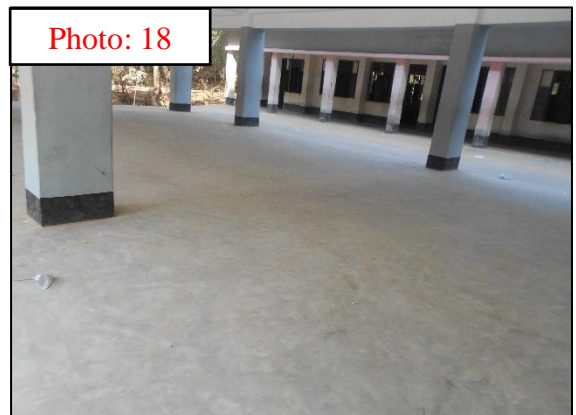
- **Roof Top Screeding:** Dr. Fixit Water Proofing Solution has been selected for application on the roof top of all repairable shelters in Laxmipur district. The item has not yet been applied in any site whereas in Noakhali, provision has been made of 16 mm thick izonil plaster and 25 mm thick patent stone casting.
- **Lean Concreting/ Patent Stone Casting:** Completed at ground floor of **LAXE-270 & LAXE-207 (Photo: 18)**.

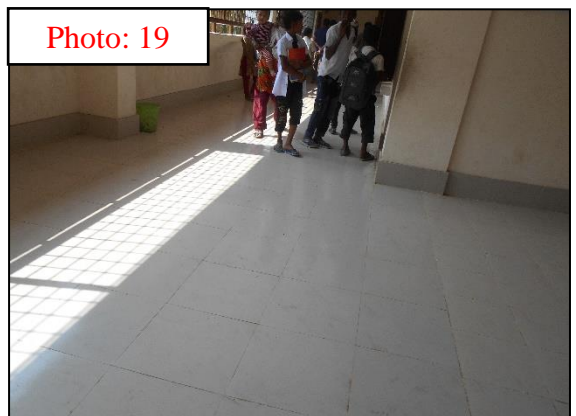
- **Tiles Placement:** Completed at staircases, 1st / 2nd floor of **LAXE-270, LAXE-259 & LAXE-382 (Photo: 19)**. Work is ongoing in **LAXE-206 & LAXE-207**.

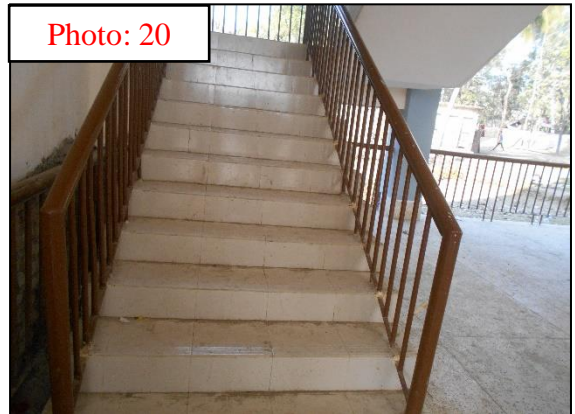
Photo: 20

- **Repair of Staircase:** Done in **LAXE-270 & LAXE-259 (Photo: 20)**. Work is ongoing in **LAXE-206**.

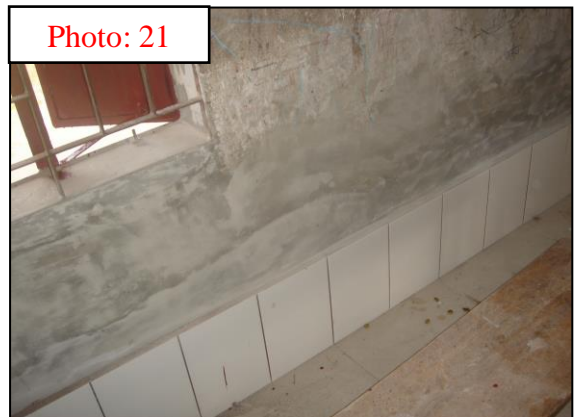
Photo: 21

- **Outside & Inside Plastering Works** (Patch repair works where necessary): Done in **LAXE-270, LAXE-259, LAXE-206 & LAXE-382 (Photo: 21)**. Work is ongoing in **LAXE-207**.

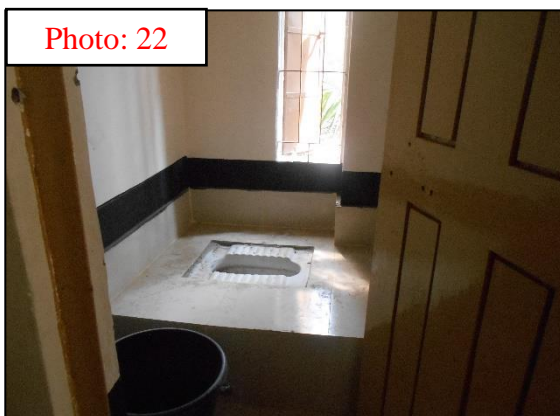
Photo: 22

- **Reconstruction of Toilet:** Work is ongoing in **LAXE-270, LAXE-206 & LAXE-382 (Photo: 22)**. There is a gap between two toilets in **LAXE-382** which helps insects to deposit soil even on tiled floor (**Photo: 23**). The gap should be filled up.

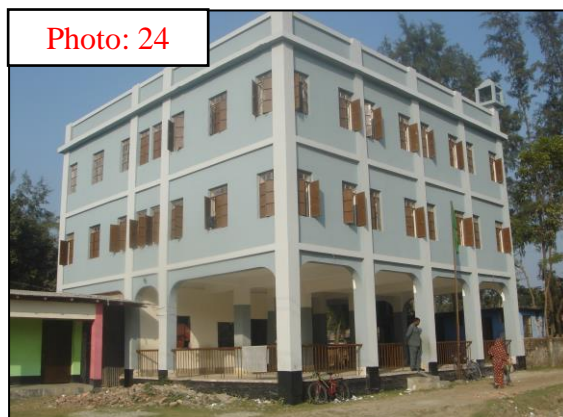
- **Outside & Inside Painting Works:** Completed in **LAXE-259 (Photo: 24)**. Work is ongoing in **LAXE-270 & LAXE-382**. Normally, painting work should be taken last after completing all necessary repair works but in many repair shelters, painting has been done in advance.

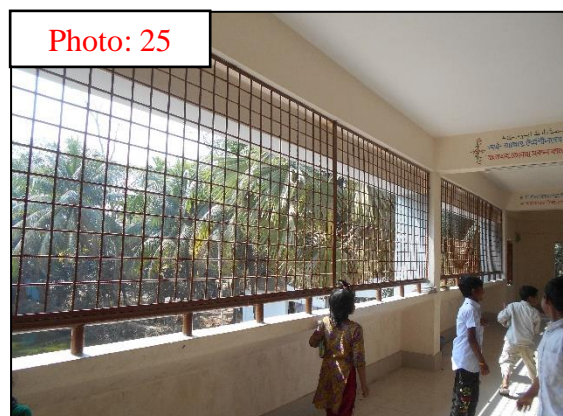
- **Supplying and fixing of Grills and Collapsible Gates:** Done in **LAXE-270, LAXE-259 & LAXE-382 (Photo: 25)**. Work is ongoing in **LAXE-206 & LAXE-207**.

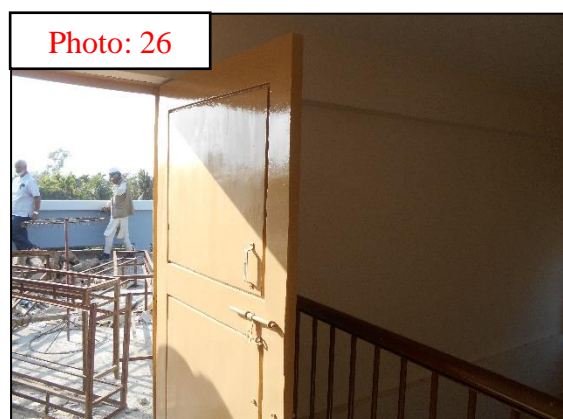
- **Repair, supplying and fixing of wooden door shutters/frames:** Done in **LAXE-259 (Photo: 26)**.
