**MULTIPURPOSE DISASTER SHELTER PROJECT (MDSP)**  
**Monitoring & Evaluation (M&E) Consultant**

**FIELD VISIT REPORT**

1. Period of Visit : 06 Feb – 07 Feb 2019
2. Location of Visit : Lakshmipur District.
3. Participant of visit : A.H.M. Mahbubur Rahman, TL, M&E Consultant,  
Md. Matiur Rahman, Civil Engineer/ M&E Specialist, M&E Consultant,
4. Officials met during Visit :

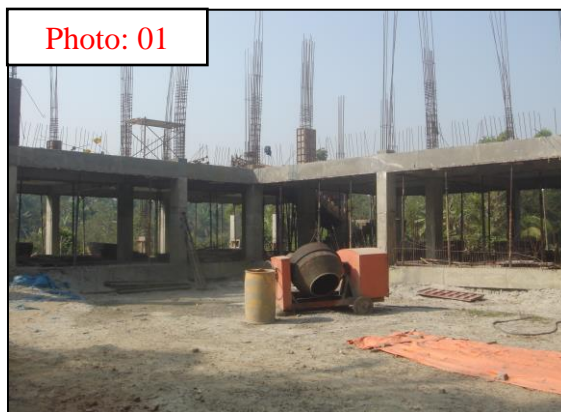
- **Staff Mobilization by the Contractor:** At the start, M/S. Navana Construction Ltd. made good mobilization of field personnel. Project Manager, Deputy Project Manager, Assistant Project Manager, Area Manager, Community Organizers, Site Engineers and other support staffs etc. were mobilized. It was learnt that there has been no physical activity since early January, 2019. We were informed that the poor physical activity is due to financial constraint. Project Manager, Deputy Project Manager of the contract package have left Laxmipur since long for which we were unable to interact with them. Community Organizers responsible for ensuring environmental and social safeguards were also not met during the visit. The shelter sites appear barren and the progress of work is indeed disappointing (**Photo: 01**).

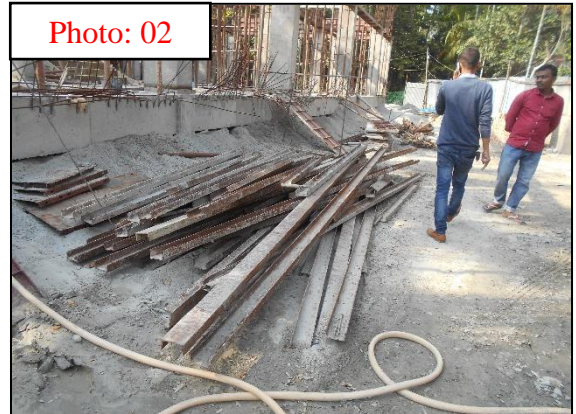
- MS angles has been kept irregularly and haphazardly (**Photo: 02**). These should be kept on raised platform in safe location.

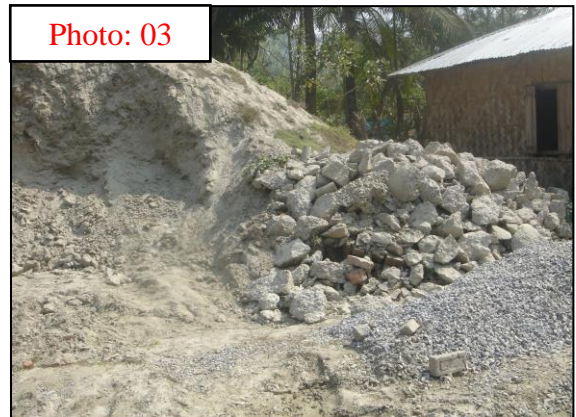
- Excavated earth has been stacked irregularly and haphazardly (**Photo: 03**). Advised to immediately remove the earth from construction sites.

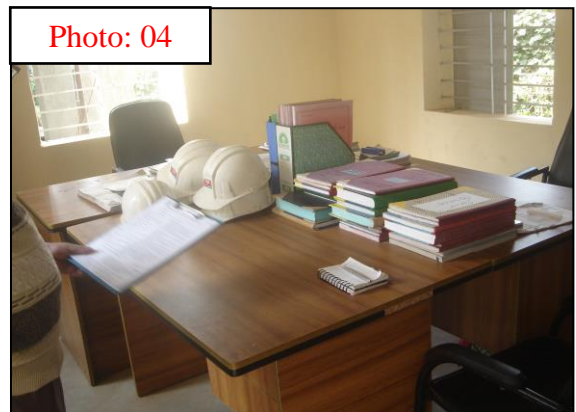
- Site offices and labour sheds have been constructed but presently remain out of use (**Photo: 04**).

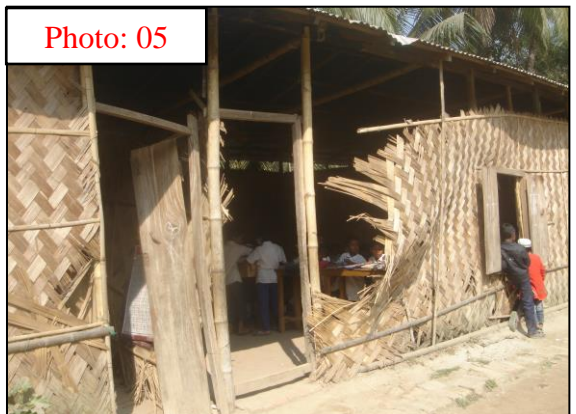
- Thatched temporary shed for continued schooling are in poor and dilapidated condition (**Photo: 05**). Dilapidated school sheds should be repaired as construction works will be delayed.

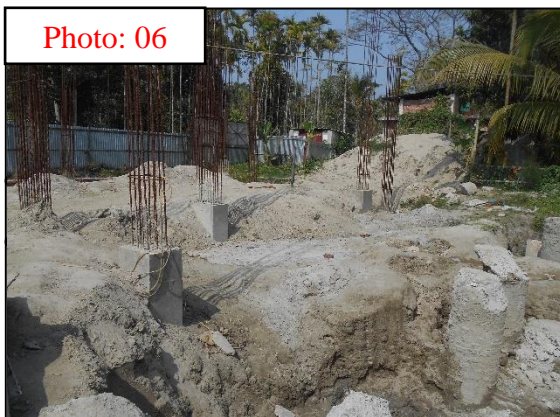
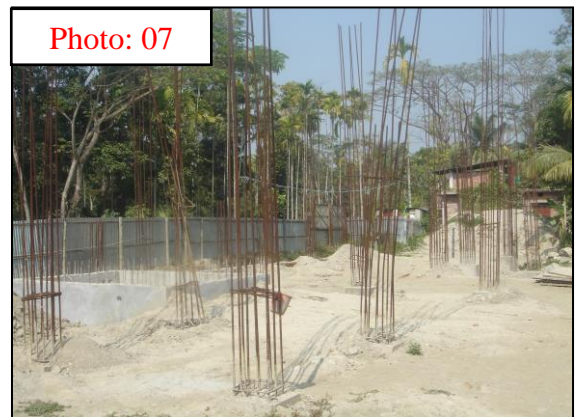
- **LAX-105:** Physical progress is still limited to shutter and re-bar placement for columns casting at 1<sup>st</sup> floor. Construction of underground water tank (2 nos.) including installation of Deep Tube-wells (4 nos.) has been completed. It was learnt that no physical activities has been done since early January 2019. The site appears barren and the progress of work is disappointing.
- **LAX-106:** No physical work was going on. Physical progress is still limited to casting of pedestal columns up to grade beams (**Photo: 06**). Installation of Deep Tube-wells (4 nos.) has been completed. Physical progress was also limited to ramp construction including construction of underground water tank (1 no.) (**Photo: 07**).

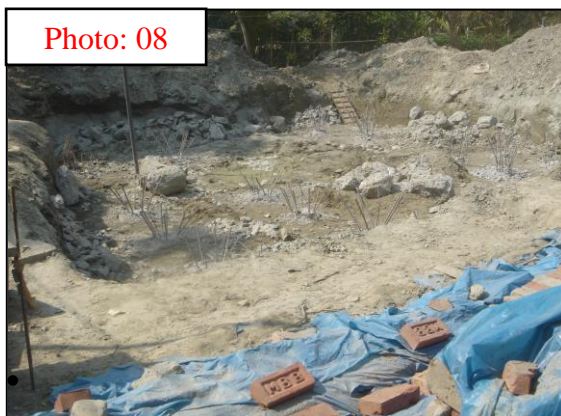
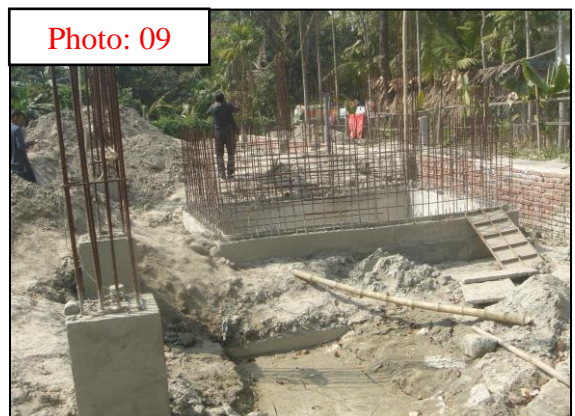
- **LAX-113:** No physical work was observed during the visit. It was known that there has been no activity since 2<sup>nd</sup> week of January 2019. Physical progress is limited to foundation works. (**Photo: 08**). Installation of Deep Tube-wells (4 nos.) has been completed. Construction of underground water tank (1 no.) has been partially done (**Photo: 09**).

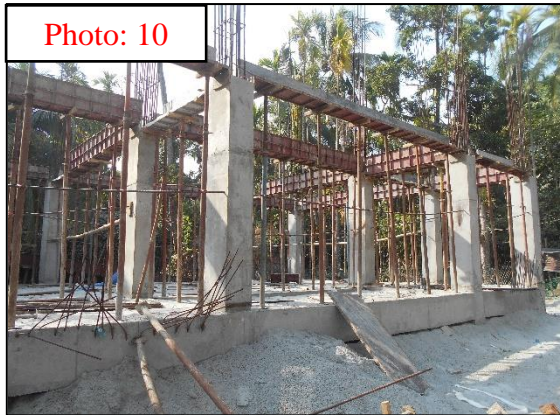
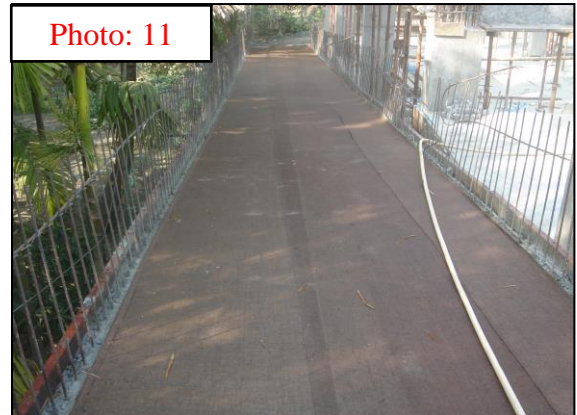
- **LAX-23:** Shutter and re-bar placement for ground floor slab casting was being done only by a few labours. **(Photo: 10)**. Construction of 2 nos. underground water reservoir including installation of Deep Tube-wells (4 nos.) has been completed. Part of the ramp has been recently cast. **(Photo: 11)**.

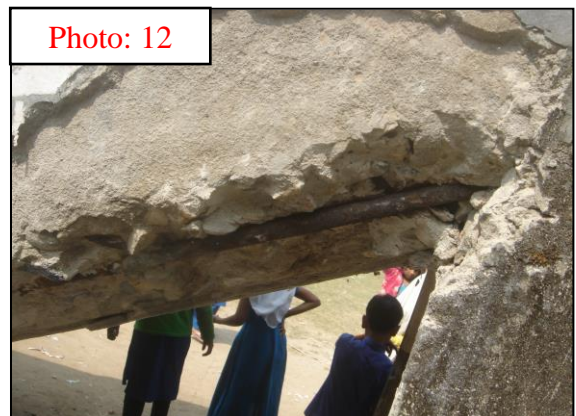
- **Construction Schedule:** No construction schedule of the contract package as also of individual shelter was available. General Construction Schedule of the package along with site specific construction schedule showing the dates of actual implementation of the various work elements against targets should have been prepared for proper monitoring by the responsible persons.
- **Material Test:** No material test report was available during the visit. It is learnt that no test of materials has been conducted till date.
- **Rehabilitation Need Assessment:** Assessment of the rehabilitation needs of the shelters could have been more exhaustive targeting overall and sustained stability of the infrastructures (**Photo: 12**).

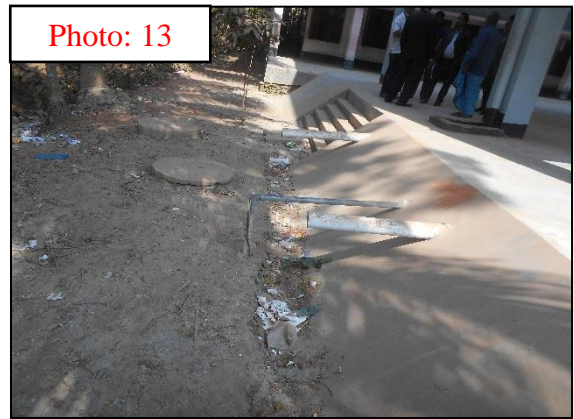
- In **LAXE-270**, construction of one septic tank for one toilet has been considered in rehabilitation item of works. Other toilet at the west of the school building has not been considered in the rehabilitation programme. It may be connected to the nearby existing soak-wells by including in the revised estimates. **(Photo: 13)**.

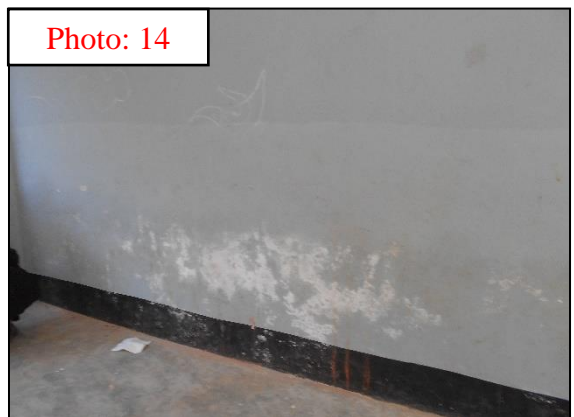
- Sand used in plastering works in some rehabilitation shelters has traces of salt content as reflected in the plaster work **(Photo: 14)**. Besides, FM of sand seems to be less than 1.00. Specified sand with prior tests should be used.

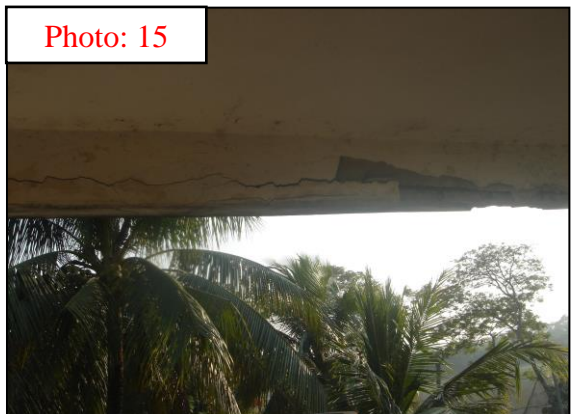
- As per BoQ item of works, submersible pump has been considered for lifting water in all shelters under Raipur UZ. The submersible pumps cannot be installed in the existing tubewell pipes because the diameter does not match. It may be replaced by conventional suction pump.
- Unlike other shelters, no provision of tile placement in staircase has been made in rehabilitation shelters of Raipur UZ.
- No work has yet been done in **LAXE-24**. The condition of the school cum shelter is very bad and needs immediate rehabilitation **(Photo: 15)**.

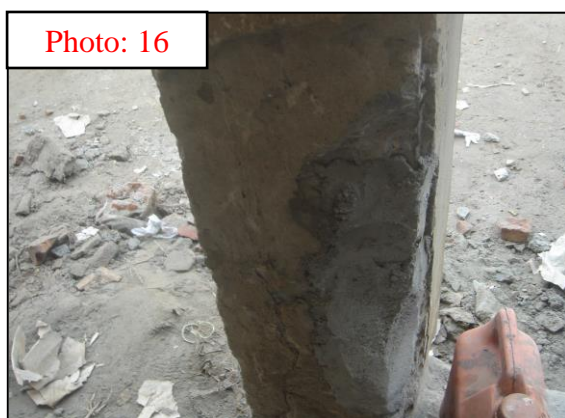
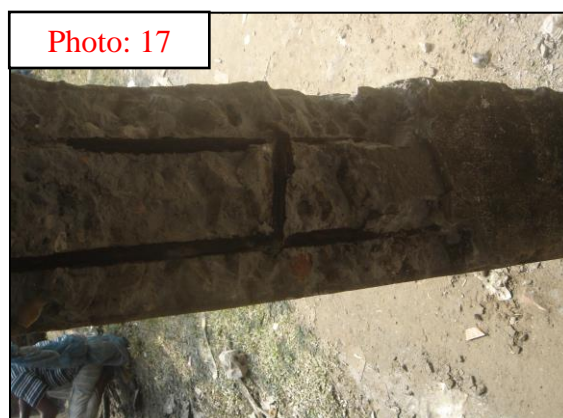
- **LAXE-207:** Repair work has been undertaken. However, the condition of the building is very critical because the existing columns, beams and slabs have almost failed (**Photo: 16 & 17**).

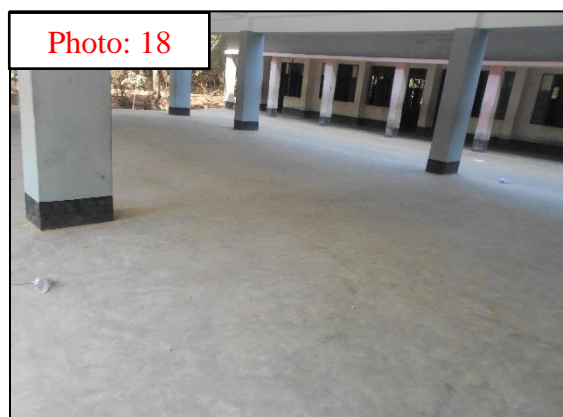
- **Roof Top Screeding:** Dr. Fixit Water Proofing Solution has been selected for application on the roof top of all repairable shelters in Laxmipur district. The item has not yet been applied in any site whereas in Noakhali, provision has been made of 16 mm thick izonil plaster and 25 mm thick patent stone casting.
- **Lean Concreting/ Patent Stone Casting:** Completed at ground floor of **LAXE-270 & LAXE-207** (**Photo: 18**).

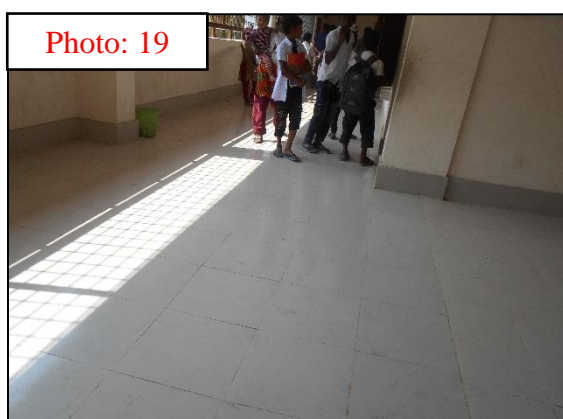
- **Tiles Placement:** Completed at staircases, 1<sup>st</sup> / 2<sup>nd</sup> floor of **LAXE-270, LAXE-259 & LAXE-382** (**Photo: 19**). Work is ongoing in **LAXE-206 & LAXE-207**.

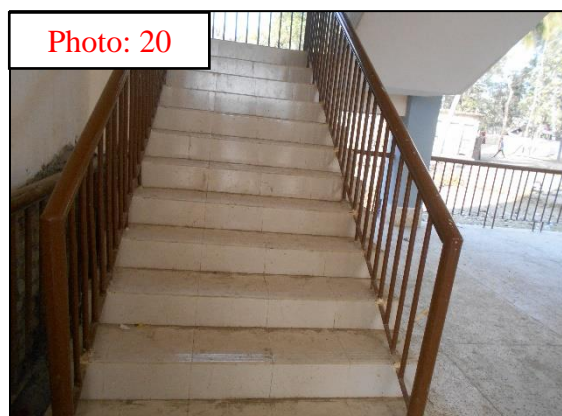
Photo: 20

- **Repair of Staircase:** Done in **LAXE-270 & LAXE-259 (Photo: 20)**. Work is ongoing in **LAXE-206**.

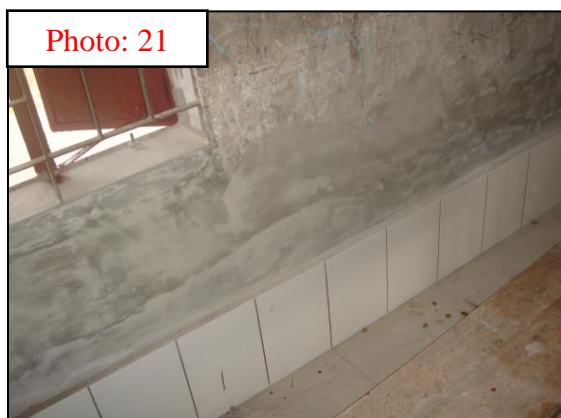
Photo: 21

- **Outside & Inside Plastering Works** (Patch repair works where necessary): Done in **LAXE-270, LAXE-259, LAXE-206 & LAXE-382 (Photo: 21)**. Work is ongoing in **LAXE-207**.

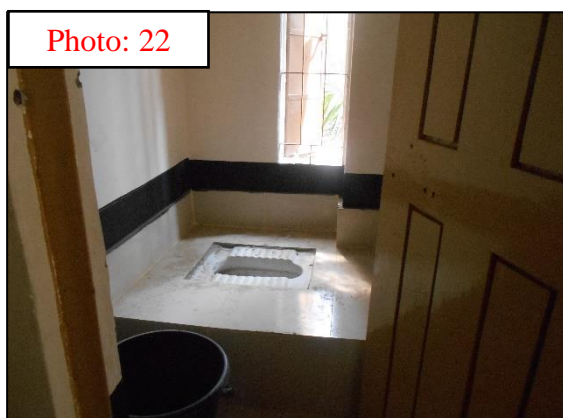
Photo: 22

- **Reconstruction of Toilet:** Work is ongoing in **LAXE-270, LAXE-206 & LAXE-382 (Photo: 22)**. There is a gap between two toilets in **LAXE-382** which helps insects to deposit soil even on tiled floor (**Photo: 23**). The gap should be filled up.

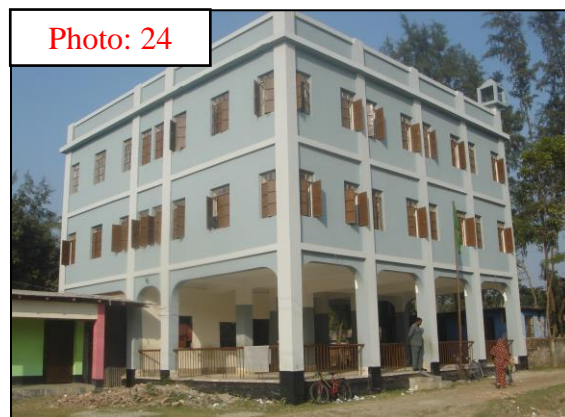
- **Outside & Inside Painting Works:** Completed in **LAXE-259 (Photo: 24)**. Work is ongoing in **LAXE-270 & LAXE-382**. Normally, painting work should be taken last after completing all necessary repair works but in many repair shelters, painting has been done in advance.

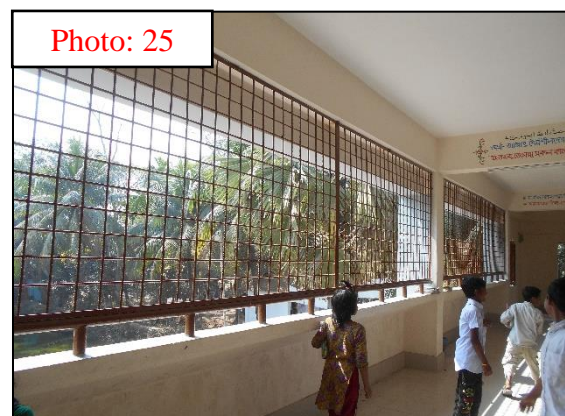
- **Supplying and fixing of Grills and Collapsible Gates:** Done in **LAXE-270, LAXE-259 & LAXE-382 (Photo: 25)**. Work is ongoing in **LAXE-206 & LAXE-207**.

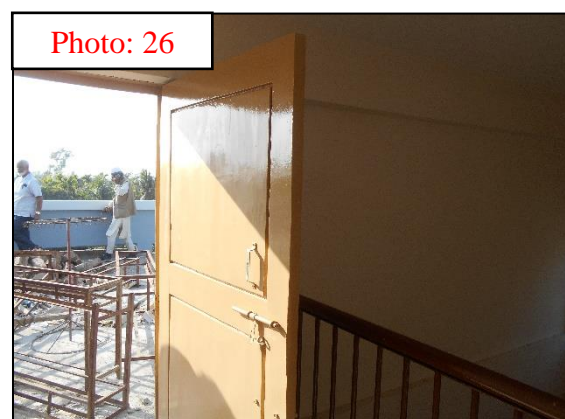
- **Repair, supplying and fixing of wooden door shutters/frames:** Done in **LAXE-259 (Photo: 26)**.
