MULTIPURPOSE DISASTER SHELTER PROJECT (MDSP)

Subject : Field Visit Report of the M&E Consultants of MDSP in Noakhali District.

1. 'Construction of New Shelter cum School' under MDSP in Noakhali district (Contract Package No. LGED/MDSP/NOA/14-15/NW-09); and
2. 'Rehabilitation of Existing School cum Shelter' under MDSP in Noakhali district (Contract Package No. LGED/MDSP/NOA/2016-2017/W-05).

FIELD VISIT REPORT

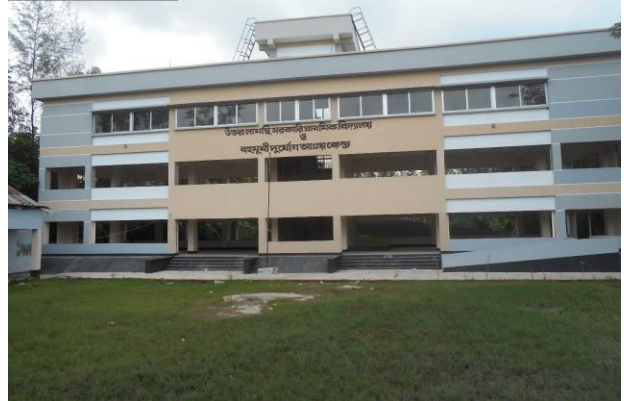
Photo-01

- Out of total 35 nos. of new shelters, 20 nos. shelters have been completed and handed over to SMCs while 13 others are ready for handing over as reported by the field officials. Works are still going on in remaining 2 shelter sites.
- The physical progress of the construction of the 7 new shelters we visited are as follows:
Completed and handed over to the SMCs: NOAP- 364: 100%; NOAP- 363: 100%; NOAP- 336: 100% and NOAP- 376: 100%.
Nearly completed and waiting for handed over to the SMCs: NOAP- 210: 98%; NOAP- 203: 98% and NOAP- 47: 98%. (Photo: 01)

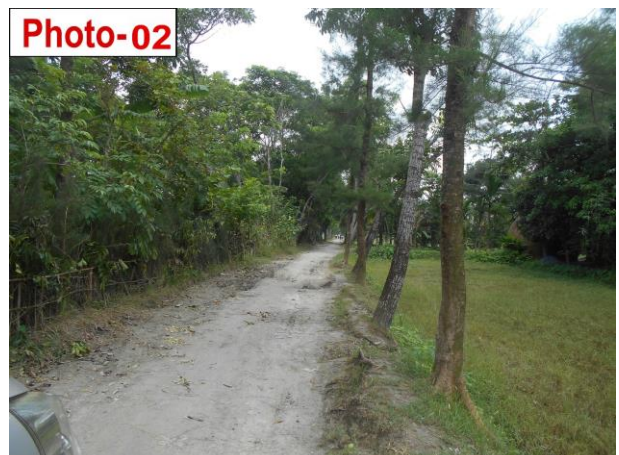
Photo-02

Construction works of the shelter connecting roads have not been taken up as yet **(Photo: 02)**.

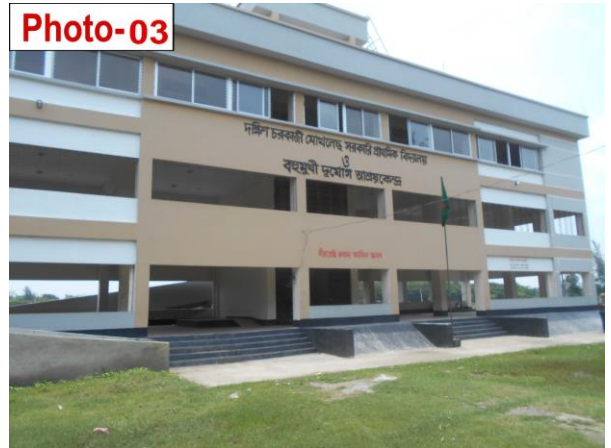
Architectural Look of the Shelter Buildings: The newly completed shelter cum school buildings have very nice look (**Photo: 03**). The completed shelters have provision of all modern facilities like water supply, sanitary toilet, electric power supply, solar power supply, rain water harvesting arrangements, underground water storage reservoir, dedicated floor with ramp for livestock accommodation, metaled internal road, shelter access road, supply of new furniture for teachers and students etc. These will indeed create confidence amongst the stakeholders to take shelter during devastating cyclone fore-casts. The new structure will also create a very congenial school environment. The overall quality of works of the shelters is good (**Photo: 04**).

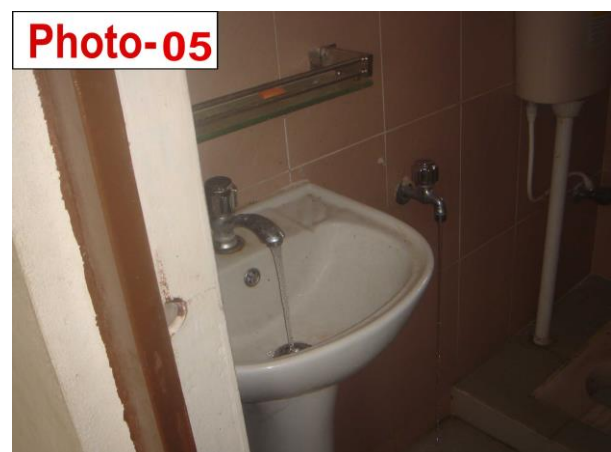
The main source of water supply to the toilets is the overhead tanks receiving water from the submersible pump. In **NOAP- 364**, the total water supply system is working properly as reported by the school authorities. (**Photo: 05**)

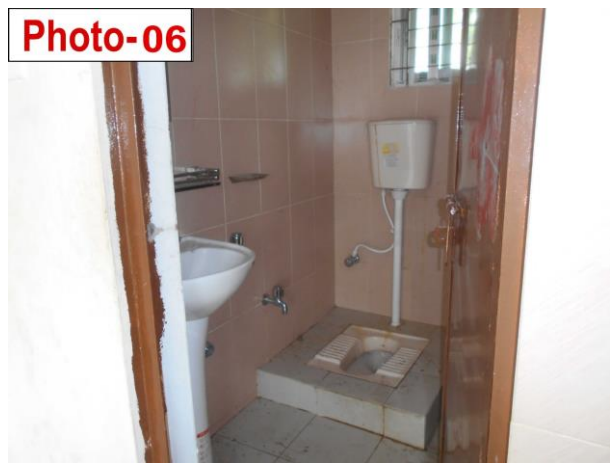
But in many other completed shelters, the **submersible pumps** and other pumps are not working properly. As a result, there is no supply of water in the toilets (**Photo: 06**). It has been reported that water is being fetched by the students by buckets from ground or 1st floor for use in the toilets. This is inhuman. All the **submersible pumps** must be kept fully operative to keep the whole water supply and sanitary system functioning properly creating a good hygienic environment.

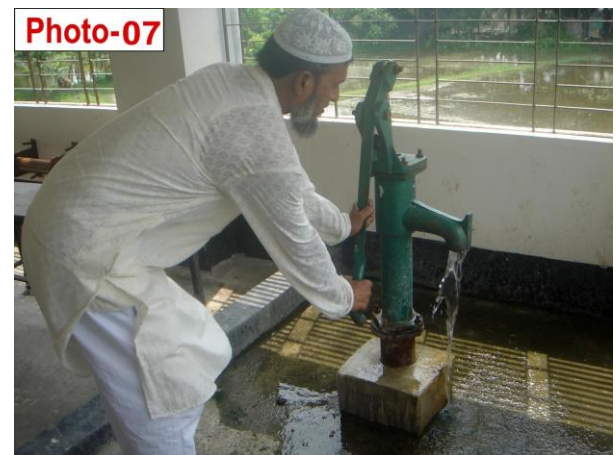
DTWs were found in operation in some shelters (**Photo: 07**) while in many other shelters these were found inoperative in GF and 1st floor. (**Photo: 08**) Due care must be given to keep the DTWs in operation.

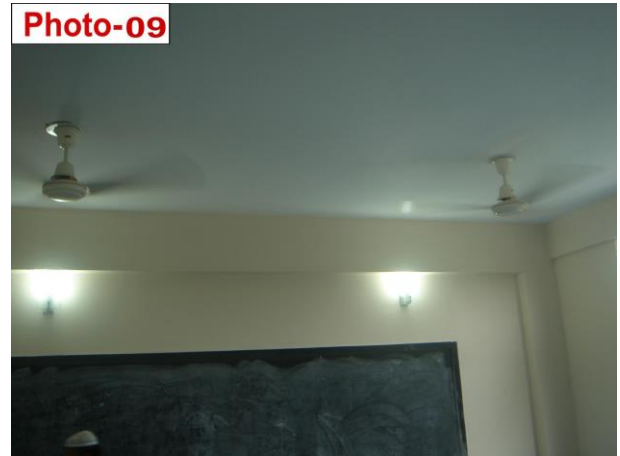
The newly installed electrification system is complete. Fans, lights etc. are working properly (**Photo: 09**). The solar power system has also been found working properly.

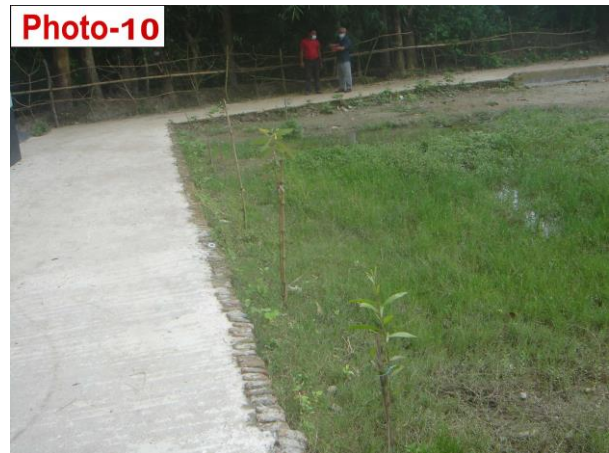
Tree plantation has been done in the premises of the completed shelters but the survival rate is very disappointing.

NOAP 47 & NOAP- 210: Plantation has been done but the saplings were found very weak and likely to die soon (**Photo: 10**).

Tree plantation should be done afresh protected by safety gabions and should be properly nursed till initial growth.

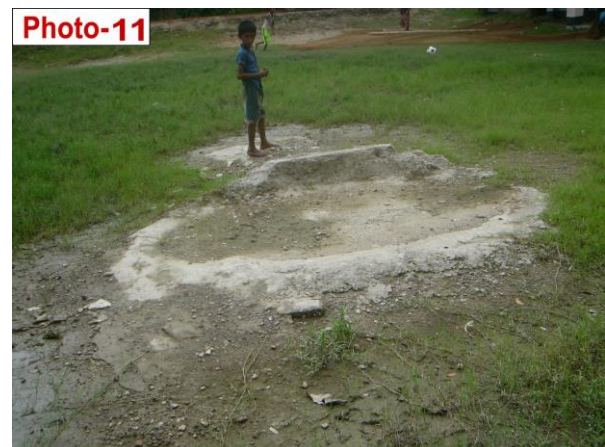
Before handing over the completed structure, the site should be neatly cleaned so that the students can use the premises as playground. This has not been done in some of the shelters. This should be done so that the students can use the playground. (**Photo: 11**).

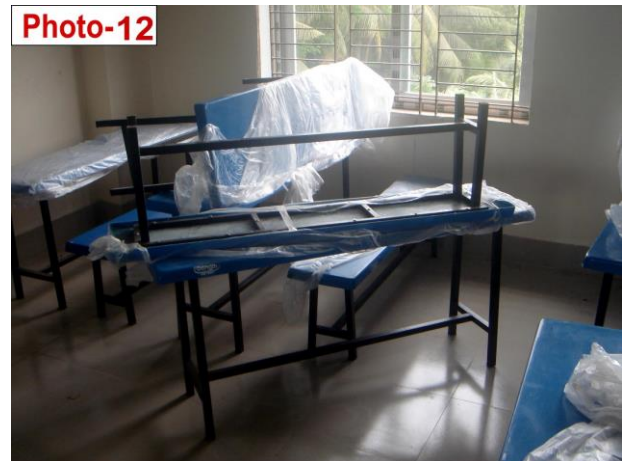
However, supply of high benches without book shelves have been made in **NOAP-210** and **NOAP- 203**. (Photo: 12). It was learnt that letter for replacing these benches has been issued by LGED. No furniture has yet been supplied yet in **NOAP- 47**.

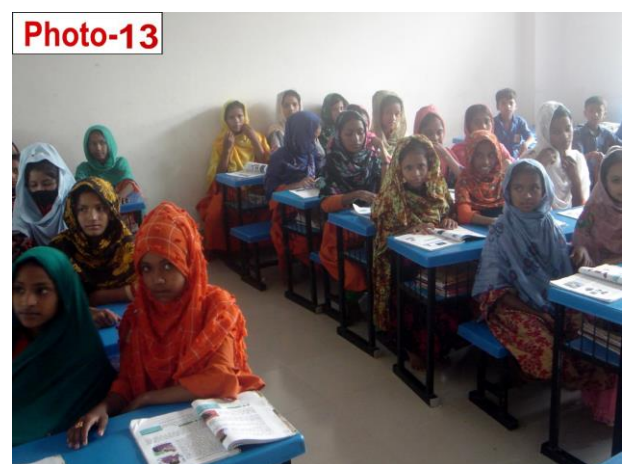
Jubilant students are seen attending new and modern class rooms. Students expressed satisfaction in having nicely furnished rooms. (Photo: 13)

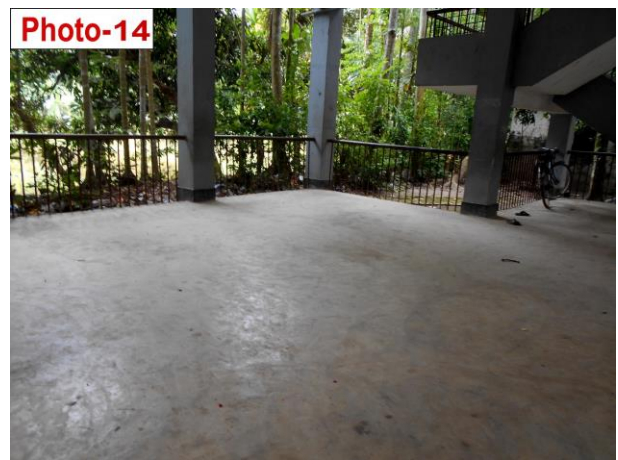
- Lean Concreting - Completed at ground floor (**Photo: 14**).

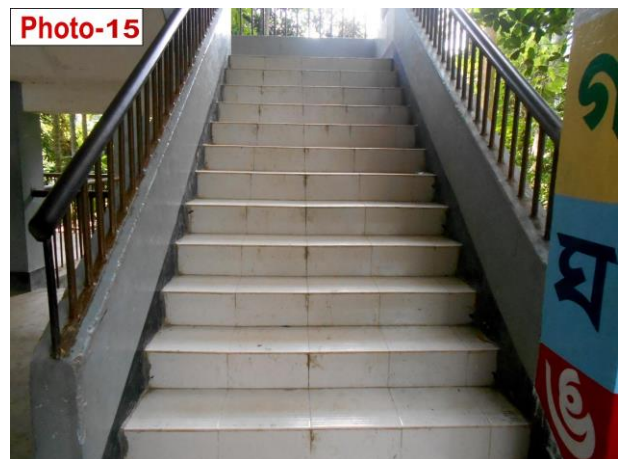
- Placement of tiles at staircase and on 1st floor- Done (**Photo: 15**).

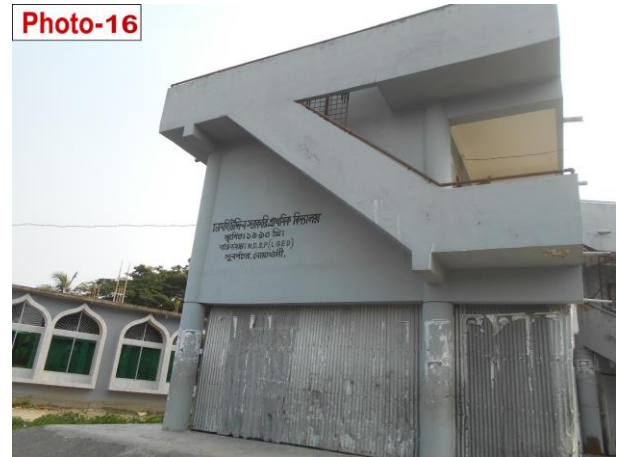
- Outside & Inside Plastering Works as necessary: Done.
- Outside & Inside Painting Works: Completed (**Photo: 16**).

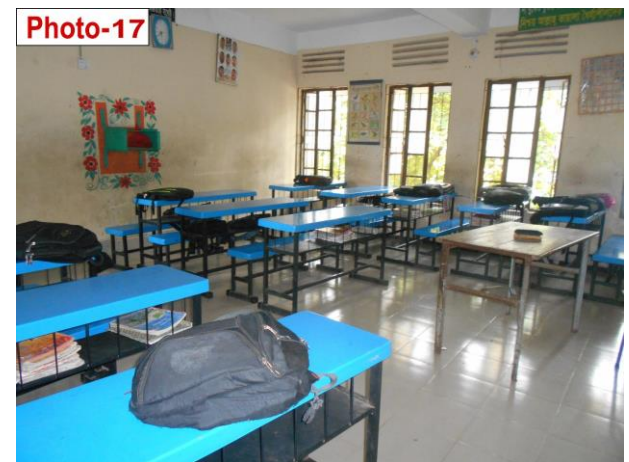
- Repair of toilets with supply and fixing of tiles and modern sanitary features: Done.
- Supplying and fixing of One Collapsible Gate: Done.
- Electrification Works: Completed
- School Furniture Supply: Done (**Photo: 17**)
