MULTIPURPOSE DISASTER SHELTER PROJECT (MDSP)

Monitoring & Evaluation (M&E) Consultant

FIELD VISIT REPORT

1. Period of Visit : 06 May – 07 May 2018
2. Location of Visit : Noakhali District.
3. Participant of visit : A.H.M. Mahbubur Rahman, TL, M&E Consultant,
Md. Matiur Rahman, Civil Engineer/ M&E Specialist, M&E Consultant,
Dr. Md. Barkat Ullah, Environment Specialist, M&E Consultant
4. Officials met during Visit :

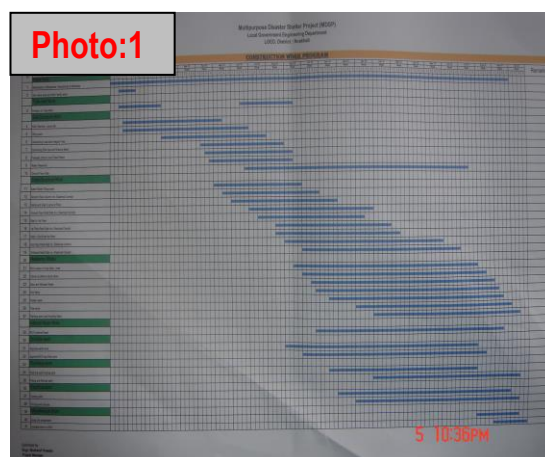
- **Construction Schedule:** A general construction Schedule of the package has been made (**Photo:1**). It should be made site specific. This is an essential instrument to program and monitor the construction activities. The schedule has been prepared for all 35 new shelter sites in a diagram that shows only the proposed start and completion dates of the various work elements. Actual dates of implementation of the various work elements have not been reflected anywhere. Construction schedule showing the dates of actual implementation of the various work elements against targets should be prepared for each individual structure site. Monitoring of the actual implementation of the various work elements against targets should be done. If necessary, the schedules may periodically be updated and followed up.

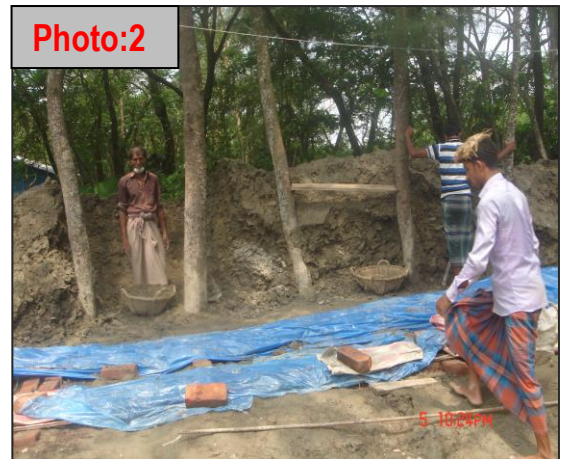
- MS rods should be stored on raised platform to avoid mud and water (**Photo: 2**).
- Site offices and labor sheds have been constructed in all sites with few exceptions.
- Steel shutter materials have been used in all RCC works.
- As per MDSP requirement, the shelters have been designed as three storey buildings with provision of livestock accommodation on the 1st floor with ramp provision. The design provides construction of several numbers of cast in situ piles with variable lengths with pile diameter of 500 mm each.

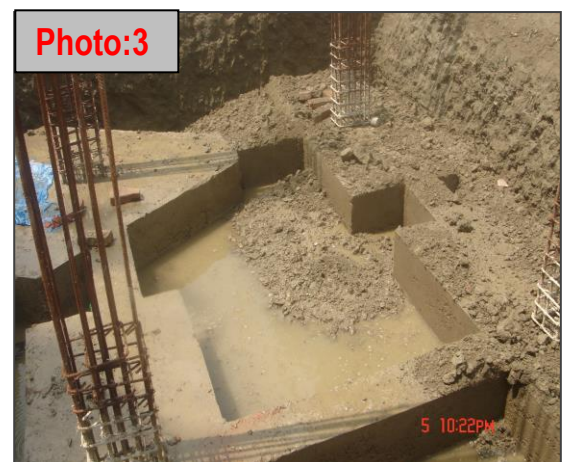
Excavated earth has been stacked irregularly and haphazardly right on the bank of the excavated pit. Backfilling by excavated earth in rain fed trench was being done (**Photo: 3**). Water should be pumped out before backfilling.

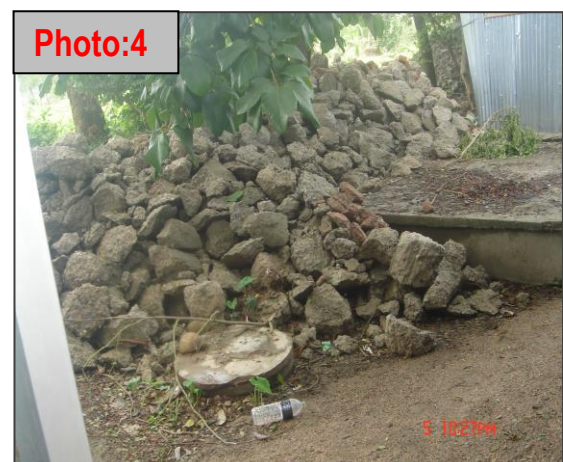
Advised to remove excavated earth and keep in waste disposal area. Debris of broken pile head has been kept in safe distance (**Photo: 4**).

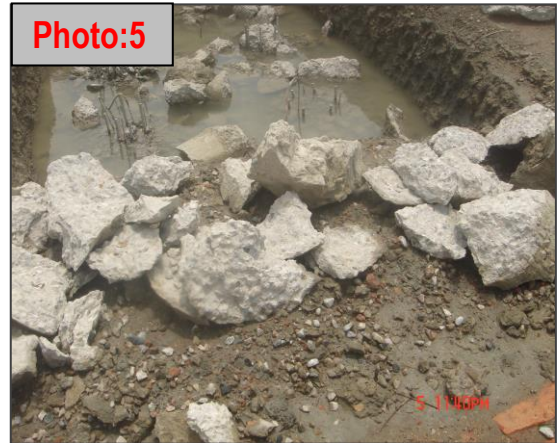
Broken concrete of the pile caps have been kept haphazardly (**Photo: 5**). The concrete debris should be removed from site and kept in waste disposal area located away from construction site.

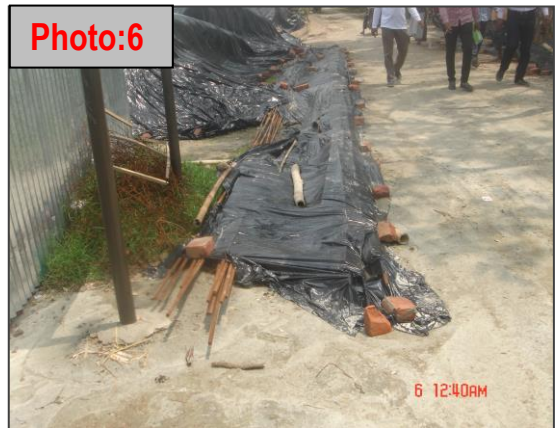
The physical progress is ahead of target. MS rod has been stored on the road risking accident (**Photo:6**).

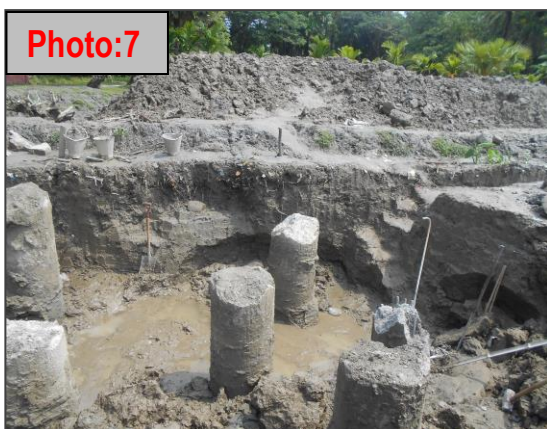
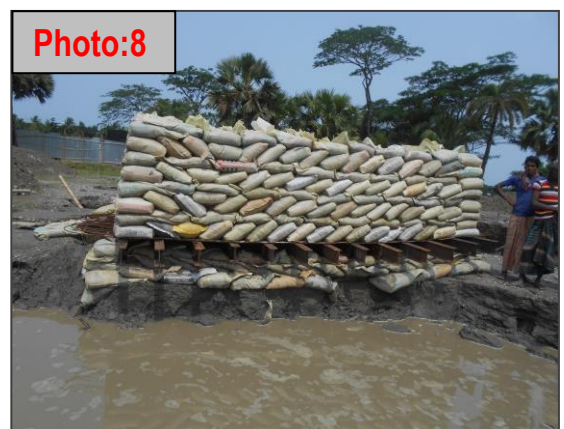
- **NOAP-364:** All 75 nos. cast-in situ piles of lengths of 17.50 m and diameter of 500 mm have been cast. Breaking of pile heads has been done. Pile Load Test has been done and is waiting for Integrity Test. No physical work was going on at site.
- **NOAP-235:** All 75 nos. cast-in situ piles of lengths of 22.00 m and diameter of 500 mm have been cast. Breaking of pile heads and earth excavation up to pile caps base are underway, (**Photo :7**). Arrangement for Pile Load Test is in progress but load arrangement has collapsed (**Photo:8**). The Contractor has assured to redo proper Pile Load Test arrangement.

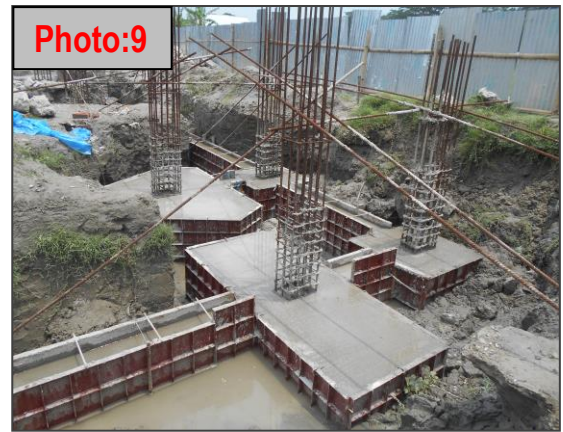
- **NOAP-229:** All 75 nos. cast-in situ piles of lengths of 14.00 m and diameter of 500 mm have been cast. 16 nos. of pile caps out of total 31 nos. including bracing beams have been cast (**Photo:9**). Rebar & shutter placement for the remaining pile caps casting is in progress.

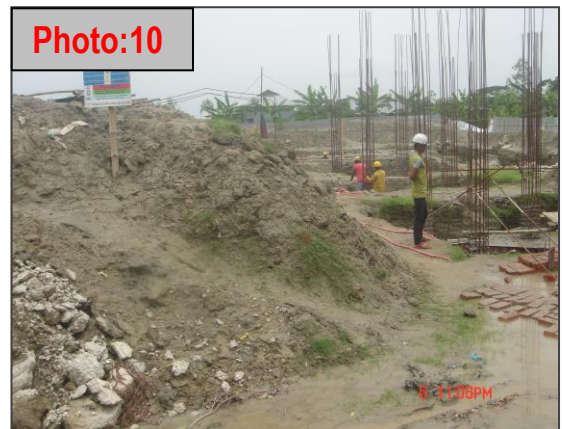
Advised to immediately remove the spoil earth to waste disposal area (**Photo:10**).

Site office has not been constructed as yet, labour shed has been constructed. Overall site management appears poor.

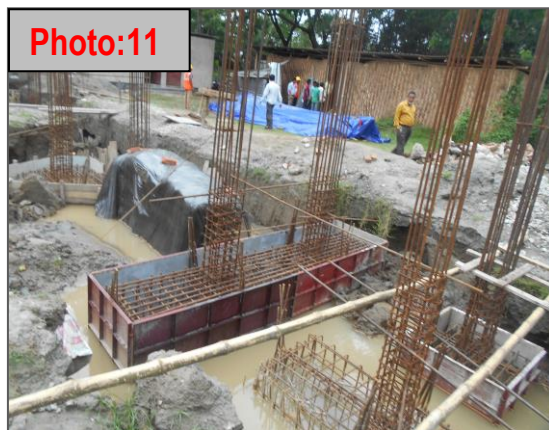
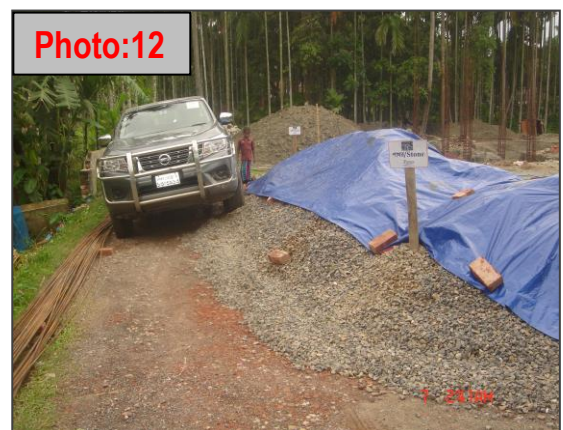
- **NOAP-375:** 25 nos. cast in situ piles out of 75 nos. have been cast so far. Each pile has a length of 22.50 m and diameter of 500 mm. Casting of situ piles is in progress at site. Progress of work is lagging behind the construction schedule.
- **NOAP-204:** All 75 nos. cast-in situ piles of lengths of 16.00 m and diameter of 500 mm have been cast. Rebar & shutter placement for pile caps casting is underway (**Photo:11**). Road had been blocked by construction materials (**Photo:12**), Roadway should be kept clean.

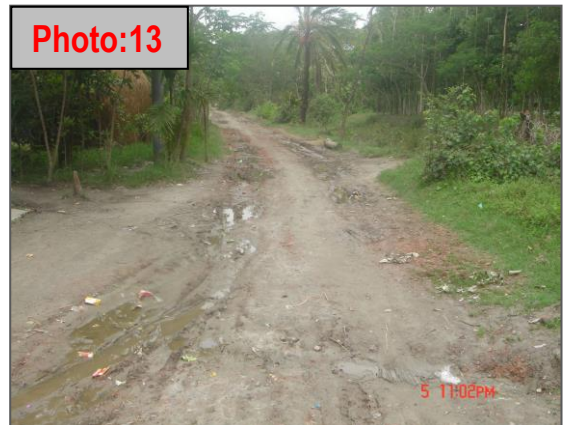
Construction works of the connecting roads have not been started as yet. Beneficiary and SMC of **NOAP 154** strongly demanded construction of the SCR immediately to facilitate improved communication during the ensuing monsoon (**Photo:13**). The matter may please be considered.

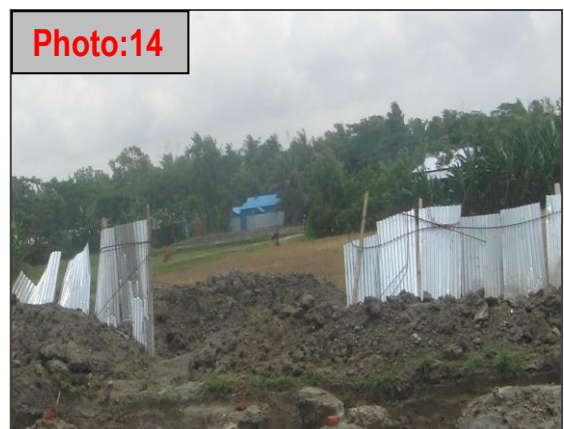
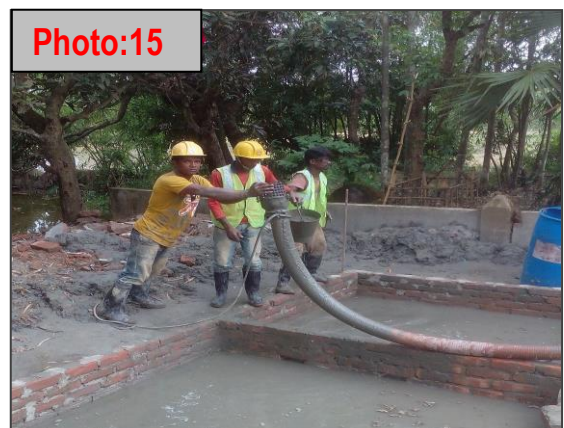
- **First Aid Box:** First aid boxes with standard contents have been procured for all sites.
- **Protecting Fencing:** Protective fencing has been erected partially in all construction sites except **NOAP-363** to keep the students and public away to avoid the danger of accident. The fencing has been made by corrugated iron sheets. The fencing should be continuous (**Photo:14**).
- **Grass Turfs:** It is not required at the moment.
- **Vegetation and Tree Plantation:** Vegetation and tree plantation will be done in due time.
- **Water Filter:** Required nos. of water filters have been procured.
- **Safety Gear Package:** Safety gear package such as helmets, hand gloves, rubber shoes, light reflecting dresses etc. have been procured. Labors are using it (**Photo:15**).
- **Temporary Sanitary Latrine:** Temporary sanitary latrines have been constructed for labors in all sites.

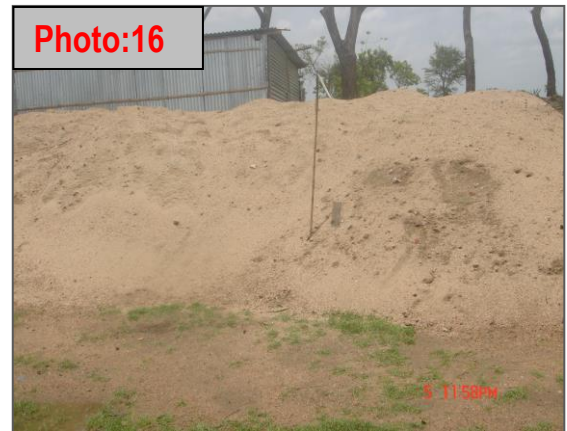
- **Dust Suppression Measures:** In some sites (NOAP363, NOAP364, NOAP375 and NOAP204), sand was kept covered in order to stop dust pollution while in some other sites, these were kept exposed (NOAP154, NOAP336, NOAP235, NOAP229). NOAP237 and NOAP204). This should always be kept covered to protect from air pollution (**Photo:16**).

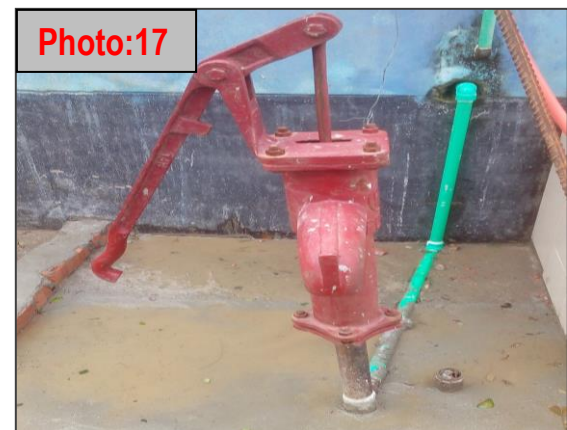
- **Tube Well:** Tube wells have been installed at all sites to have safe drinking water for the labors and site staff. The colour of head of tube well is red in almost all tube wells. Red color indicates arsenic presence and therefore should be colored green (**Photo: 17**).

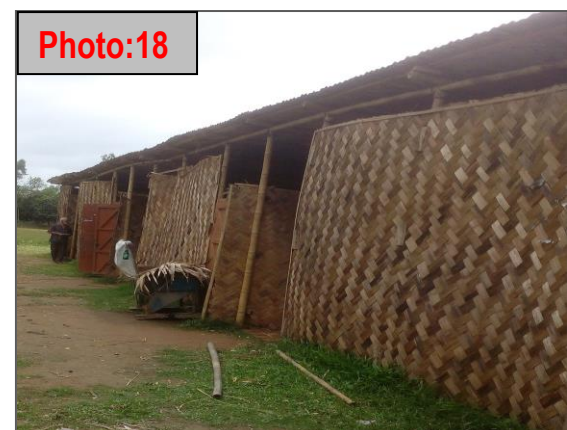
- **Construction of Temporary Shed for Uninterrupted Schooling:** There is provision to construct temporary shed for class accommodation where existing school building has been demolished. In NOAP204, one thatched temporary shed for schooling has been constructed but the quality of this shed is very poor (**Photo: 18**).
