MULTIPURPOSE DISASTER SHELTER PROJECT (MDSP)

FIELD VISIT REPORT

1. Period of Visit : 04 Feb – 05 Feb 2019
2. Location of Visit : Noakhali District.
3. Participant of visit : A.H.M. Mahbubur Rahman, TL, M&E Consultant,
Md. Matiur Rahman, Civil Engineer/ M&E Specialist, M&E Consultant,
4. Officials met during Visit :

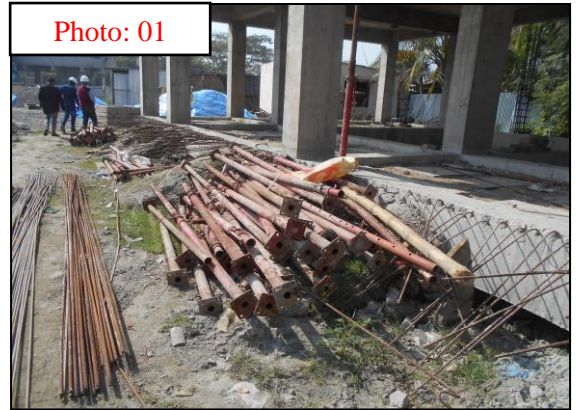
- The quality of construction materials such as MS Rod, stone chips, coarse sand etc. procured at sites appears good. Laboratory tests of MS rod, coarse sand, cement etc. have been done. Chemical test of water has also been done. Test reports have been made available during our visit.
- MS rods should be stored on raised platform to avoid mud and water (**Photo: 01**).

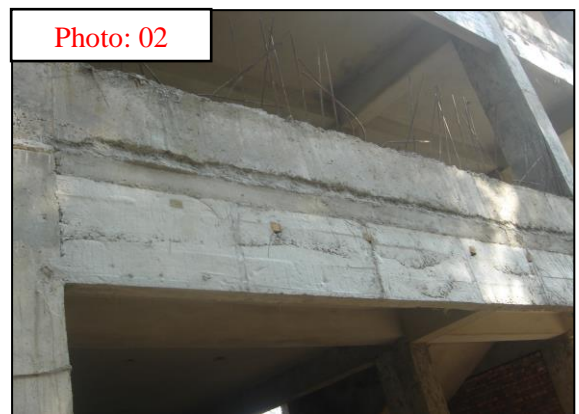
- Generally, concrete work is good but at some places, quality of concrete should be improved. (**Photo: 02**)

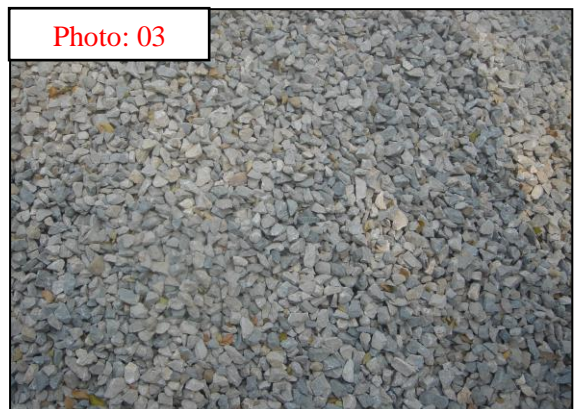
- Stone chips at some sites appear larger in size (**Photo: 03**). Properly graded stone chips should be used.

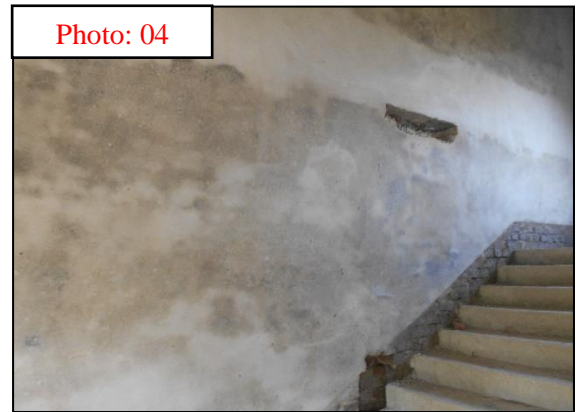
- Sand used for plastering works in **NOAP-154** exposes traces of salt. **(Photo: 04)**
- Site offices and labor sheds have been constructed in all sites.
- Steel shutter materials have been used in all RCC works.

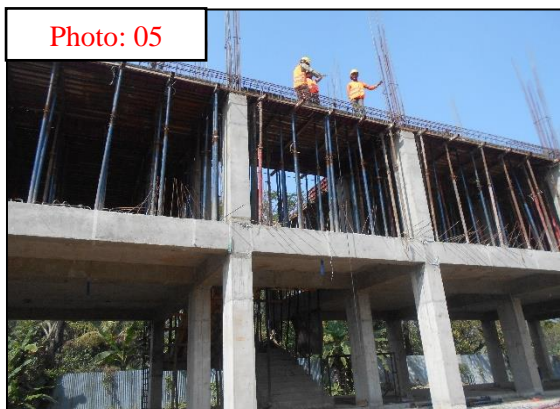
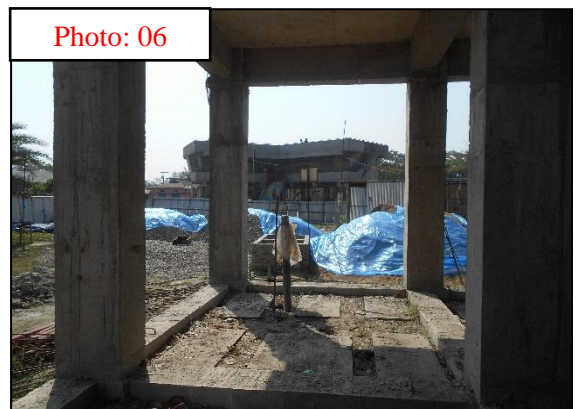
- **NOAP-376:** Shutter and re-bar placement for 1st floor slab casting is going on **(Photo: 05)**. Installation of Deep Tube-wells (4 nos.) has been completed **(Photo: 06)**.

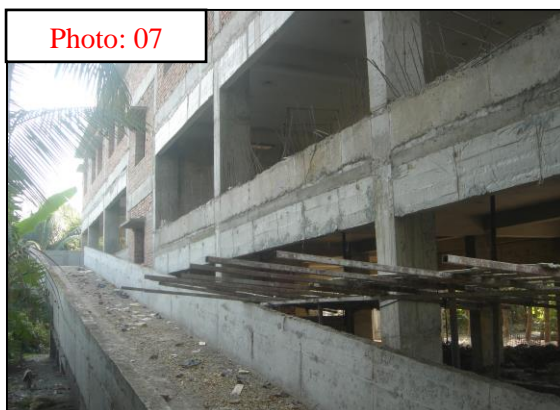
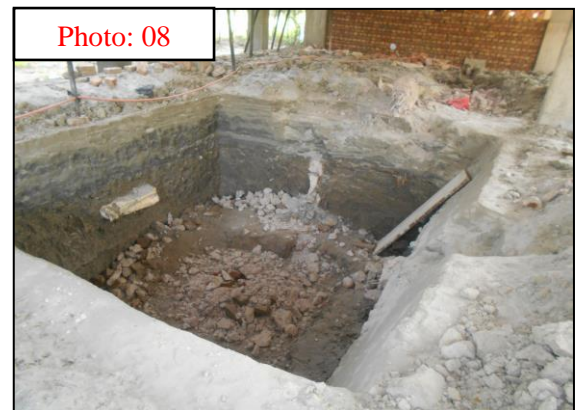
- **NOAP-154:** No physical work was observed on the day of the visit. 2nd floor slab casting has been done **(Photo: 07)**. Ramp construction including Installation of Deep Tube-wells (4 nos.) has been completed. Brickwork & re-excavation of earth for the construction of underground water tank **(Photo: 08)** were in progress.

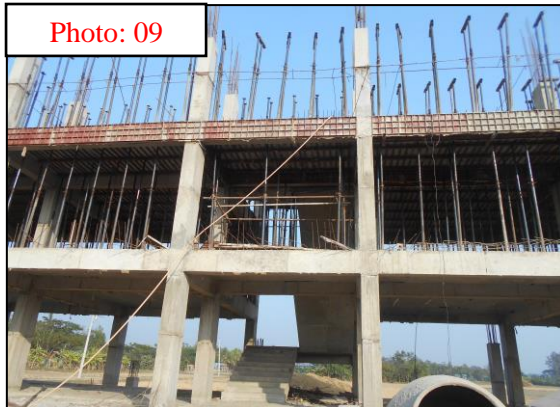
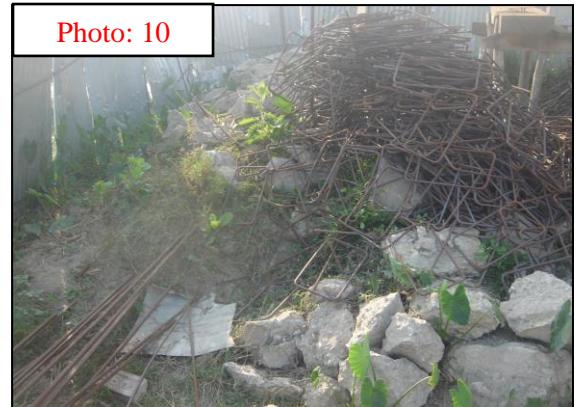
- **NOAP-336:** Shutter placement for 2nd floor slab casting is in progress (**Photo: 09**). Installation of Deep Tube-wells (4 nos.) has been completed. Important construction material like rods and stirrups have stacked haphazardly and carelessly. (**Photo: 10**)

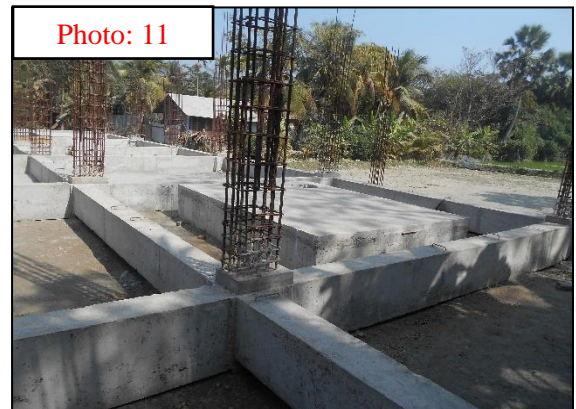
- **NOAP-210:** Physical progress is still limited to casting of column kickers (**Photo: 11**). Construction of 2 nos. underground water reservoir has been completed. It was learnt that no physical activities has been done since mid-October 2018. A lot of physical works is yet to be done to complete the shelters. The site appears barren and the progress of work is so disappointing.

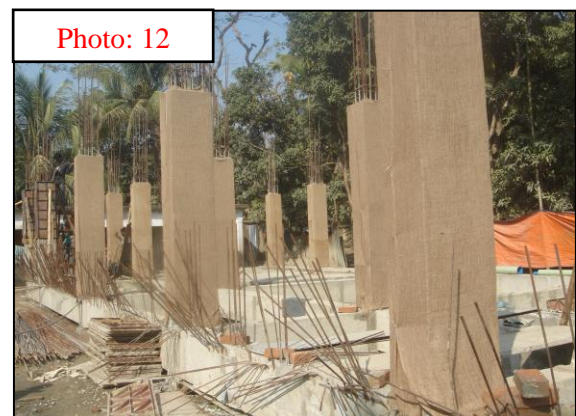
- **NOAP-100:** Ground floor columns casting is going on. Curing arrangement observed (**Photo: 12**). Construction of 2 nos. underground water reservoir has also been completed.

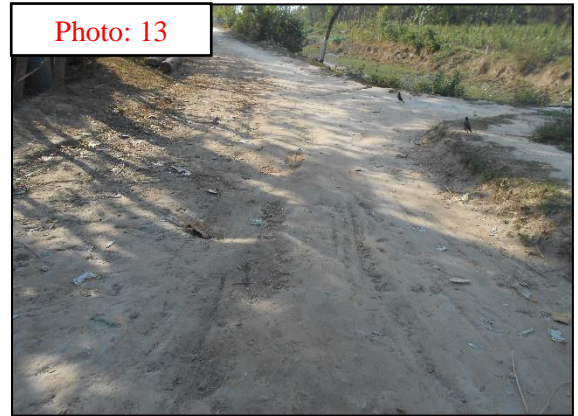
Construction works of the connecting roads have not been taken up as yet. Beneficiary and SMC of **NOAP 154** strongly demanded construction of the SCR immediately to facilitate improved communication during the ensuing monsoon (**Photo: 13**). The matter may please be taken into account.

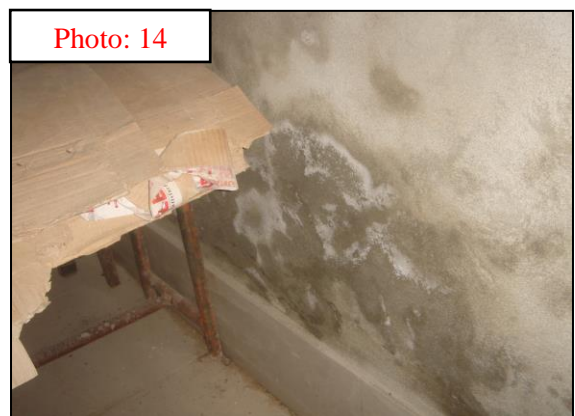
- Sand used in plastering works in some rehabilitation shelters has traces of salt content as reflected in the plaster work (**Photo: 14**). Besides, FM of sand seems to be less than 1.00. Specified sand with prior tests should be used.

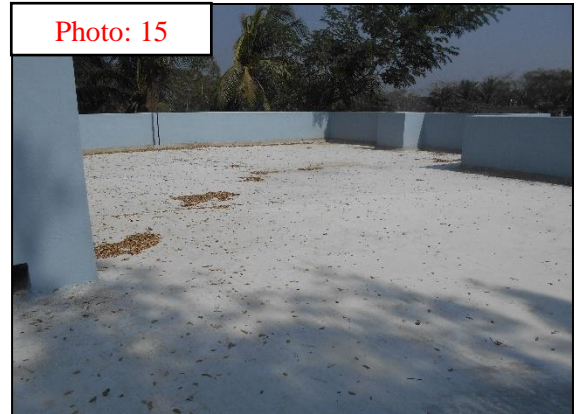
- **Roof Top Screeding:** It consists of 16 mm thick izonil plaster plus 25 mm thick patent stone casting connected by a fibre layer. Done in all visited sites (**Photo: 15**)

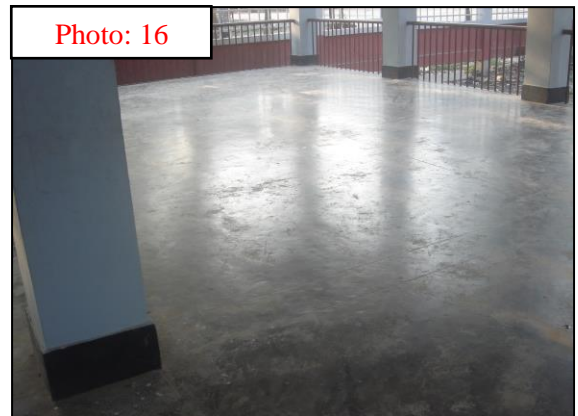
- **Patent Stone Casting:** Completed at ground floor of **NOAE-313 & NOAE-314**. The ground floor of **NOAE-313** has undulated rough surface instead of levelled smooth surface (**Photo: 16**). Curative measures should be taken.

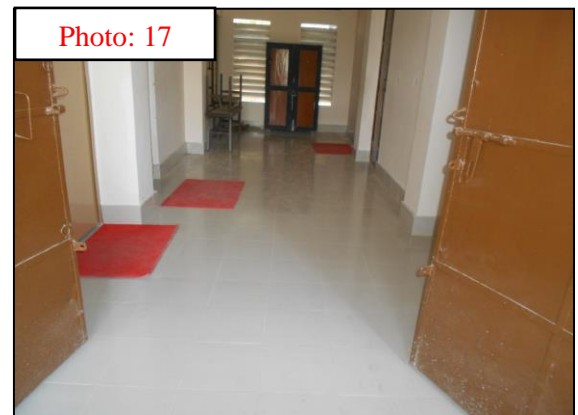
- **Tiles Placement:** Completed at staircase, ground floor/ 1st floor of **NOAE-313 & NOAE-314**, **NOAE-161**, **NOAE-402**, **NOAE-503 & NOAE- 69** (**Photo: 17**). Work is ongoing in **NOAE-509 & NOAE-59**.

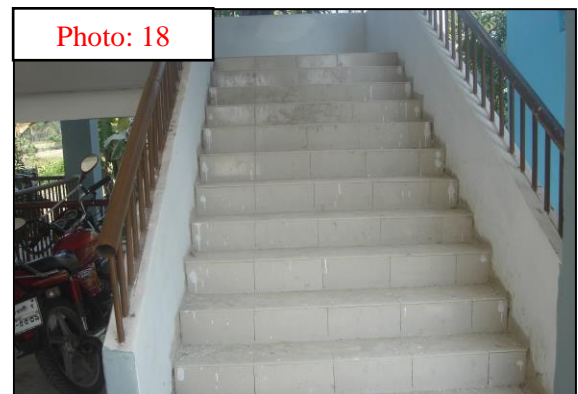
- **Brick Work:** Patch brick work has been completed in **NOAE-509**.
- **Repair of Staircase:** Done in **NOAE-313**, **NOAE-161**, **NOAE-402 & NOAE-503** (**Photo: 18**). Work is ongoing in **NOAE-314 & NOAE-69**.

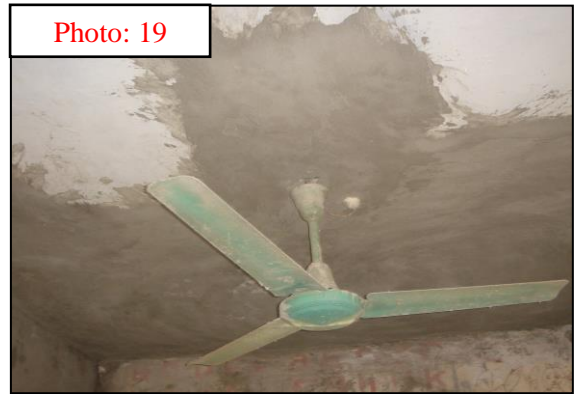
- **Outside & Inside Plastering Works** (Patch repair works where necessary): Done in **NOAE-314, NOAE-161, NOAE-402, NOAE-503 & NOAE-69 (Photo: 19)**. Work is ongoing in **NOAE-313, NOAE-509 & NOAE-59**.

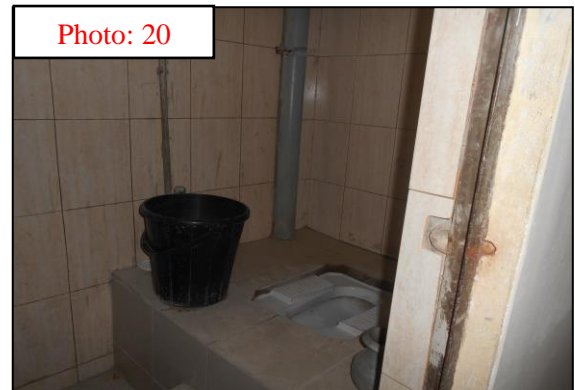
- **Reconstruction of Toilet:** Completed in **NOAE-314 (Photo: 20)**. Work is ongoing in **NOAE-313, NOAE-509 & NOAE-503**. There is no outlet for drainage in **NOAE-161**. Drainage outlet must be provided.

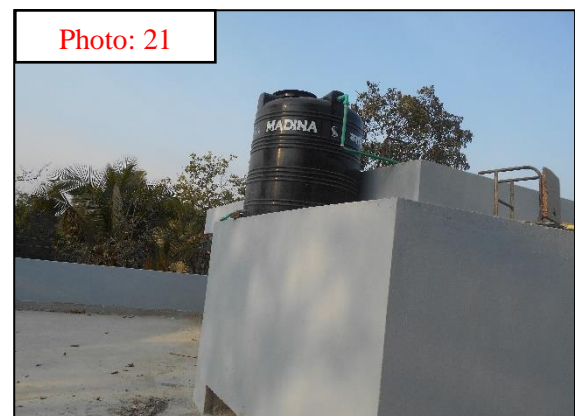
- **Construction/ Re-construction of Septic Tank:** Completed only in **NOAE-503**. Work has not yet started in other sites.
- **Installation of Water Tank at Roof:** Installation of PVC Water Tank at roofs of **NOAE-402 & NOAE-503** has been completed (**Photo: 21**). Work is ongoing in **NOAE-59**.

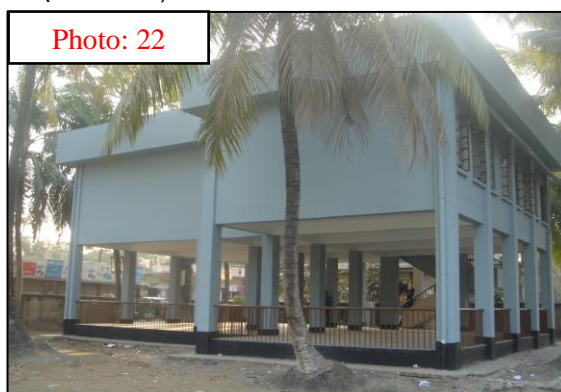
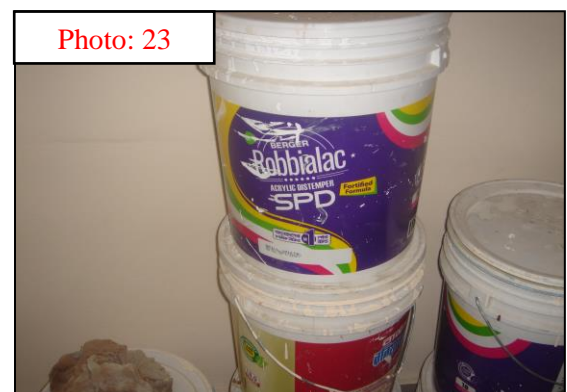
- **Outside & Inside Painting Works:** Works is ongoing in all sites except **NOAE-509 (Photo: 22)**. In **NOAE-402**, it was observed that acrylic distemper has been used for painting instead of plastic paint (**Photo: 23**).

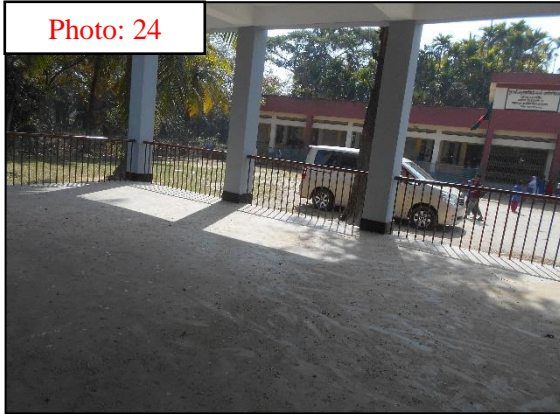
Photo: 24

- **Supplying and fixing of Grills and Collapsible Gates:** Done in all sites (Photo: 24) & (Photo: 25)

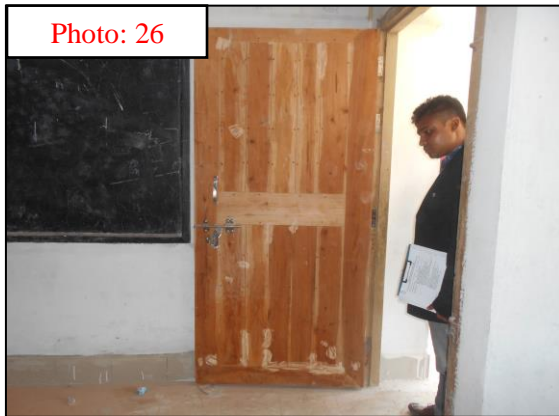
Photo: 26

- **Repair or supplying and fixing of wooden door shutters/ frames:** Done in NOAE-314. (Photo: 26) but all workmanship is not up to standard (Photo: 27)

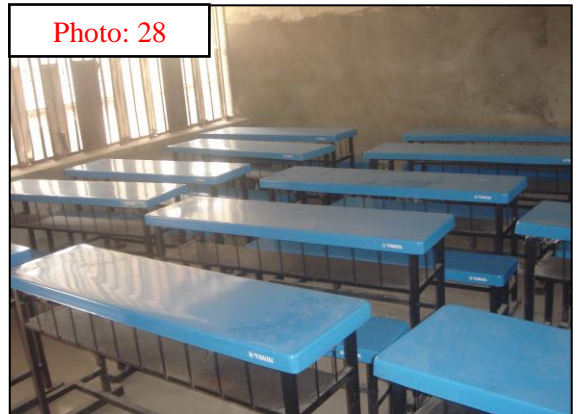
Photo: 28

- **School Furniture Supply:** Only high and low benches of Tanin Brand have been supplied in NOAE-314 (Photo: 28). Other furniture such as Chairs and tables for the teachers, Steel Almirah etc. should be supplied early as requested by the teachers.

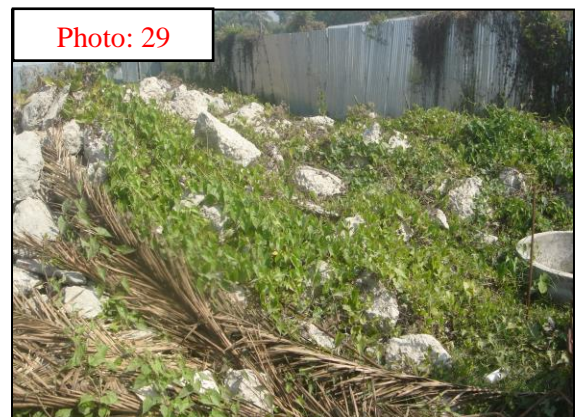
- **Temporary Camp Site Waste Disposal Facility:** Demarcated area for waste disposal particularly for disposal of construction debris like earth, concrete etc. was not observed. The contractor should arrange a separate demarcated area away from construction site to temporarily dispose construction debris in order to create a safe environment for smooth construction works. It is always advisable to remove the debris from site with immediate effect (**Photo: 29**).

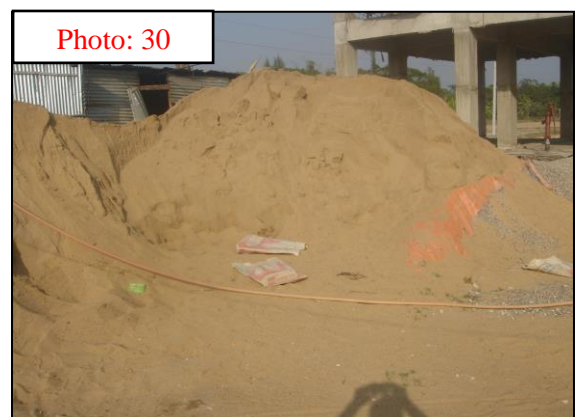
- **Dust Suppression Measures:** In some sites, sand was kept covered in order to prevent dust pollution while in some other sites, these were kept exposed. This should always be kept covered to protect from air pollution (**Photo: 30**).

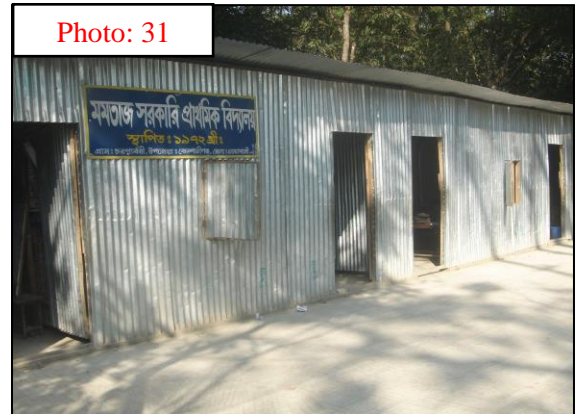
- **Construction of Temporary Shed for Uninterrupted Schooling:** There is provision to construct temporary shed for class accommodation where existing school building has been demolished. In **NOAP-204**, one thatched temporary shed for schooling has been constructed but the quality of this shed is very poor (**Photo: 31**).
