MULTIPURPOSE DISASTER SHELTER PROJECT (MDSP)

Subject : Field Visit Report of the M&E Consultants of MDSP in Patuakhali District undertaken on 10-11 August 2022.

i) Construction of New Shelter Package LGED/MDSP/PATU/14-15/NW-05

FIELD VISIT REPORT

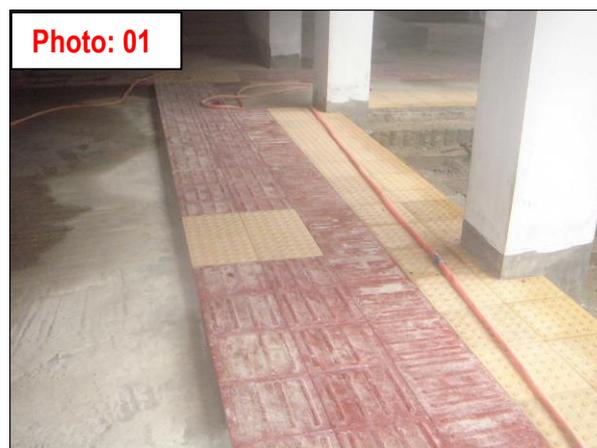
- **Change in Floor Design.** There has been some changes in the ground, 1st floor and ramp design. Tiled walkway has been introduced to facilitate movement of the blind people. **(Photo: 01).**

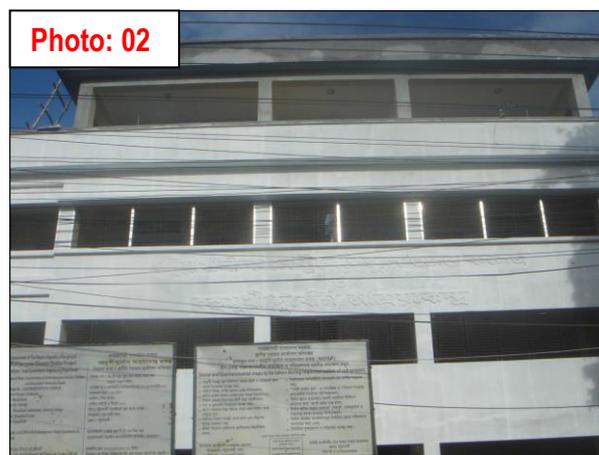
- **Additional Rooms at Roof Floor.** We have observed two additional rooms in the roof floor of **PAP 801.** **(Photo: 02).** These rooms will add additional shelter space. Besides, the new shelters have inadequate school rooms. This will be helpful for the school as well.

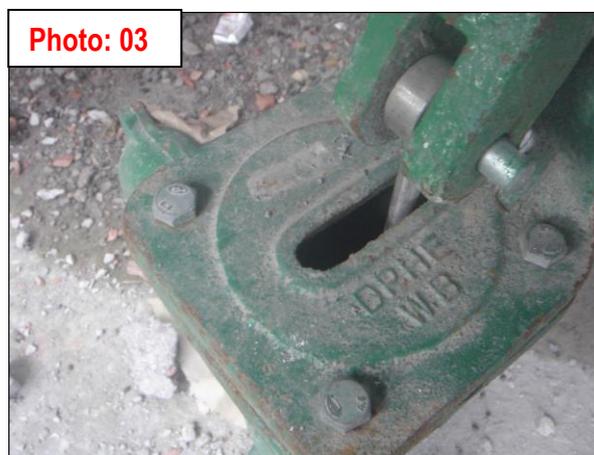
- **Tube well.** Tube wells have been sunk. Some tube well 'Heads' are marked "DPHE" **(Photo: 03).** These are Government tube wells used by the 'Department of Public Health Engineering' in departmental works. The "DPHE" marked tube well heads should be replaced.

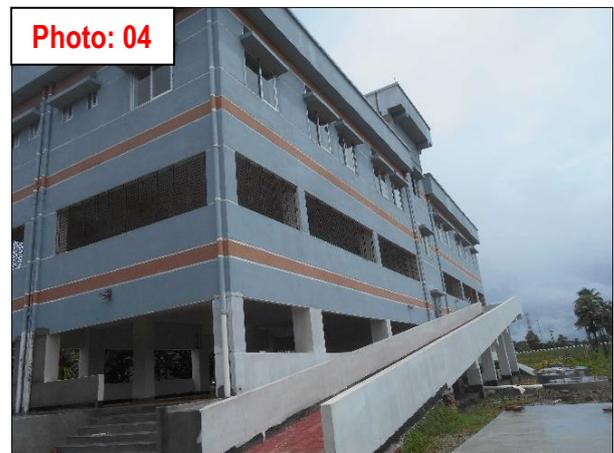
Frame of the RCC Structure including ramp of all the 7 shelters have been done (**Photo: 04**).

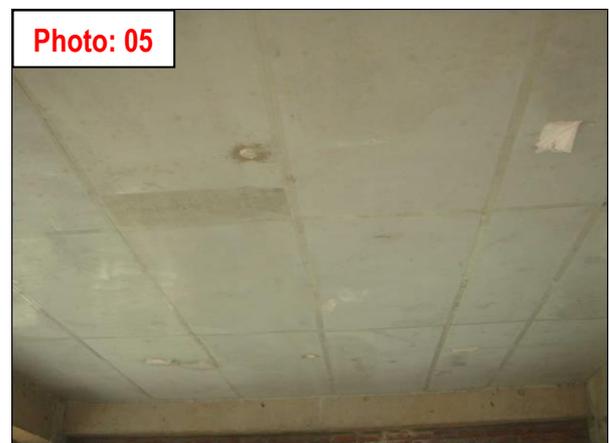
- Quality of concrete works is good (**Photo: 05**).

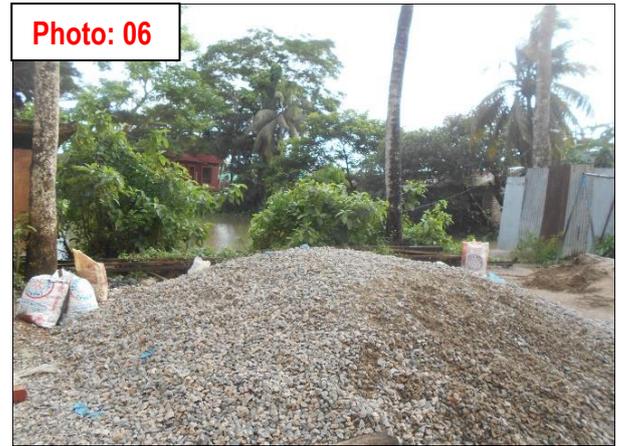
- The quality of construction materials such as MS rod, stone chips, coarse sand, fine sand etc. procured at sites appears good (**Photo: 06**).

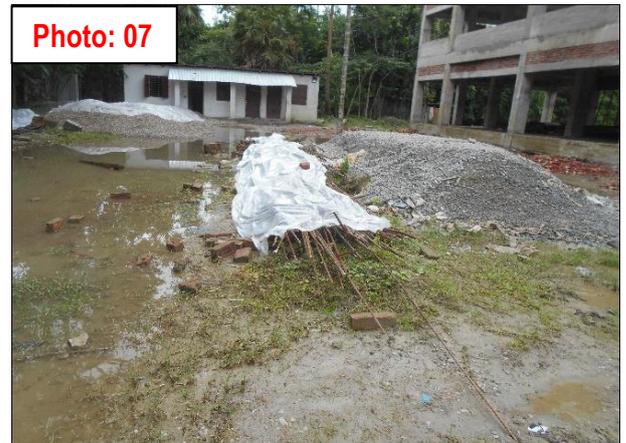
- MS rod should be stored on raised platform to avoid mud and water (**Photo: 07**).

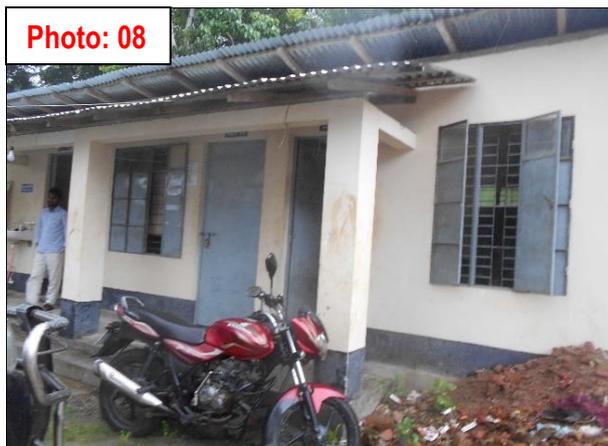
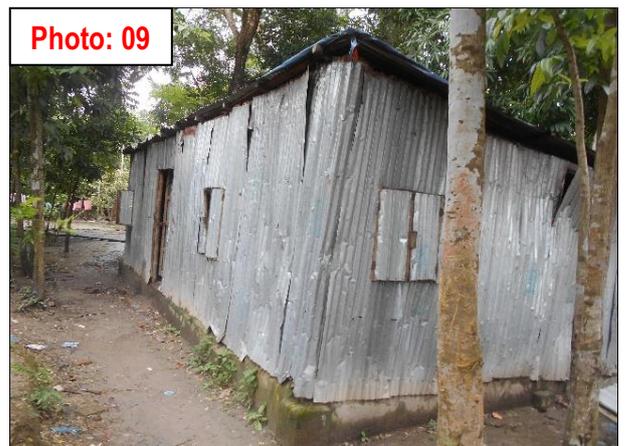
- Site offices have been built at all shelter sites (**Photo: 08**). Site office fixtures are of good quality. Labour sheds have also been built but the conditions of the sheds appear damaged. (**Photo: 09**).

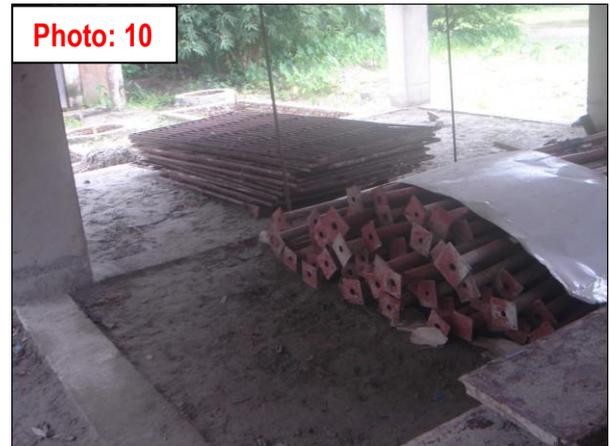
- Unused props and shutter materials have been properly stacked (**Photo: 10**).

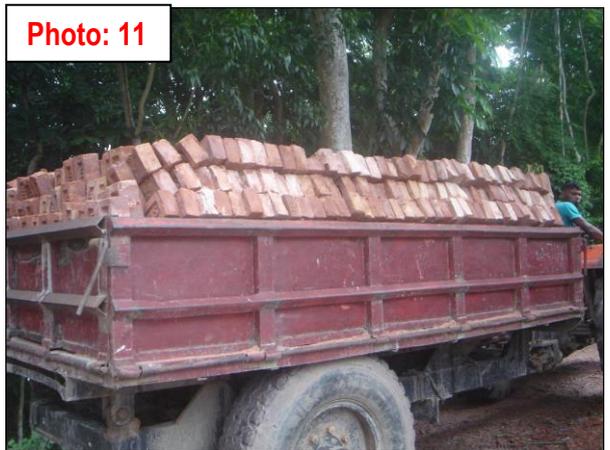
- Quality of bricks being procured appear good (**Photo: 11**).

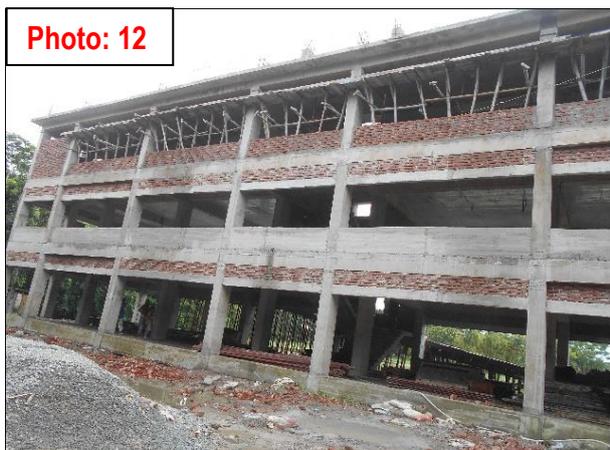
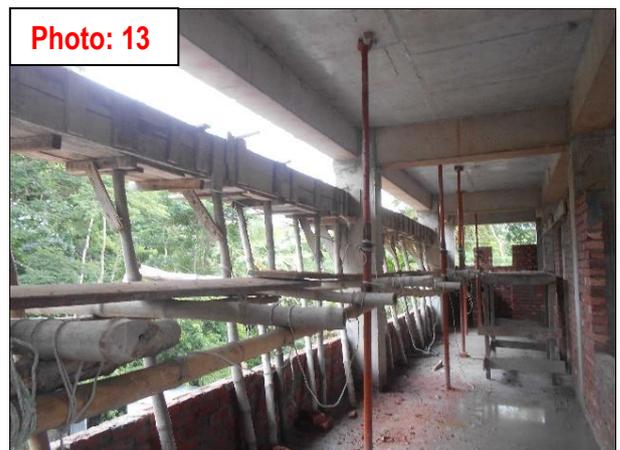
- **PAP-226:** Frame Structure including ramp construction has been done (**Photo: 12**). Brick works at 1st & 2nd floors are still ongoing. Lintels casting at 2nd floor is ongoing (**Photo: 13**).

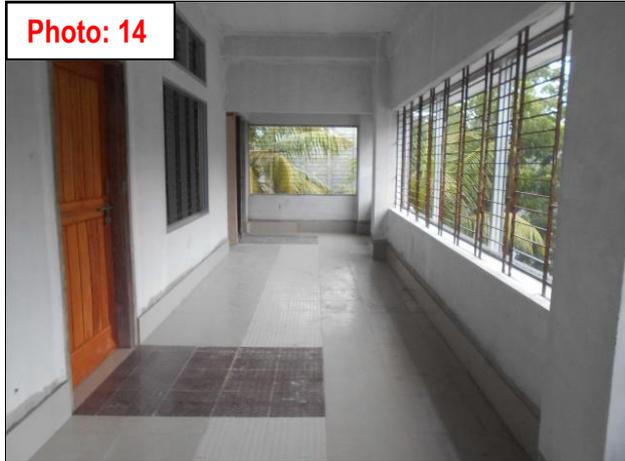
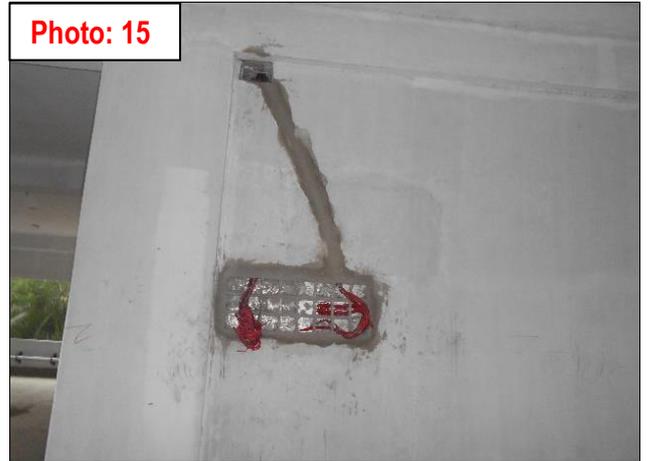
- **PAP-901:** Frame Structure including ramp construction has been done. Fitting & fixing of window grills & stair rails at 1st & 2nd floors and fitting & fixing of wooden door frames & shutters have also been done (**Photo: 14**). Works are still ongoing at site are: tiles placement works; painting works; fitting & fixing of Thai aluminium windows at 2nd floor; fitting and fixing of plumbing fixtures at toilets; fitting & fixing of tube wells accessories; installation of OHWTs; electrification works and installation of Solar Panels etc. (**Photo: 15**) School Furniture have not yet been supplied.

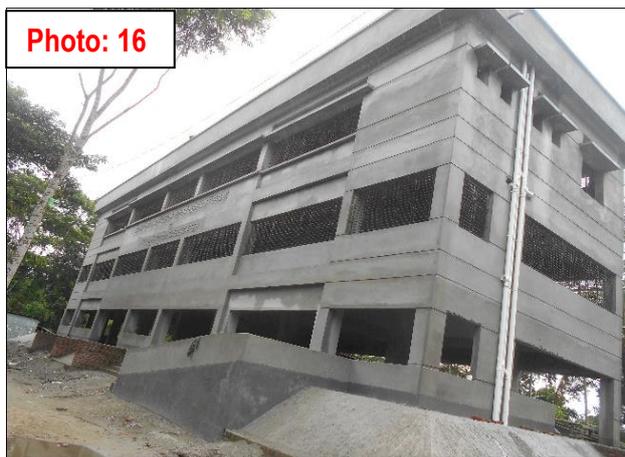
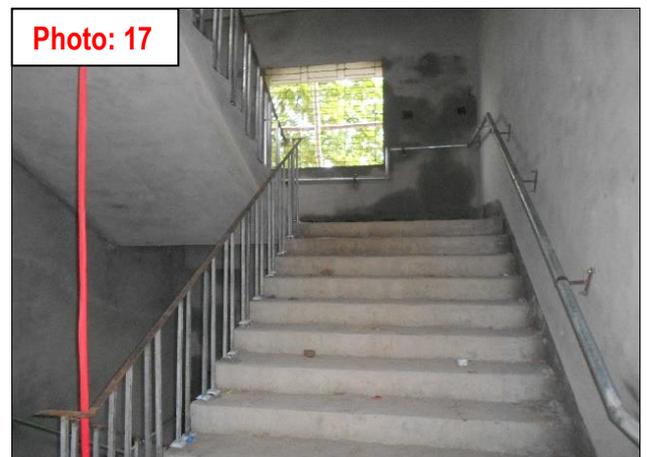
- **PAP-145:** Frame Structure including ramp construction has been done. Fitting & fixing of windows grills at 1st & 2nd floors & cattle rails at 1st floor have also been done (**Photo: 16**). Plastering works, tiles placement works, fitting & fixing of stair rails, fitting and fixing of plumbing fixtures at toilets, electrification works etc. are still ongoing at site (**Photo: 17**).

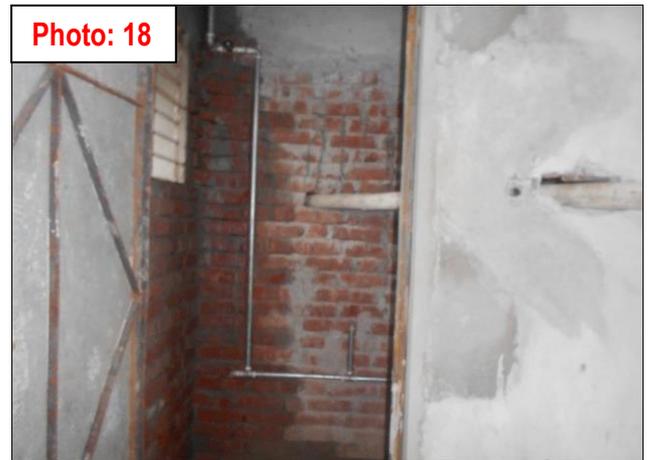
- **PAP-69:** Frame Structure including ramp construction has also been done. Brick work, plastering works, fitting & fixing of stair rails, fitting and fixing of plumbing fixtures at toilets, electrification works etc. are still ongoing at site (**Photo: 18**).

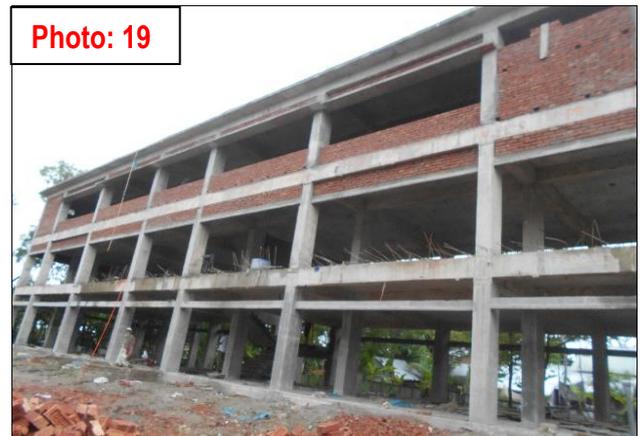
- **PAP-72:** Frame Structure including ramp construction has been done (**Photo: 19**). Brick works at 1st & 2nd floors are still ongoing.

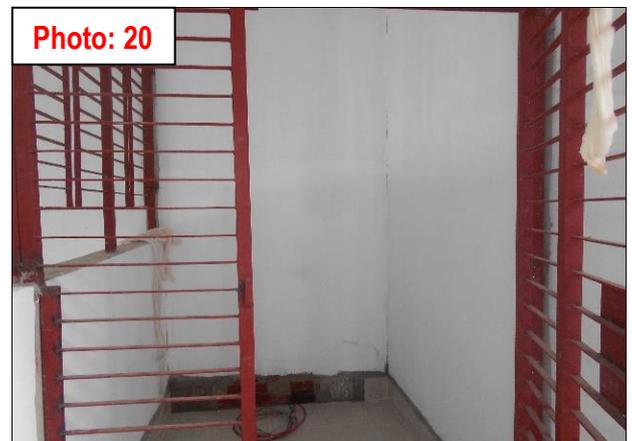
- **PAP-354:** Frame Structure including ramp construction has been done. Tiles placement works, fitting & fixing of window grills & stair rails at 1st & 2nd floors and fitting & fixing of wooden door frames & shutters, fitting and fixing of plumbing fixtures at toilets and fitting & fixing of Thai aluminium windows at 2nd floor etc. have also been done. Works are still ongoing at site are: painting works; fitting & fixing of tube wells accessories; installation of OHWTs; electrification works and installation of Solar Panels etc. (**Photo: 20**). School Furniture have not yet been supplied.

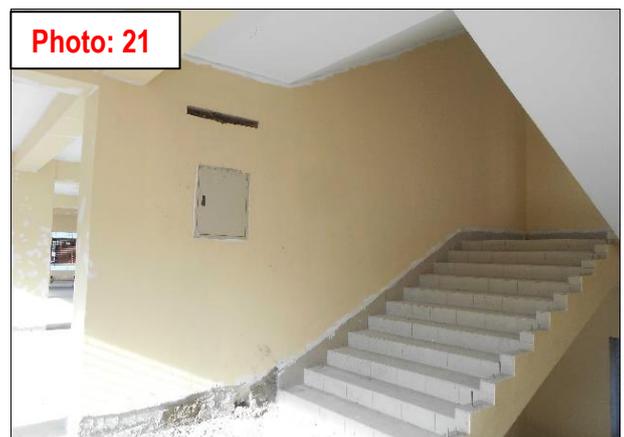
- **PAP-801:** Frame Structure including ramp construction has been done. Progresses of completed and ongoing works at site are almost same as **PAP-354** (**Photo: 21**).

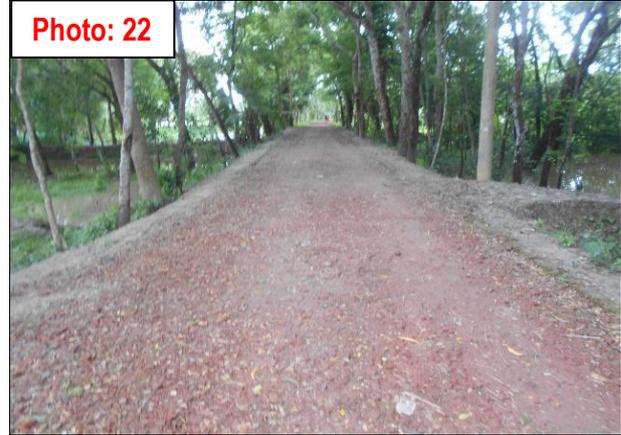
Construction of WBM of the roads connected to PAP-226 and PAP-901 are still ongoing (Photo: 22).

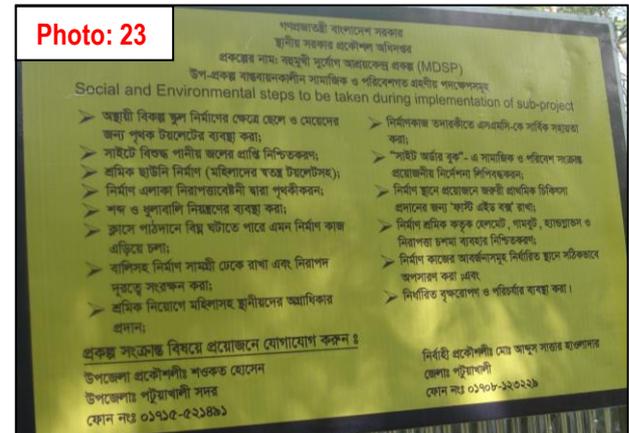
The project related environmental and social safety measures have been shown in display board at each site. (Photo: 23).

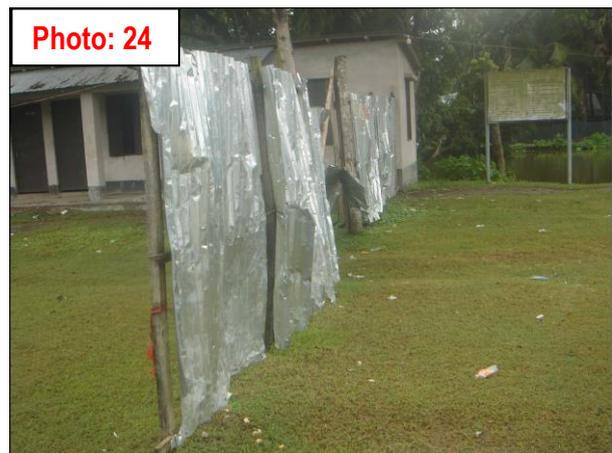
- **Protection Fencing:** Protective fencing by corrugated iron sheet has been done. At PAP 69, the fencing is found to be broken. (Photo: 24).
