MULTIPURPOSE DISASTER SHELTER PROJECT (MDSP)

Subject : Field Visit Report of the M&E Consultants of MDSP in Chattogram District undertaken on 06-07 December, 2022.

FIELD VISIT REPORT

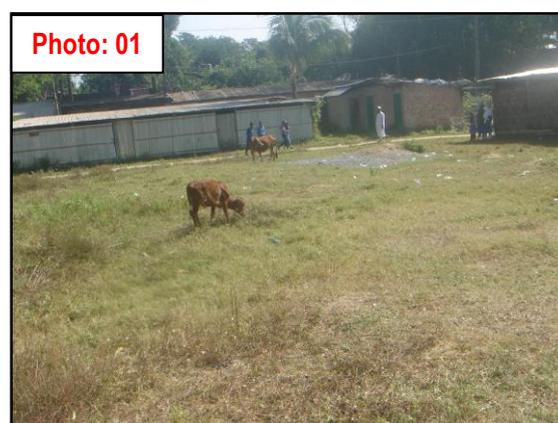
- As of end of November 2022, overall physical progress of the package **NW-03B** is **27.50%** against the revised target of **97%** (in terms of time allowed). It shows that the physical progress of the package is lagging much behind the schedule. A further extension will therefore be inevitable on condition that the contractor will fully engage itself in accelerating construction activities aiming completion by the extended period.

- Visualizing implementation activities, the slow progress of the package appears to be the negligence of the contractor, although the effect of COVID-19 may be termed partly responsible. In any case, construction program needs to be immediately re-scheduled targeting completion within project period and all action to complete works must be ensured by all concerned.
(Photo: 01)

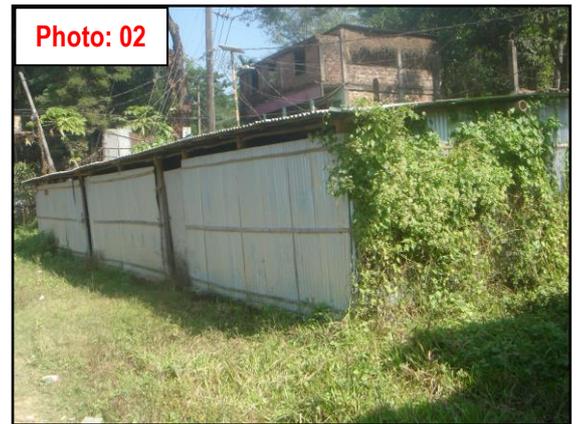
Mobilization activity includes the construction of site offices, installation of tube wells, labor sheds, store sheds, toilets, demarcating waste disposal areas and mobilizing necessary machineries etc. Although some of the items were more or less mobilized at initial stage, but at present, most of these items were not seen except some dilapidated site offices and labor sheds. **(Photo: 02)**

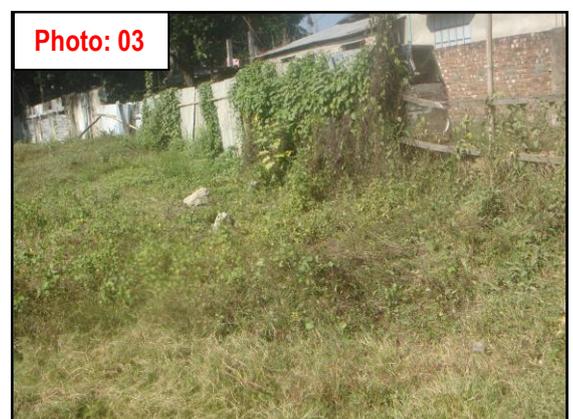
- There was no physical activity except CTGP-576. CTGP-3220 seems to be cow pasture.
- Construction works of all the sites visited are still limited to foundation works only **(Photo: 03)**.

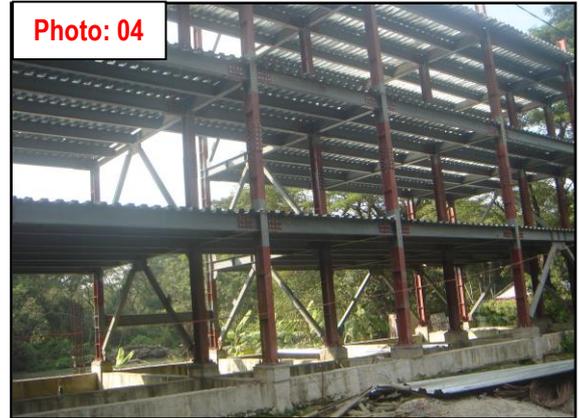
- However, at **CTGP-576**, erection work has gained some progress although no physical activity was reported in the recent past (**Photo: 04**).

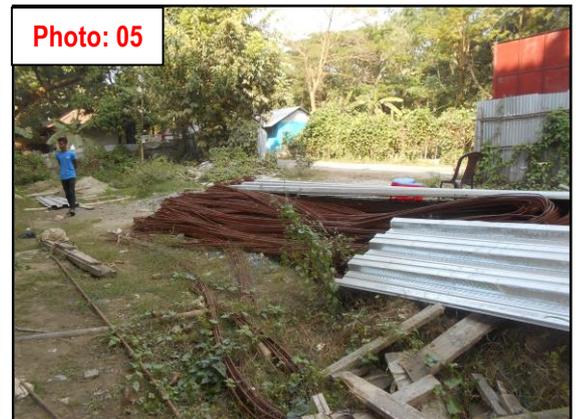
- Installation of 3 nos. of Deep Tube-wells and 1 No. of Submersible Pump have been done in **CTGP-576**.
- The quality of construction materials such as MS rod, stone chips, coarse sand etc. procured at sites appears good.
- MS Rod should be stored on raised platform to avoid mud and water in **CTGP-576** (**Photo: 05**).

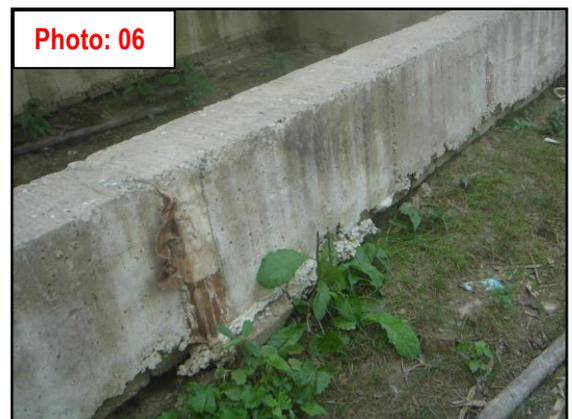
- Concrete work in CTGP-576, the quality of concrete work Appears poor (**Photo: 06**)

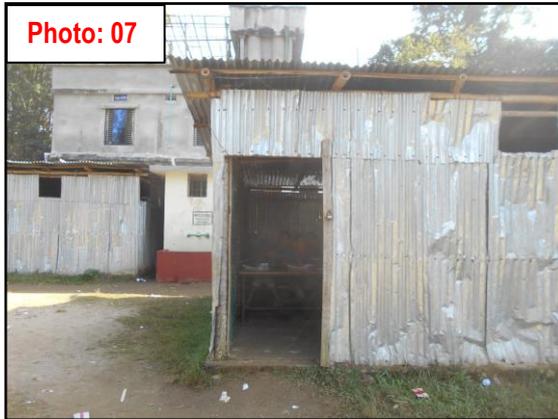
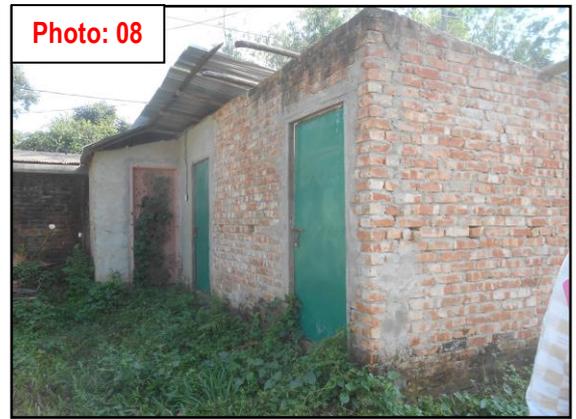
- Labour sheds have been constructed in all visited shelter sites (**Photo: 07**) except **CTGP-3220**. Site offices have been constructed in all visited shelter sites except **CTGP-576**. The site offices are not suitable for uses (**Photo: 08**).

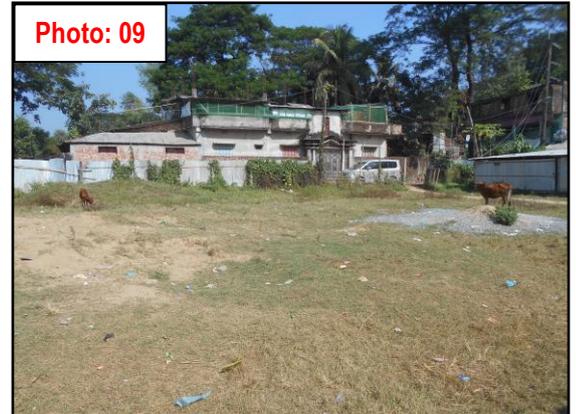
- **CTGP-3220:** All 67 nos. cast-in-situ piles of lengths of 20 m and diameter 500 mm have been cast. Pile Load Test has been done but Pile Integrity Test has not been done. It was learnt that there has been no activity since piling works completed on 21 January 2021. The site appears barren (**Photo: 09**).

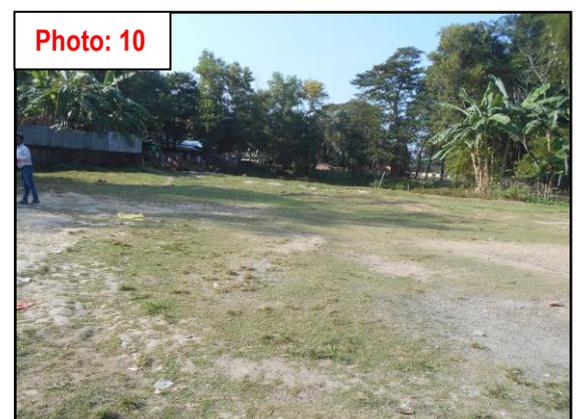
- **CTGP-1004:** All the 67 nos. cast-in situ piles of lengths of 20 m and diameter of 500 mm have been cast. There was no physical activity since 26 March 2021 (**Photo: 10**).

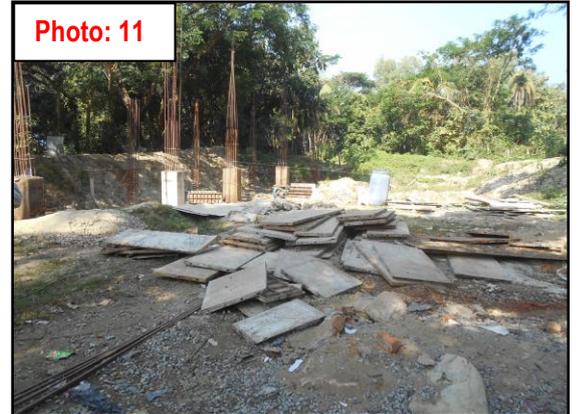
- **Site Plan:** No site plan showing the demarcated storage yard of construction materials, labour sheds, tube wells and toilets for construction labours, re-bar fabrication yard, waste disposal areas etc. was available at any working site. As a result, unplanned and haphazard construction activities were observed (**Photo: 11**).

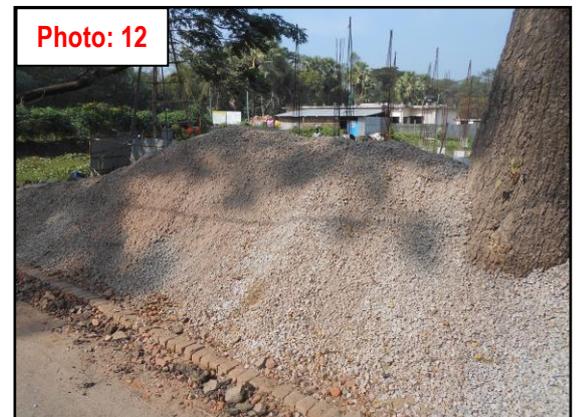
- Construction works at the visited shelter sites are still limited to foundation works up to grade beams level.
- Laboratory tests of MS rod, coarse sand, cement etc. have been done. Test reports have been available in the field and test results are O.K.
- The quality of construction materials such as MS rod, stone chips, coarse sand etc. procured at sites appears good but procured stone chips at **CTGP-589** are found mixed with dust (**Photo: 12**).

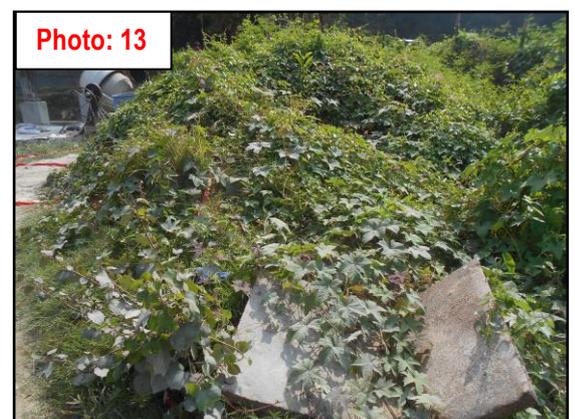
- Excavated earth has been stacked irregularly and haphazardly. Advised to immediately to remove the garbage waste from construction site (**Photo: 13**).

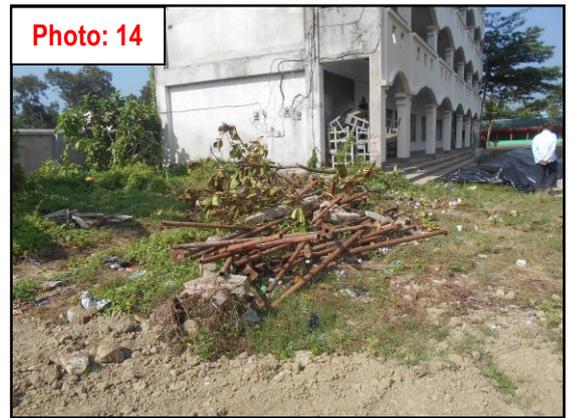
- MS rod and steel props has not been properly stacked (**Photo: 14**).

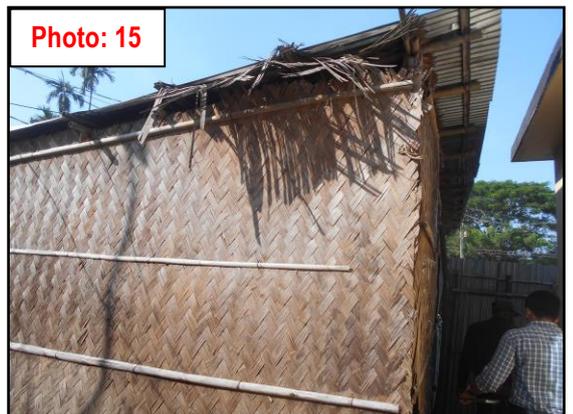
- Site offices have not yet been constructed in any of the shelter sites. Labour sheds in some shelter sites are found unusable (**Photo: 15**).

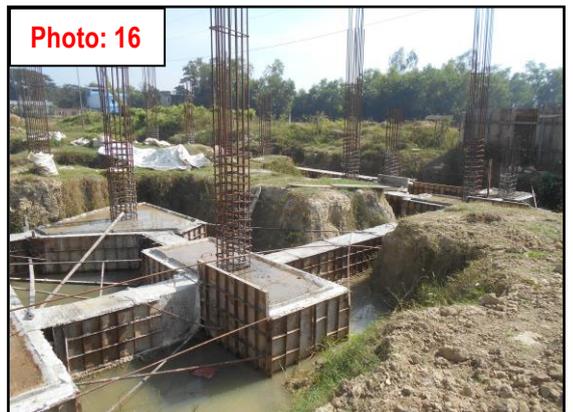
- **CTGP-1497:** Pile caps casting is ongoing. There has been no physical activity at site since 8 November 2022 (**Photo: 16**).

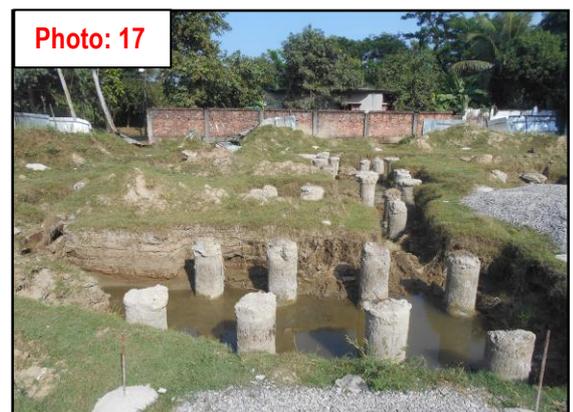
- **CTGP-1051:** All the 70 nos. cast-in situ piles of lengths of 20 m and diameter of 500 mm have been cast) Pile Load test has been done, but Pile Integrity test has yet to be done. No physical activity was observed (**Photo: 17**).

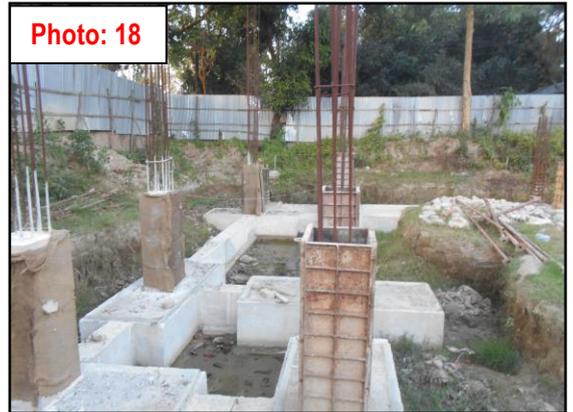
- **CTGP-1061:** Pile caps casting including bracing beams and pedestal columns are in progress. No physical activity was also seen (**Photo: 18**).

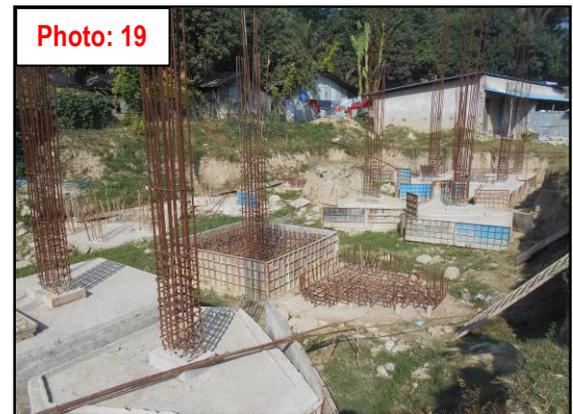
- **CTGP-1087:** Pile caps casting including bracing beams was in progress. No physical work was going on since 21 October 2022 (**Photo: 19**).

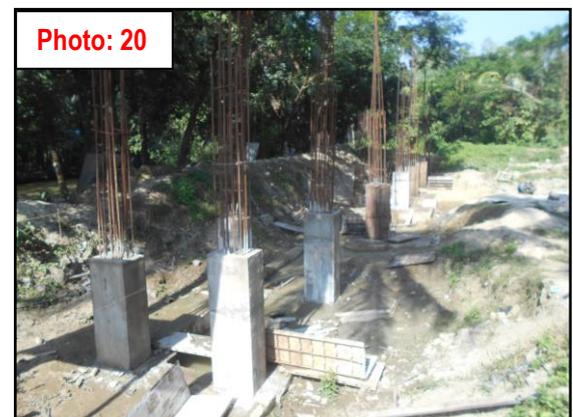
- **CTGP-1100:** Casting of pedestal columns was in progress. No physical activity was seen (**Photo: 20**).

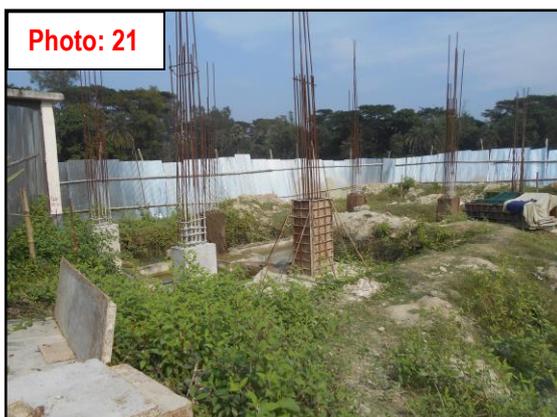
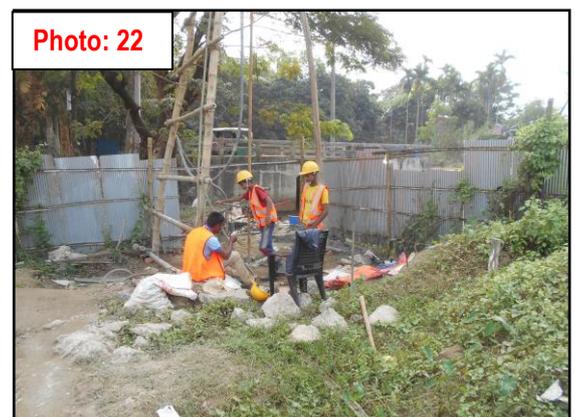
- **CTGP-589:** Pedestal columns casting was in progress (**Photo: 21**). Installation of Deep Tube well (Environment) was going on (**Photo: 22**).

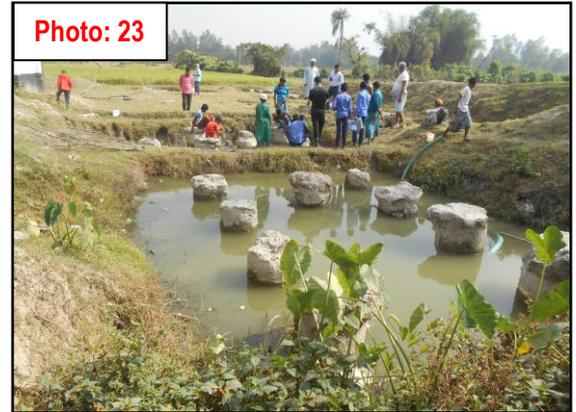
- **CTGP-1504:** All the 75nos. cast-in situ piles of lengths of 20 m and diameter of 500 mm have been cast) Pile Load test and Pile Integrity test have not yet been done. There has been no activity since 1 year (**Photo: 23**).

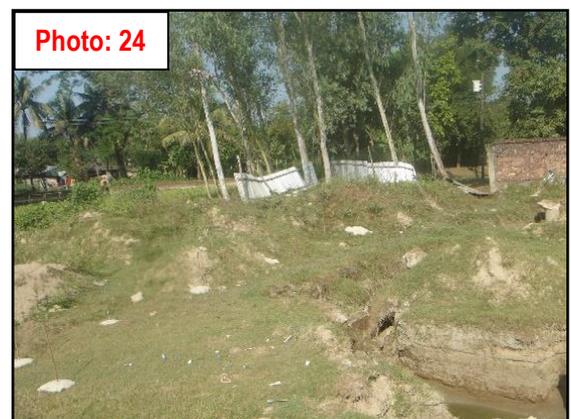
b) **Fencing:** Safety fencing are in dilapidated condition in most of the sites (**Photo: 24**).

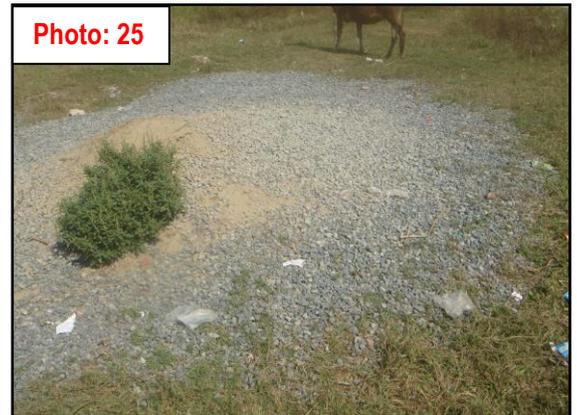
d) **Dust Suppression Measures:** Sand stored in some of the sites has been covered but grasses have grown on sand stone heap at CTGP-3220 (**Photo: 25**)

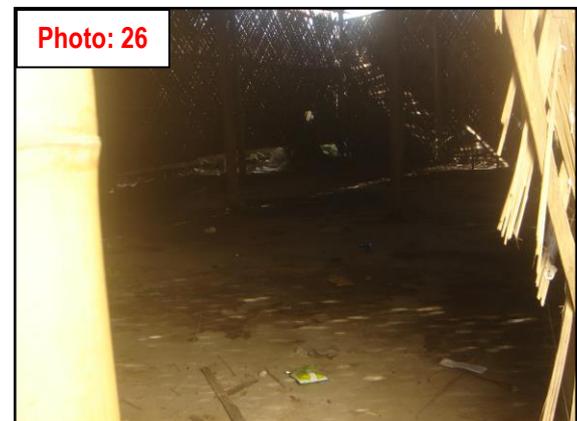
e) **Labor Shed:** In most sites, Labor sheds have been constructed but at some sites, these are poor condition, (**Photo: 26**).

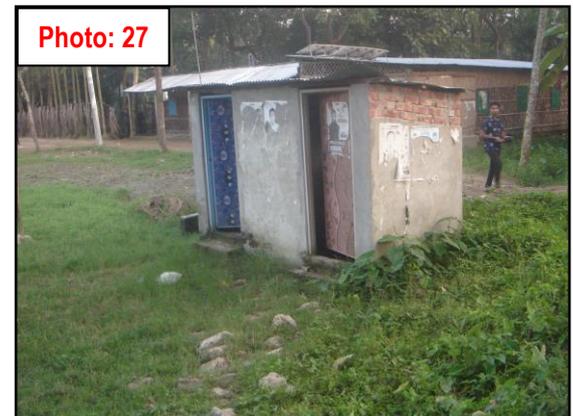
g) **Temporary Sanitary Latrine:** Sanitary latrines have been built but the quality need improvement. (**Photo: 27**).

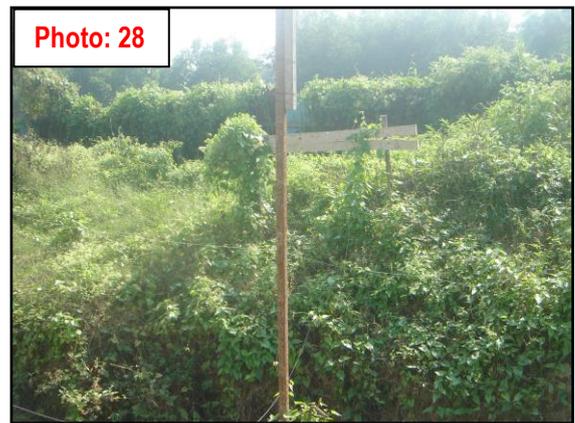
- i) **Site Cleaning:** This item is meant to keep the site clean during and after construction. This item has generally been neglected. **(Photo: 28).**

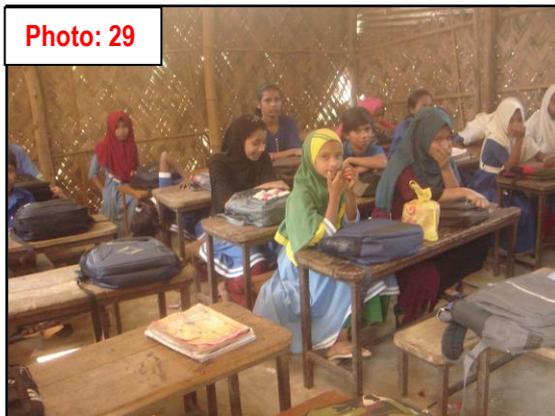
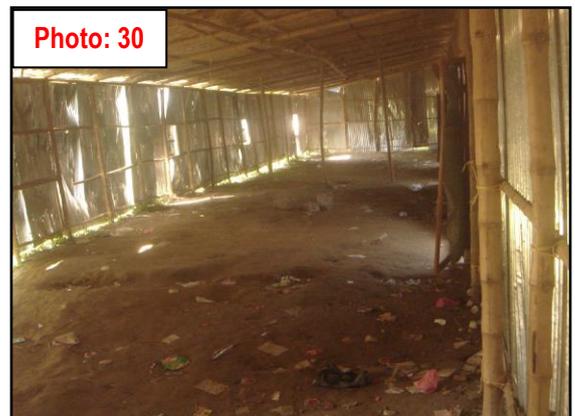
- j) **Construction of Temporary School:** Construction of temporary sheds have been built where necessary but some of them are in use **(Photo: 29)** while in places it remains abandoned **(Photo: 30)**
