MULTIPURPOSE DISASTER SHELTER PROJECT (MDSP)
Monitoring & Evaluation (M&E) Consultant

FIELD VISIT REPORT

1. Period of Visit : 22 May – 23 May 2017
2. Location of Visit : Feni District.
3. Participant of visit : A.H.M. Mahbubur Rahman, TL, M&E Consultant,
Md. Matiur Rahman, Civil Engineer/ M&E Specialist, M&E Consultant,
4. Officials met during Visit :

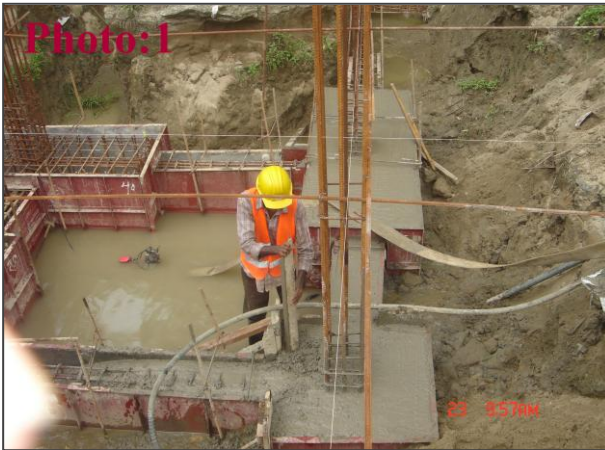
- Physical works in **FEP-339** are limited to the casting of some pile caps and in the placement of shuttering materials for casting of some pedestal columns below Grade Beams (**Photo: 1**) in **FEP-341** are still limited to the re-bar placement related to casting of pile caps and connecting bracing beams (**Photo: 2**). The physical works in **FEP-020** are limited to the placement of shuttering materials in connection with the casting of Grade Beams and the same in **FEP-217** are still limited to the casting of pile caps and pile caps connected bracing beams (**Photo: 3**).

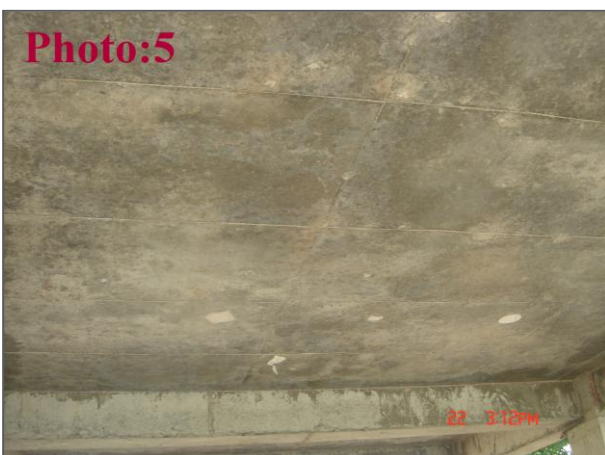
- Progress of physical works in most of the shelters under **Contract Package No.03** are more advanced compared to works of Contracts of **Packages 1 and 2**. 1st floor slab including construction of ram and part of internal brickwork have been done in FEP-201 (**Photo: 4**).
- The roof slab concreting in FEP-201 is very good (**Photo: 5**) because of the use of proper steel shutter materials and pipe props. This quality should be maintained in all buildings.

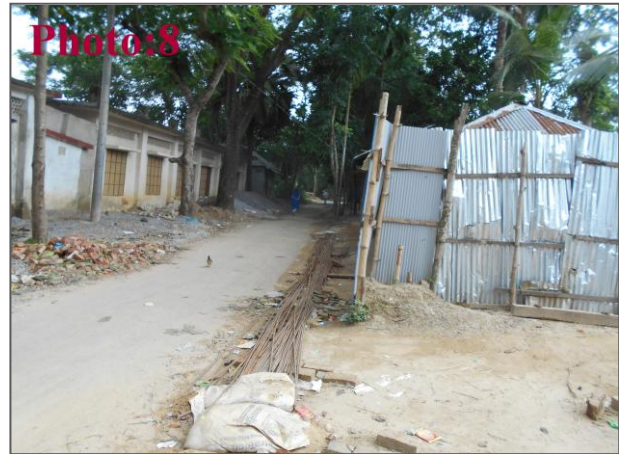
- Reinforcement steel have not been properly stacked at sites (**Photo: 7**), and even some M.S rods have been kept on roadside (**Photo: 8**).The should be rectified.

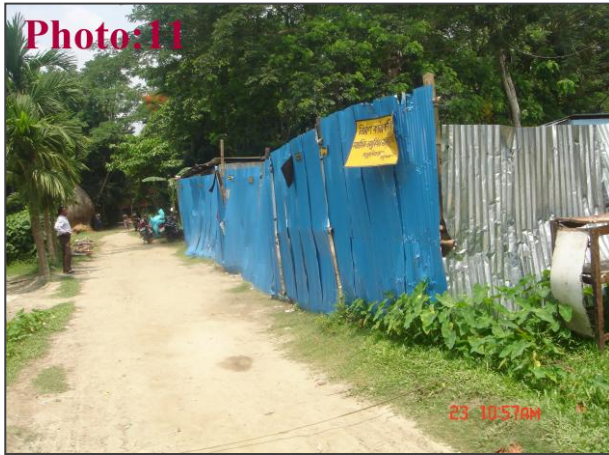
- **Posting of Signboard:** Contract information signboards were found describing subproject activities at all construction sites.
- **Erection of Safety Fence:** Safety barrier has been erected in all construction sites to keep the students and public away to avoid danger of accident. The quality of fencing work should be more stable (Photo: 11).
- **Labor Shed:** Labor sheds made of CI sheets have been erected but there is hardly any provision of ventilation (Photo: 12). Ventilation provision should be made.

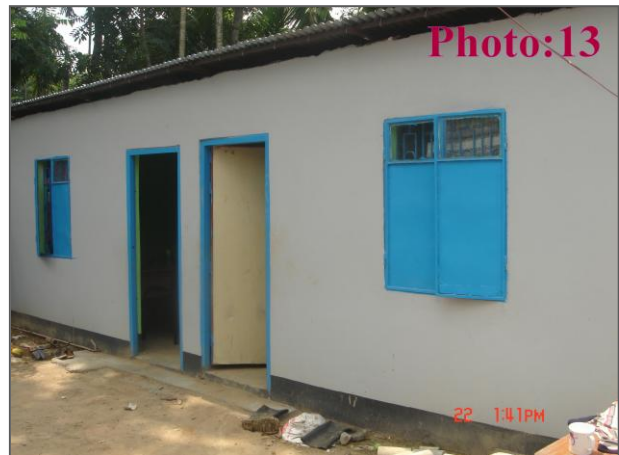
- **Site Camp Office:** Site camp offices have been constructed but these are lagging required furniture like racks, almirah to keep important documents (Photo: 13).

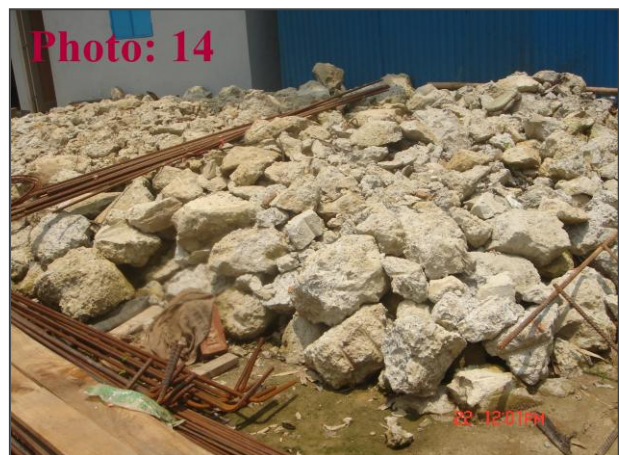
- **Drainage Congestion/ Water Logging:** No drainage congestion/water logging problem was observed.
- **Waste disposal/Management:** No planned practice of stockpiling of construction debris was observed. Under-construction debris and garbage are kept haphazardly. Garbage must be stockpiled and removed to a pre-selected distant place. (Photo: 14). FREs/ site supervisors should monitor this issue
