MULTIPURPOSE DISASTER SHELTER PROJECT (MDSP)
Monitoring & Evaluation (M&E) Consultant

FIELD VISIT REPORT

1. Period of Visit : 08 May – 09 May 2018
2. Location of Visit : Lakshmipur District.
3. Participant of visit : A.H.M. Mahbubur Rahman, TL, M&E Consultant,
Md. Matiur Rahman, Civil Engineer/ M&E Specialist, M&E Consultant,
Dr. Md. Barkat Ullah, Environment Specialist, M&E Consultant
4. Officials met during Visit :

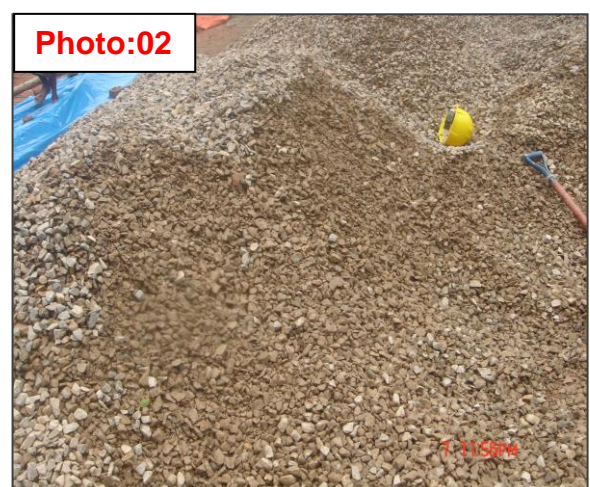
- Stone chips being used in **LAX-284** is found to contain mud and dust particles. (**Photo: 02**). The polluted stone chips should be well washed before use.

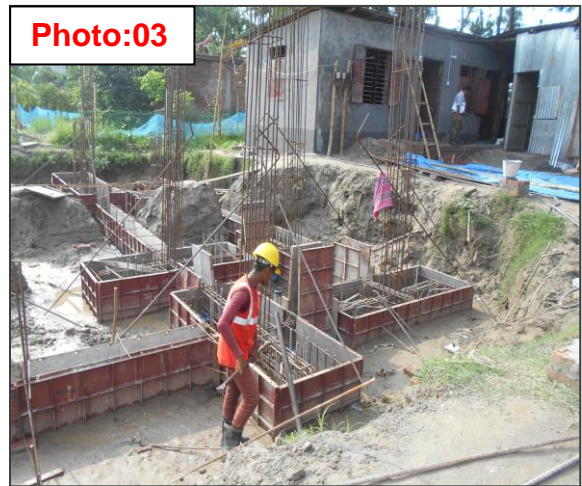
- Quality steel shutters have been used in all RCC works (**Photo: 03**).
- Site offices and labour sheds have been constructed in most of the sites except in **LAX-284**. Site offices are under construction in **LAX-105 & LAX-106**

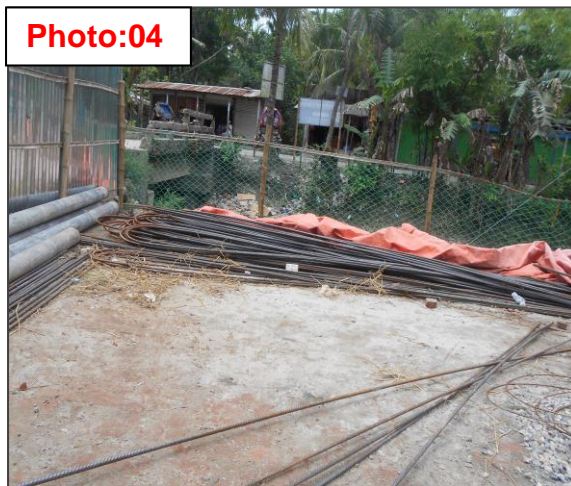
- MS rod has been stacked irregularly and haphazardly (**Photo: 04**). There should be raised platform in safe location to store MS rod, MS angles, Steel shutter materials etc.
- Excavated earth has been stacked irregularly and haphazardly (**Photo: 05**). Advised to immediately remove the earth to the demarcated waste disposal area.

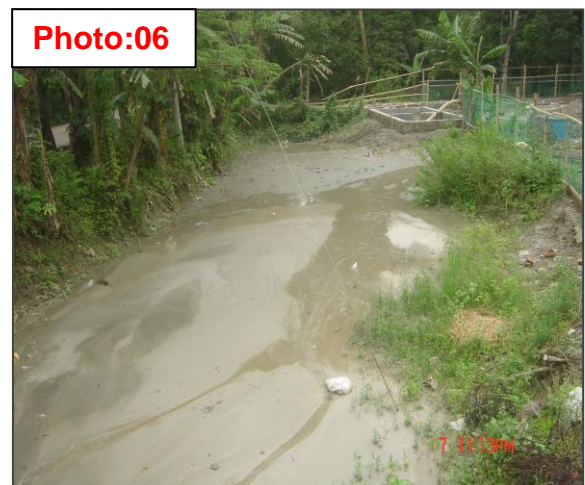
- **Creation of drainage obstruction.** At **LAX-163** shelter site, the drainage channel Tulatoli khal has been found to be filled in by the slurry coming from piling works. In no case, the drainage khal should be filled up creating obstruction to open drainage flow. The FRE of the D&S consultant and the Contractor were advised to take immediate measures to maintain free flow in the Tolatoli drainage khal (**Photo:06**).
- In **LAX-335**, the existing school playground has been destroyed to accommodate the construction of the shelter.
- The shelters have been designed as three storey buildings with provision of livestock accommodation on the 1st floor with ramp provision. The design provides construction of several numbers of cast in situ piles with variable lengths with pile diameter of 500 mm each.

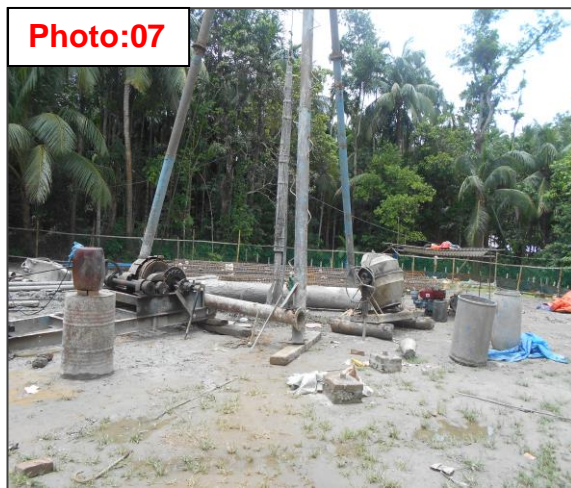
- **Cast in Situ Piles Casting:** All cast in situ piles with variable lengths with pile diameter of 500 mm each have been cast in **LAX-335, LAX-333, LAX-336, LAX-310, LAX-105 & LAX-106**. Works are still ongoing in **LAX-163, LAX-125 & LAX-284 (Photo: 07)**.
- **Pile Load Test:** Pile load tests have been done only in **LAX-335, LAX-310 & LAX-105**. Arrangement for Pile Load Test is still ongoing in **LAX-336 (Photo: 08)**.

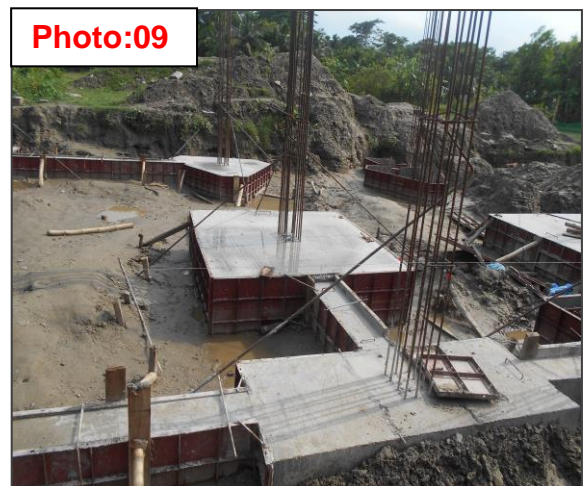
- **Pile Integrity Test:** Pile integrity test has been done in **LAX-105** only.
- **Pile Caps Casting including Bracing Beams:** Pile cap casting including bracing beams is underway only in **LAX-105**. Here, 12 nos. of pile caps out of total 31 nos. including bracing beams have been done (**Photo:09**). Rebar & shutter placement for the remaining pile caps casting is in progress at site.

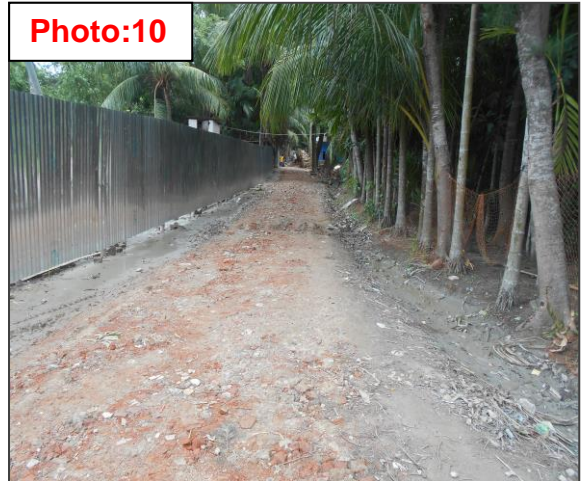
Construction works of the shelter connecting roads at shelter sites has not been taken up as yet (**Photo :10**).

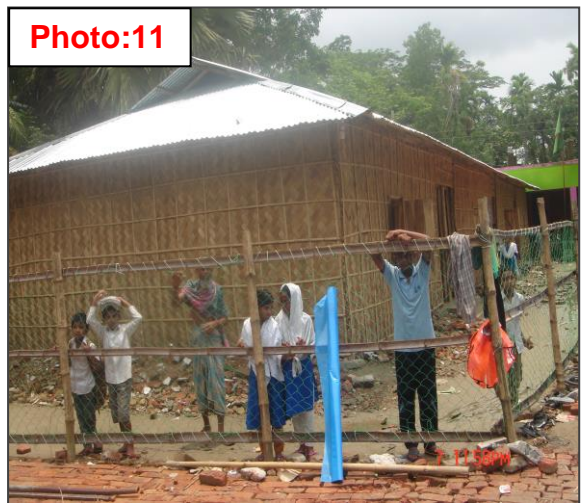
- **First Aid Box:** First aid boxes with standard contents have been procured at all sites.
- **Protective Fencing:** Protective fencing has been erected in almost all construction sites to keep the site away from public thoroughfare particularly students to avoid the danger of accident. The fencing is made mixed of CI sheets and nylon wires (**Photo: 11**).
- **Grass Turfs:** It is not required at the moment.
- **Vegetation and Tree Plantation:** Vegetation and tree plantation will be done in due time.
- **Water Filter:** Required nos. of water filters have been procured in each and every construction site (**Photo:12**).

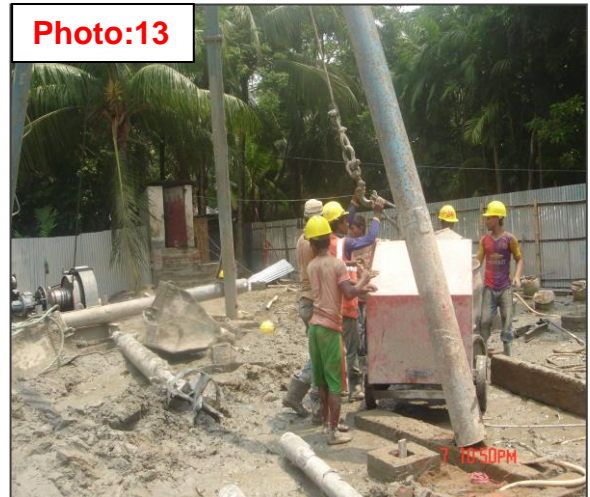
- **Safety Gear Package:** Safety gear package such as helmets, hand gloves, rubber shoes and light reflecting dresses have been procured in all construction sites. Labors are using this safety gear package during working period of shelter construction (**Photo:13**).

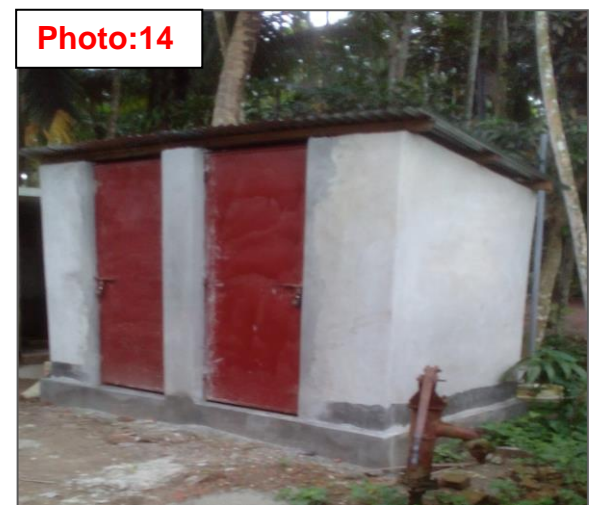
- **Temporary Sanitary Latrine:** Temporary sanitary latrines have been constructed for labors in all sites (**Photo:14**).

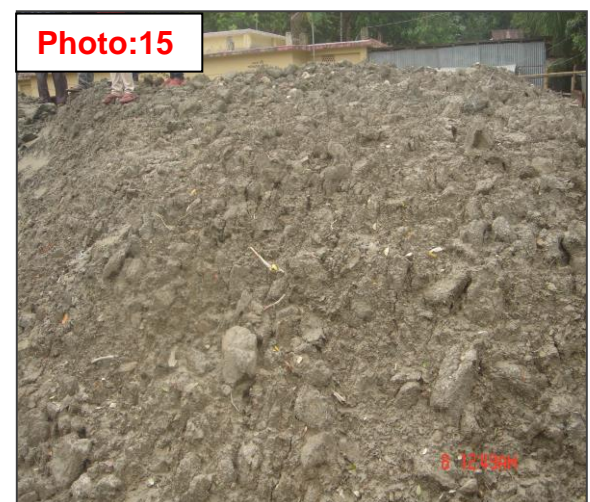
Mount of earth has been dumped right on the excavated pit of **LAX- 335** creating an unworkable environment at the site (**Photo:15**). Site Engineer informed that they will be arranging soon space for waste disposal.

- **Temporary Camp Site Waste Disposal Facility:** Demarcated area for waste disposal particularly for disposal of construction debris like earth, concrete etc. was not observed. The Contractor should arrange a separate demarcated area away from construction site to temporarily dispose construction debris in order to create a safe environment for smooth construction works.

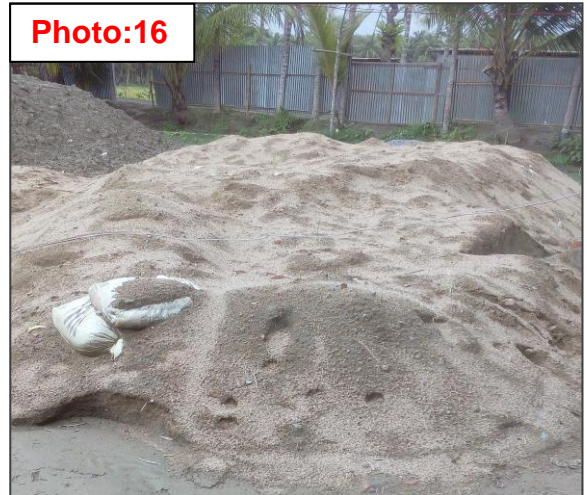
- **Dust Suppression Measures:** In some sites (LAX-163, LAX-125, LAX-335, LAX-333, LAX-336 and LAX 106), sand was kept covered in order to stop dust pollution while in **LAX-284 and LAX-310**, these were kept exposed. Sand should always be kept covered to protect from air pollution (**Photo:16**).

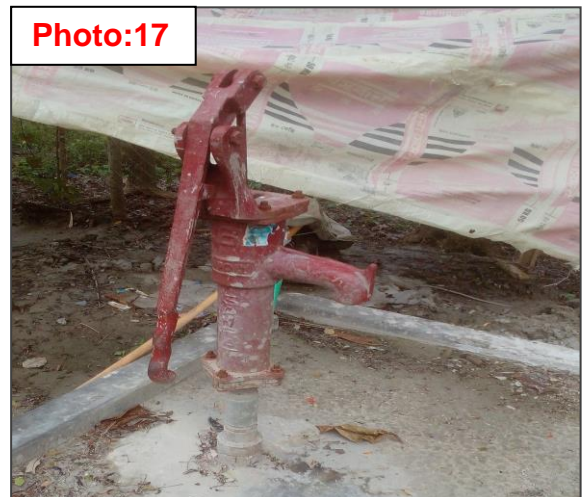
- **Tube Well:** Tube wells have been installed at all sites to have safe drinking water for the labors and site staff. The colour of head of the some tube wells is red. Red colour indicates arsenic presence and therefore should be coloured green or as appropriate (**Photo: 17**).

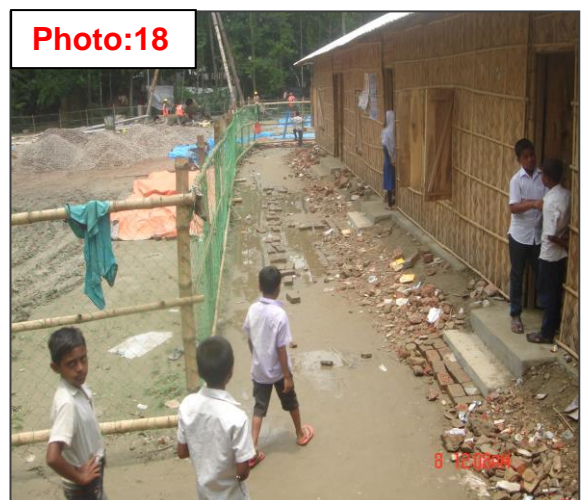
- **Construction of Temporary Shed for Uninterrupted Schooling:** The quality of most of the sheds to accommodate temporary schooling is relatively better although it is made of tarza fencing (**Photo:18**).

They however mentioned that due to dismantling of the existing school buildings, some temporary school sheds have been made as alternative accommodation for classes but the quality of the temporary needs to be improved.
