MULTIPURPOSE DISASTER SHELTER PROJECT (MDSP)
Monitoring & Evaluation (M&E) Consultant

FIELD VISIT REPORT

5. Activities of Visit : **Monitoring Field Activities of MDSP**
6. Sites visited : Package no. MDSP-II-7-LPI-0-NW-01 in Barisal district
Contractor: M/S. Navana Construction Ltd.

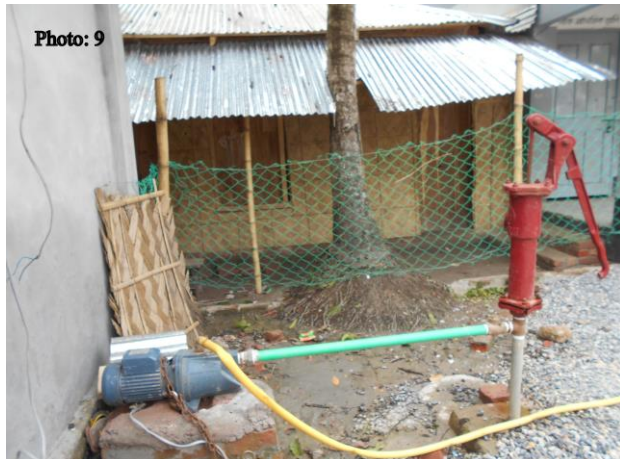
- Water Supply and Sanitation Facility: -Tube wells have been sunk. The wells are generally sunk at a depth of 275 m to 300 m to obtain good quality water free from salt and arsenic. Water quality tests are performed before installation of wells. Advised to colour the tube wells other than red as red coloured tube wells indicate arsenic presence (**Photo 9**).
- Air/Dust Pollution: In some sites, sand was kept under cover to stop dust pollution while in some sites, these were kept exposed. This should be kept under cover (**Photo 10**).
