**MULTIPURPOSE DISASTER SHELTER PROJECT (MDSP)**  
**Monitoring & Evaluation (M&E) Consultant**

**FIELD VISIT REPORT**

1. Period of Visit : 10 September – 11 September 2018
2. Location of Visit : Bhola District.
3. Participant of visit : A.H.M. Mahbubur Rahman, TL, M&E Consultant,  
Dr. Md. Barkat Ullah, Environment Specialist, M&E Consultant.
4. Officials met during Visit :

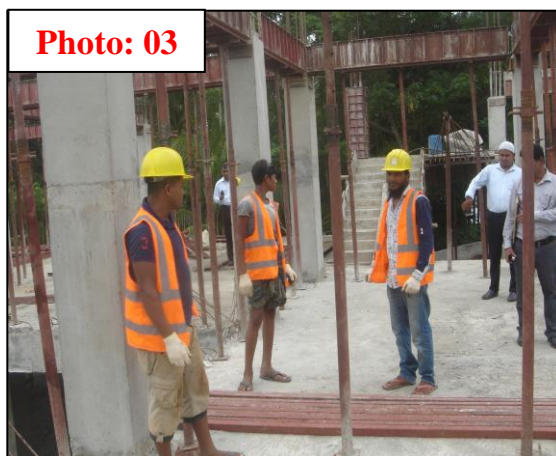
- Laboratory tests of MS rod, coarse sand, cement etc. are being done. Test reports of water, coarse aggregate/ fine aggregate have been made available in the field.
- The quality of stone chips are generally good, however at some sites, stone chips with relatively larger size have been found **(Photo: 02)**. Contractor representatives have been advised to use only properly graded stone chips following design requirement.
- Quality steel shutters with steel props have been used in all RCC works **(Photo: 03)**.
- Site offices and labor sheds have been constructed in most of the sites.
- MS rods have generally been properly stacked **(Photo: 04)** however with few exceptions.

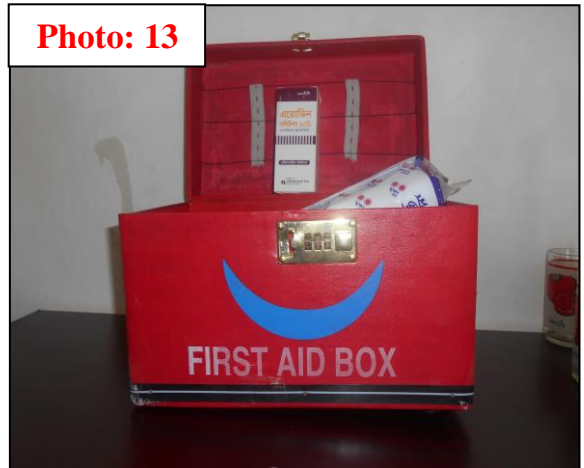
**Photo: 13**

- **First Aid Box:** 2 nos. first aid boxes with standard contents have been procured in all sites (**Photo: 13**). .

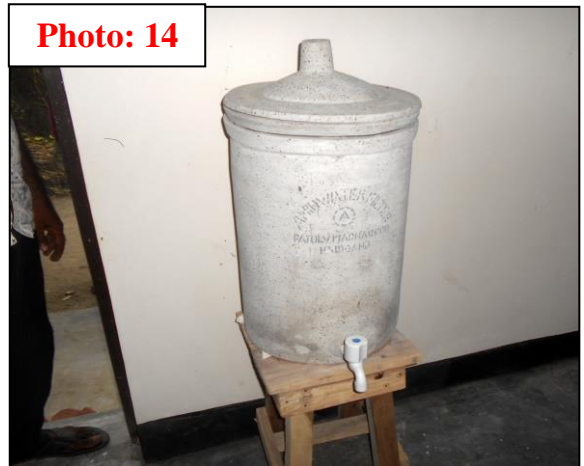
**Photo: 14**

- **Water Filter:** Ceramic water filters have been procured at all construction sites (**Photo: 14**).
- **Site Cleaning:** The site has been cleaned at mobilization stage.
- **Grass Turfs:** It is not due yet.
- **Tree Plantation:** Vegetation and tree plantation will be done in due time.

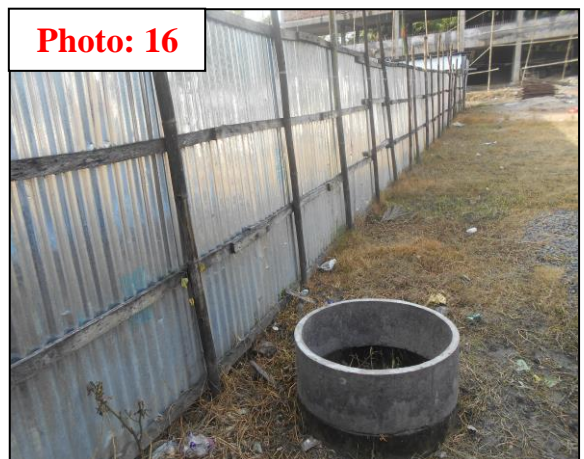
**Photo: 16**

- **Protection Fencing:** Protective fencing has been found in all construction sites. The fencing has been made by corrugated iron sheets (**Photo: 16**).

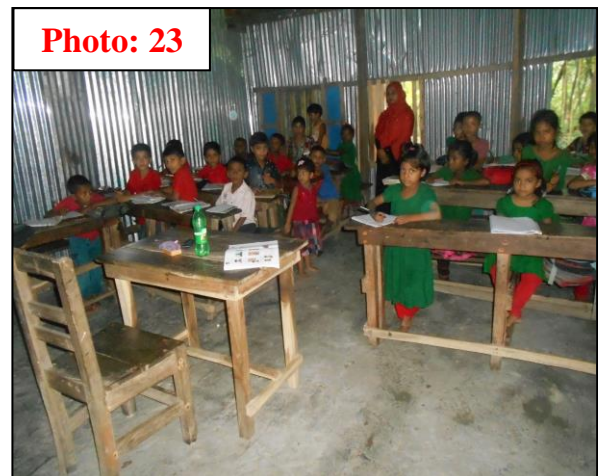
- **Construction of Temporary Shed for Schooling:** There is provision for construction of temporary sheds (75'x20') for class accommodation where existing school buildings had to be demolished (**Photo:23**).

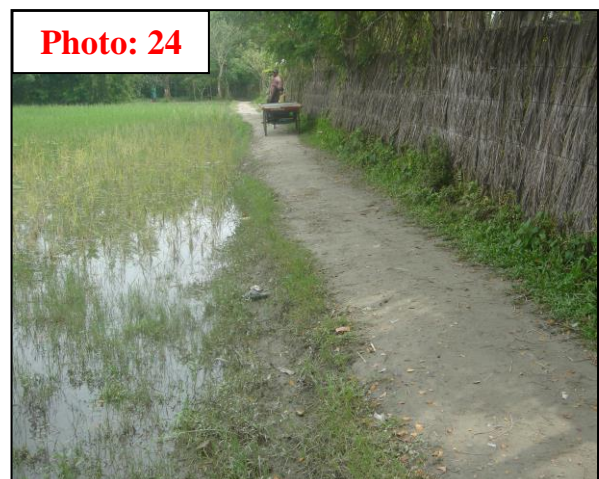
The school cum shelter buildings under contract have been mostly constructed in the existing school premises. So, there has been no need for land acquisition and resulting resettlement of PAPs. However, for the **SCR-43**, some additional land was required on both sides of the existing narrow kutchra road to build the SCR as per design (**Photo: 24**). One Mr. Shelim Howladar of **SCR-43** locality under Bhola Sadar UZ informed that the additional land needed for the road has been wilfully donated by the land owners. About 100 nos. betel nut trees had to be felled to accommodate the SCR. The tree owners themselves cut the trees willingly and took these away.
