MULTIPURPOSE DISASTER SHELTER PROJECT (MDSP)
Monitoring & Evaluation (M&E) Consultant

FIELD VISIT REPORT

1. Period of visit : 23-25 September 2017
2. Location of visit : Feni district.
3. Participants of visit : A.H.M. Mahbubur Rahman, TL, M&E Consultant
Md. Barkat Ullah, Environmental Specialist, M&E Consultant
4. Officials met during visit :

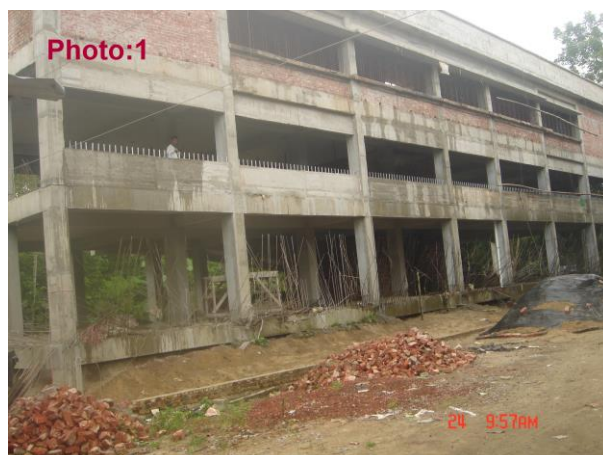
- The reported physical progress of the construction of the 6 new shelter works are as follows: **FEP-176: 65%; FEP-333: 32%; FEP-292: 30%; FEP-014: 34%, FEP-020: 36% and FEP-171: 63%.**
- The completion dates of almost all the shelters are **31 December 2017**. Progress of physical works in most of the shelters under **Contract Package No.03** are advanced compared to works of Contracts of **Packages 1 and 2**. It is however apparent that the works of the three packages may not be completed in time.
- **FEP-176:** all the RCC work of ground floor, 1st floor and 2nd floor has been done. The quality of concrete should be improved (**Photo 1**).
Because of scarcity of land, sanitary pit concreting has been done inside for subsequent placement outside (**Photo 2**).

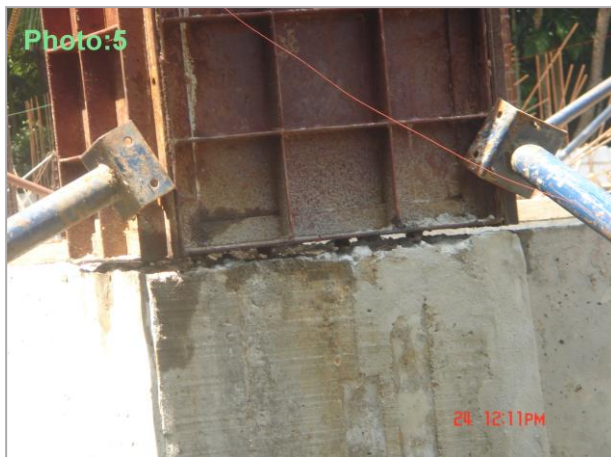
- There is bulging in the concrete of parapet which is seen to be scrubbed before plastering (**Photo 3**).
- **FEP-333:** construction of the grade beams have been done. Concrete quality of grade beam looks fairly good (**Photo 4**).
Preparation for casting columns above grade beam is in progress. Column shutters should be so placed that there remains no gap in the joint (**Photo 5**).
The labor shed has been made by using CI sheets but there is no cross ventilation arrangement. Ventilation arrangement should be made (**Photo 6**).
